JACKSON COUNTY SURVEYOR

SECTION CORNER RE-ESTABLISHMENT

SWAIN SURVEYING, INC.
27-1/2 N. Main Street
Ashland, Oregon 97520

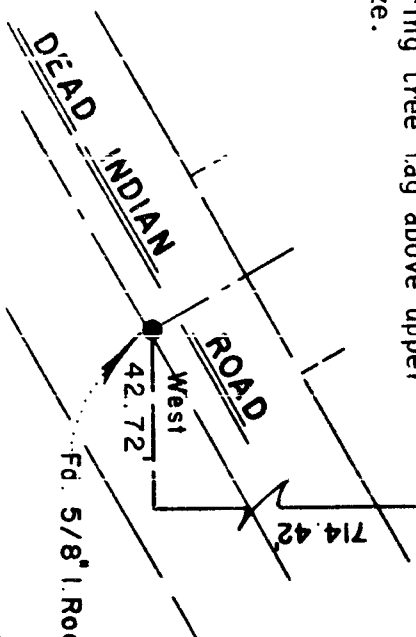
SECTION CORNER
Re-set 2" Galv. iron pipe with 3" diam. Br. Cap mkd: SWAIN SURVEYING T. 385.

N. 89° 00' W. 162.2'
A White Oak, 10-1/2" DBH, scribed PLS 759 in upper blaze & BT in lower blaze. Placed brass nail and tag mkd: LS 759 between the 'E' & 'T'. Placed T. 39 S.
bearing tree tag above upper blaze.

In July, 1986 the section corner common to Sections 31 & 32, T. 38 S., R. 2 E. and Sections 5 & 6, T. 39 S., R. 2 E., of the Willamette Base and Meridian, Jackson County, Oregon was visited by me and found to have been distributed. The location of this monument, as set by me in 1971, was 0.9+ West of the position as found in July of this year. From control points and monuments set by me in 1971 and recovered by me in July and October of this year, I proceeded to re-set the same and monuments set by me in 1971 and shown on Recorded Survey No. 4719. In 1971 there was no road in the immediate location as was monumented by me in 1971 and shown on Recorded Survey No. 4719. In 1971 there was a road in the immediate area. There is now a road West of said section corner. I believe this was the most likely reason for the section corner being disturbed. No fence corner now exist as was reported in Recorded Survey No. 4719. In 1971 the bearing trees were located by utilizing a Wild T-16 and a 300 foot metal tape. The re-measurements were made utilizing a Wild T-2 and a Topcon EDM1. There is a slight variation in bearing from the 1971 measurement due mainly to the lack of opening said blazes to get the same location as was used at that time. However, it is felt that the variation is well within reason. An additional bearing taken to help perpetuate this corner location. This corner location was monumented with the same galvanized iron pipe which is now set in concrete and a ring of stones, more or less flush with the ground. A metal post with a 'Survey Monument' warning sign was placed Southwesterly, 3 feet from said pipe monument. Measurements made to said corner location in 1971 were made with a H-P 3800A distance meter. Measurements made to said corner in 1986 were made with a Topcon DM-S1 distance meter. The basis of bearing is the same as Recorded Survey No. 4719.
