OREGON CORNER RESTORATION FORM

TOWNSHIP 33S RANGE 2E 528

400200 528/527
533/534

400220
S 1/4 28/27

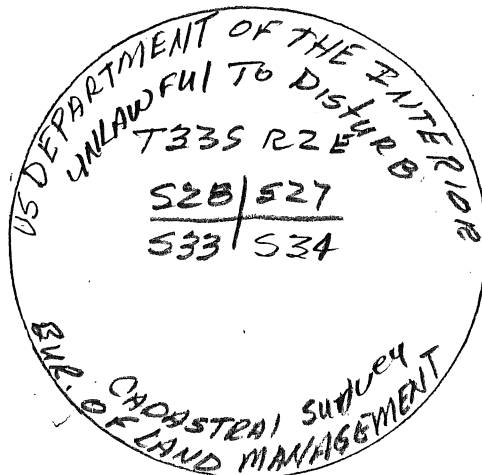
- BLM BRASS CAP
- 14" SAWED FIR STUMP N122°E 20⁵ FT HEALED SCAR
- 26" SAWED FIR STUMP N26°W 37² FT (ROTTED)
- Monument Detail 19" SAWED FIR STUMP N149°E 29² FT GOOD SCAR
- 22" FIR S72¹/₄°E 42² FT GOOD SCAR
- 19" CAPPED FIR STUMP S68°W 63⁴ FT GOOD SCAR
- 26" SAWED FIR STUMP N10°W 42² FT GOOD SCAR
- 15" W. FIR N7¹/₄°E 31⁴ FT GOOD SCAR
- 24" FIR S64¹/₂°W 8⁴ FT GOOD SCAR
- 18" FIR N53°W 40³ FT GOOD SCAR
