MAP of SURVEY

Donation Land Claim No. 38 &
the Northwest Quarter of Section 5,
Township 39 South, Range 1 East of the
Willamette Base & Meridian, Jackson County, Oregon.

Survey Narrative to comply with O.R.S. 209.250
Oregon Revised Statutes

Blossom View Estates

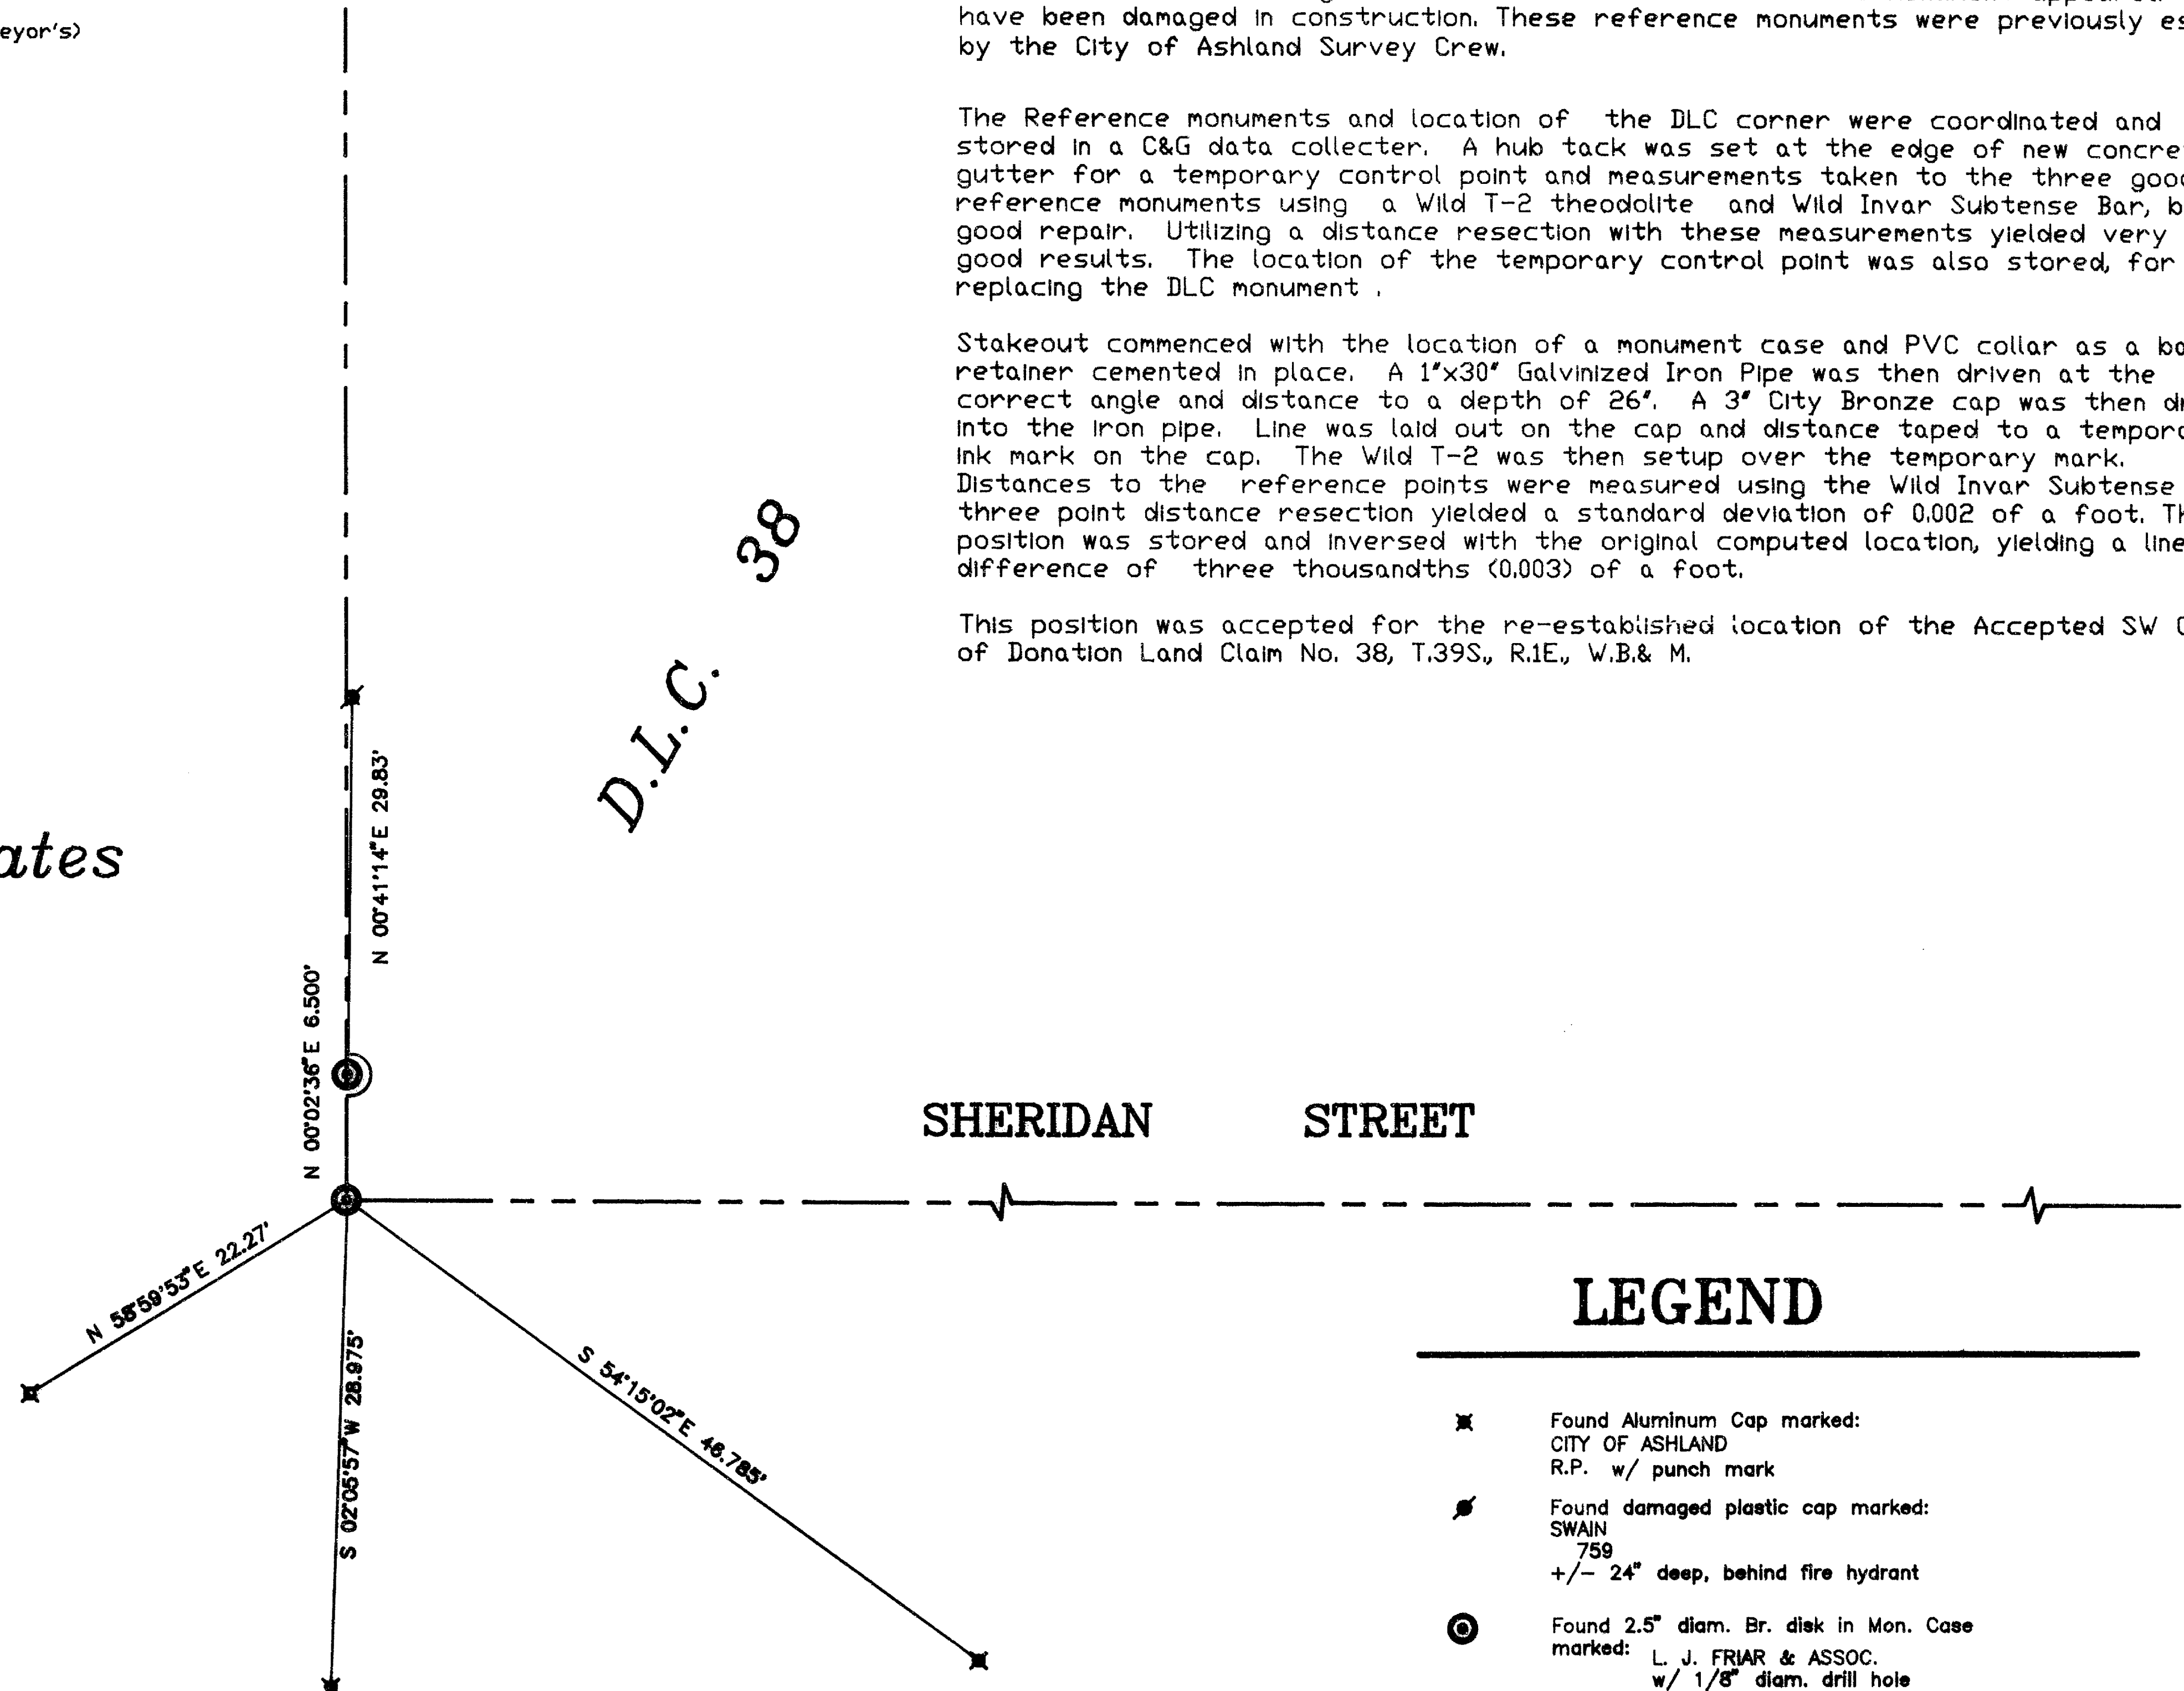
Field investigation of Blossom View Estates, a Planned Community in the City of Ashland and the Northwest Quarter of Section 5 Township 39 South, Range 1 East of the Willamette Meridian, revealed that the monument for the Southwest Corner of Donation Land Claim 38, T.39S, R.1E, Jackson County had been disturbed in construction and reset some 2 ft. out of position by parties unknown. Also found were three (3) of four reference monuments in good condition. The fourth reference monument appeared to have been damaged in construction. These reference monuments were previously established by the City of Ashland Survey Crew.

The Reference monuments and location of the DLC corner were coordinated and stored in a C&G data collector. A hub tack was set at the edge of new concrete gutter for a temporary control point and measurements taken to the three good reference monuments using a Wild T-2 theodolite and Wild Invar Subtense Bar, both in good repair. Utilizing a distance resection with these measurements yielded very good results. The location of the temporary control point was also stored, for use in replacing the DLC monument.

Stakeout commenced with the location of a monument case and PVC collar as a bank retainer cemented in place. A 1"x30" Galvanized Iron Pipe was then driven at the correct angle and distance to a depth of 26". A 3" City Bronze cap was then driven into the iron pipe. Line was laid out on the cap and distance taped to a temporary ink mark on the cap. The Wild T-2 was then setup over the temporary mark. Distances to the reference points were measured using the Wild Invar Subtense bar. A three point distance resection yielded a standard deviation of 0.002 of a foot. This position was stored and inverted with the original computed location, yielding a linear difference of three thousandths (0.003) of a foot.

This position was accepted for the re-established location of the Accepted SW Corner of Donation Land Claim No. 38, T.39S, R.1E, W.B.& M.
