# MAP OF SURVEY POST CONSTRUCTION MONUMENT RECOVERY

LOCATED IN THE SOUTHEAST 1/4 OF SECTION 23  
TOWNSHIP 38 SOUTH, RANGE 1 WEST, WILLAMETTE MERIDIAN  
JACKSON COUNTY, OREGON

SURVEY FOR: ROGUE VALLEY SEWER SERVICE  
138 WEST VILAS RD, CENTRAL POINT, OR 97502 SHEET 1 OF 1

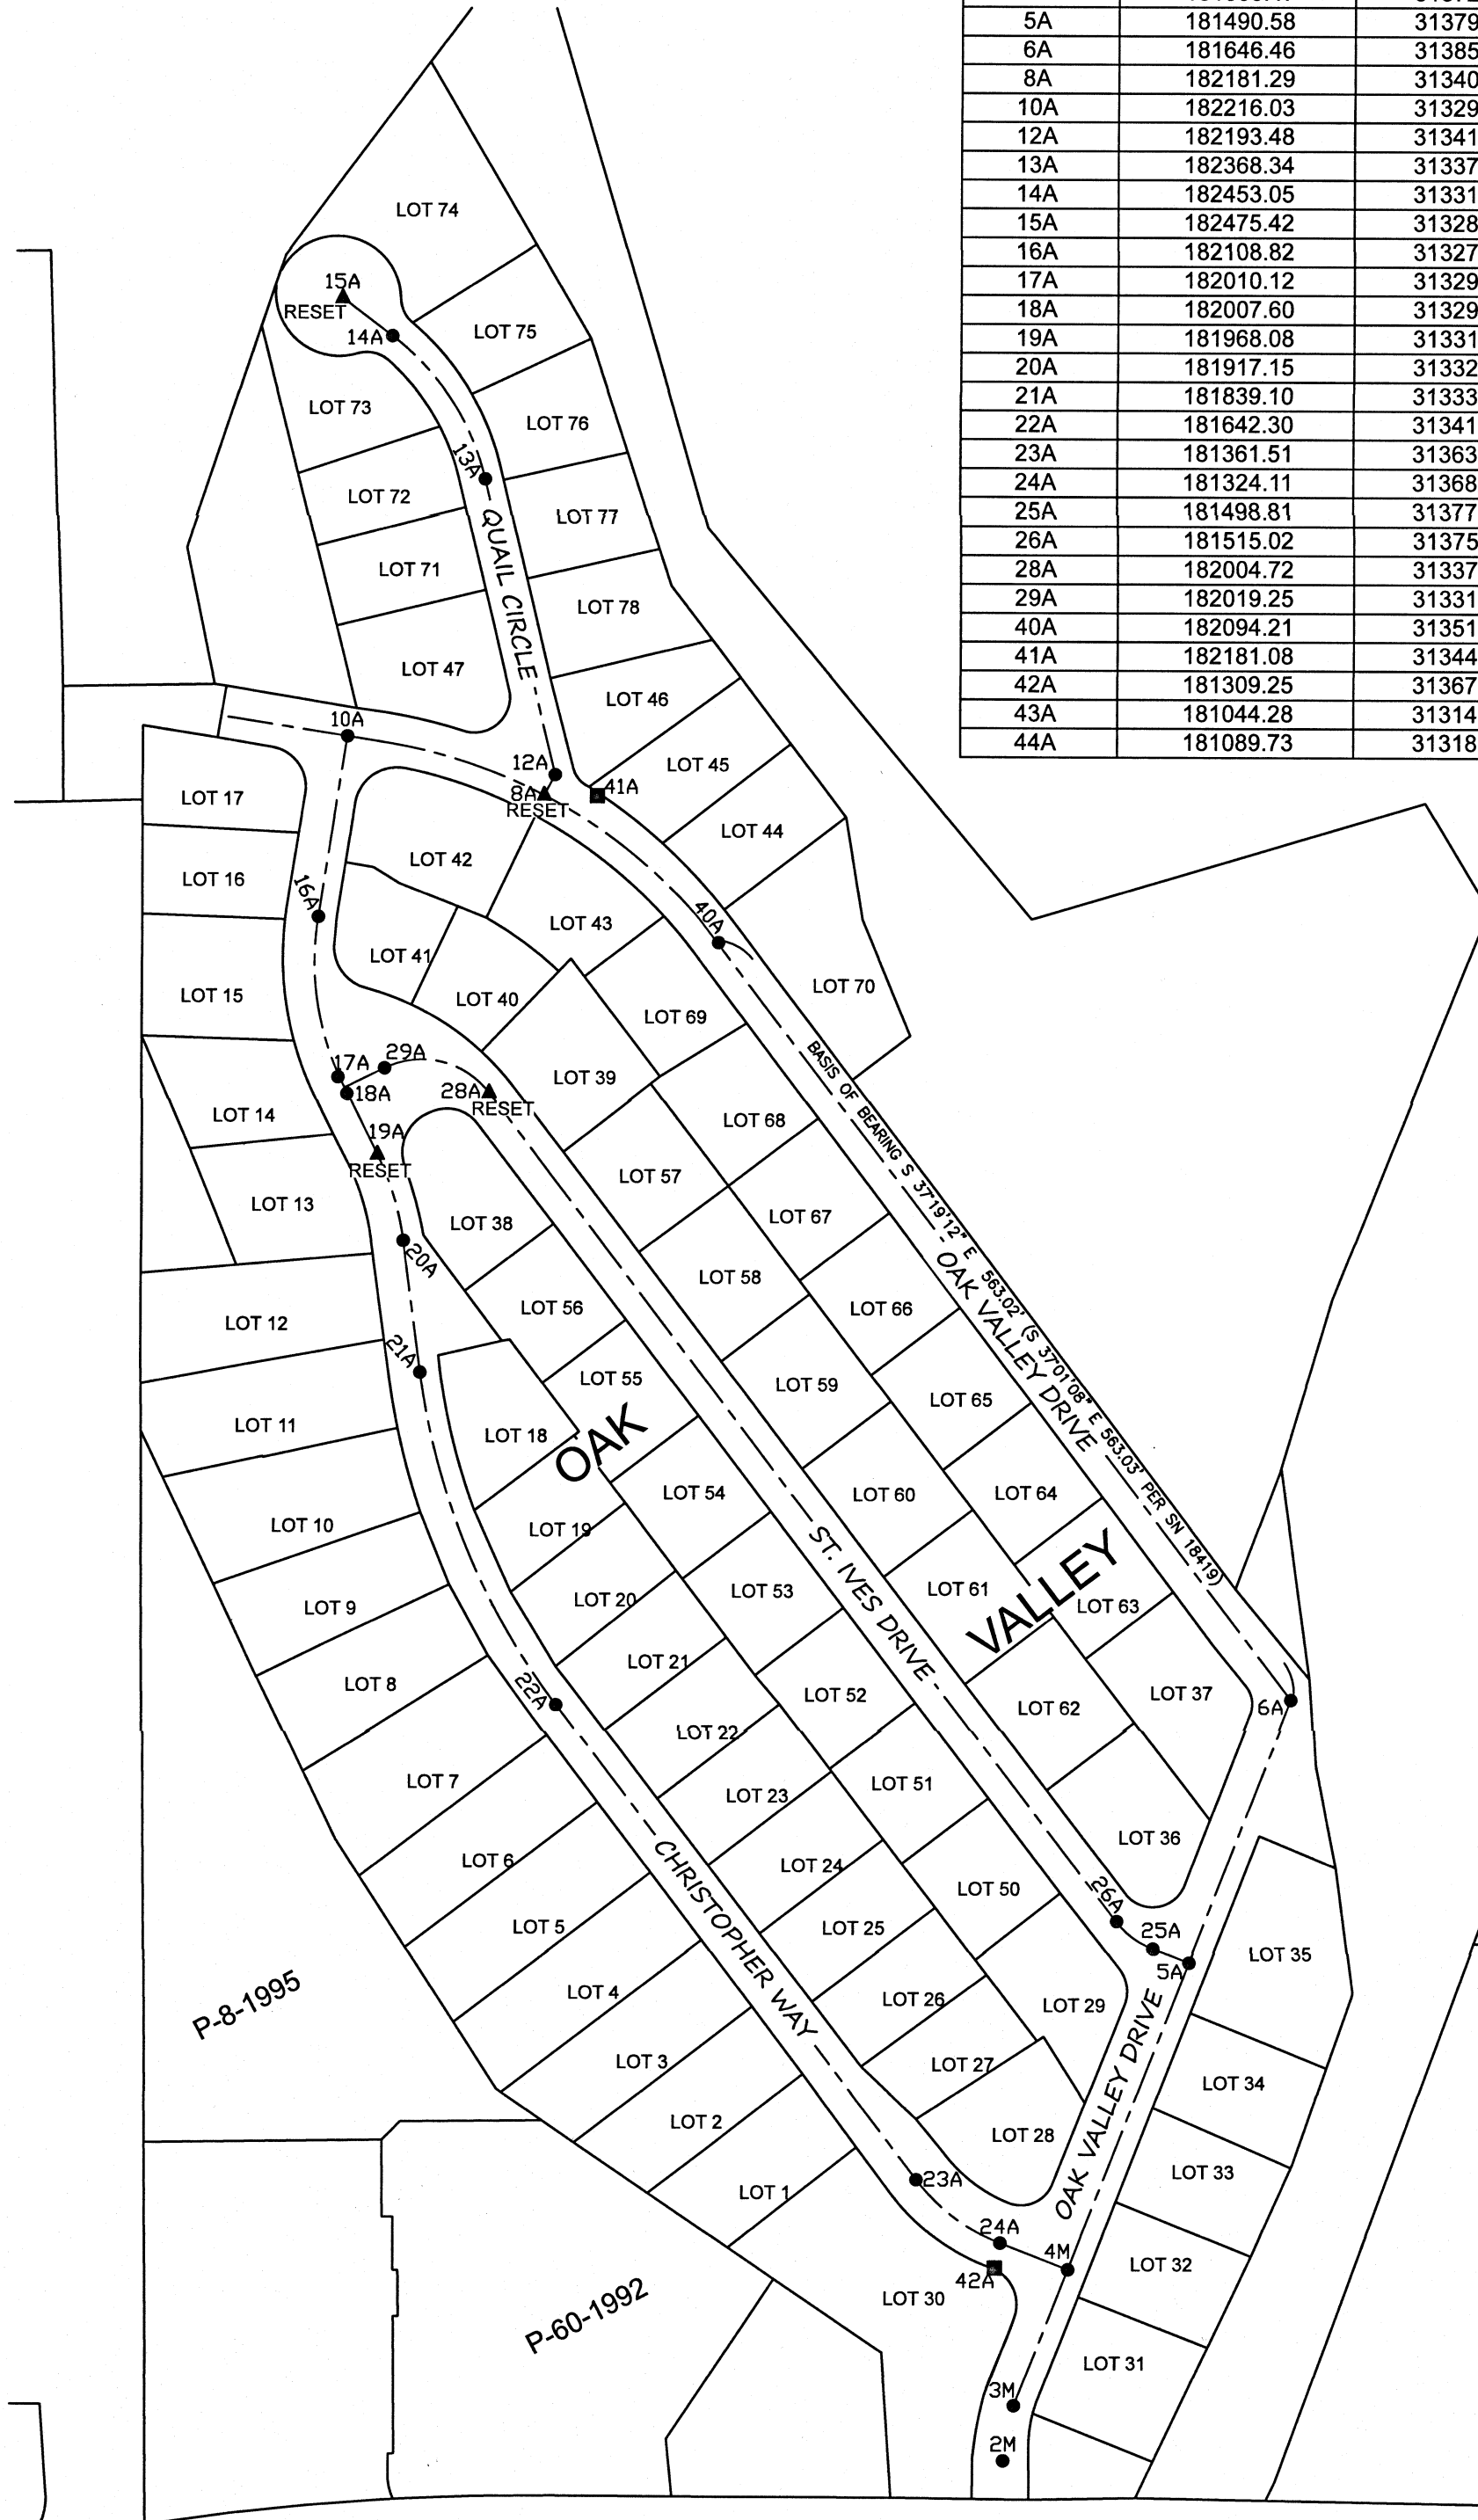
THIS SURVEY WAS PERFORMED POST CONSTRUCTION TO THE ROGUE VALLEY SEWER PROJECT "J331 OAK VALLEY SEWER REIMBURSEMENT PROJECT". USING FILED SURVEY NUMBER 23354 AS THE BASIS FOR CONTROL TO SEARCH FOR AND DETERMINE WHAT MONUMENTS HAD BEEN DESTROYED DURING SAID CONSTRUCTION. IT WAS FOUND THAT ONLY POINTS 8A, 15A 19A AND 28A HAD BEEN DESTROYED AND NOW RESET IN THEIR ORIGINAL LOCATION AS SHOWN HERE-ON. AFTER SAID CONSTRUCTION THE ENTIRE NETWORK OF STREETS WERE OVERLAYED WITH 1"-2" OF ASPHALT COVERING BUT NOT DISTURBING OR DESTROYING MONUMENTS.
