**SURVEY IN S. 1/2 SEC. 36, N. 1/2 SEC. 1, T. 36 & 37 S., R. 2 W.  
 FOR: JACKSON CO.  
 PROJECT NO. 8722 & 8809**

BY: EDWARD MC GINTY  
 JACKSON CO. SURVEYOR  
 COUNTY COURT HOUSE  
 MEDFORD, OREGON

S SCALE 1"=400'  
 MONUMENT SEE NARRATIVE  
 JULY 22, 1988

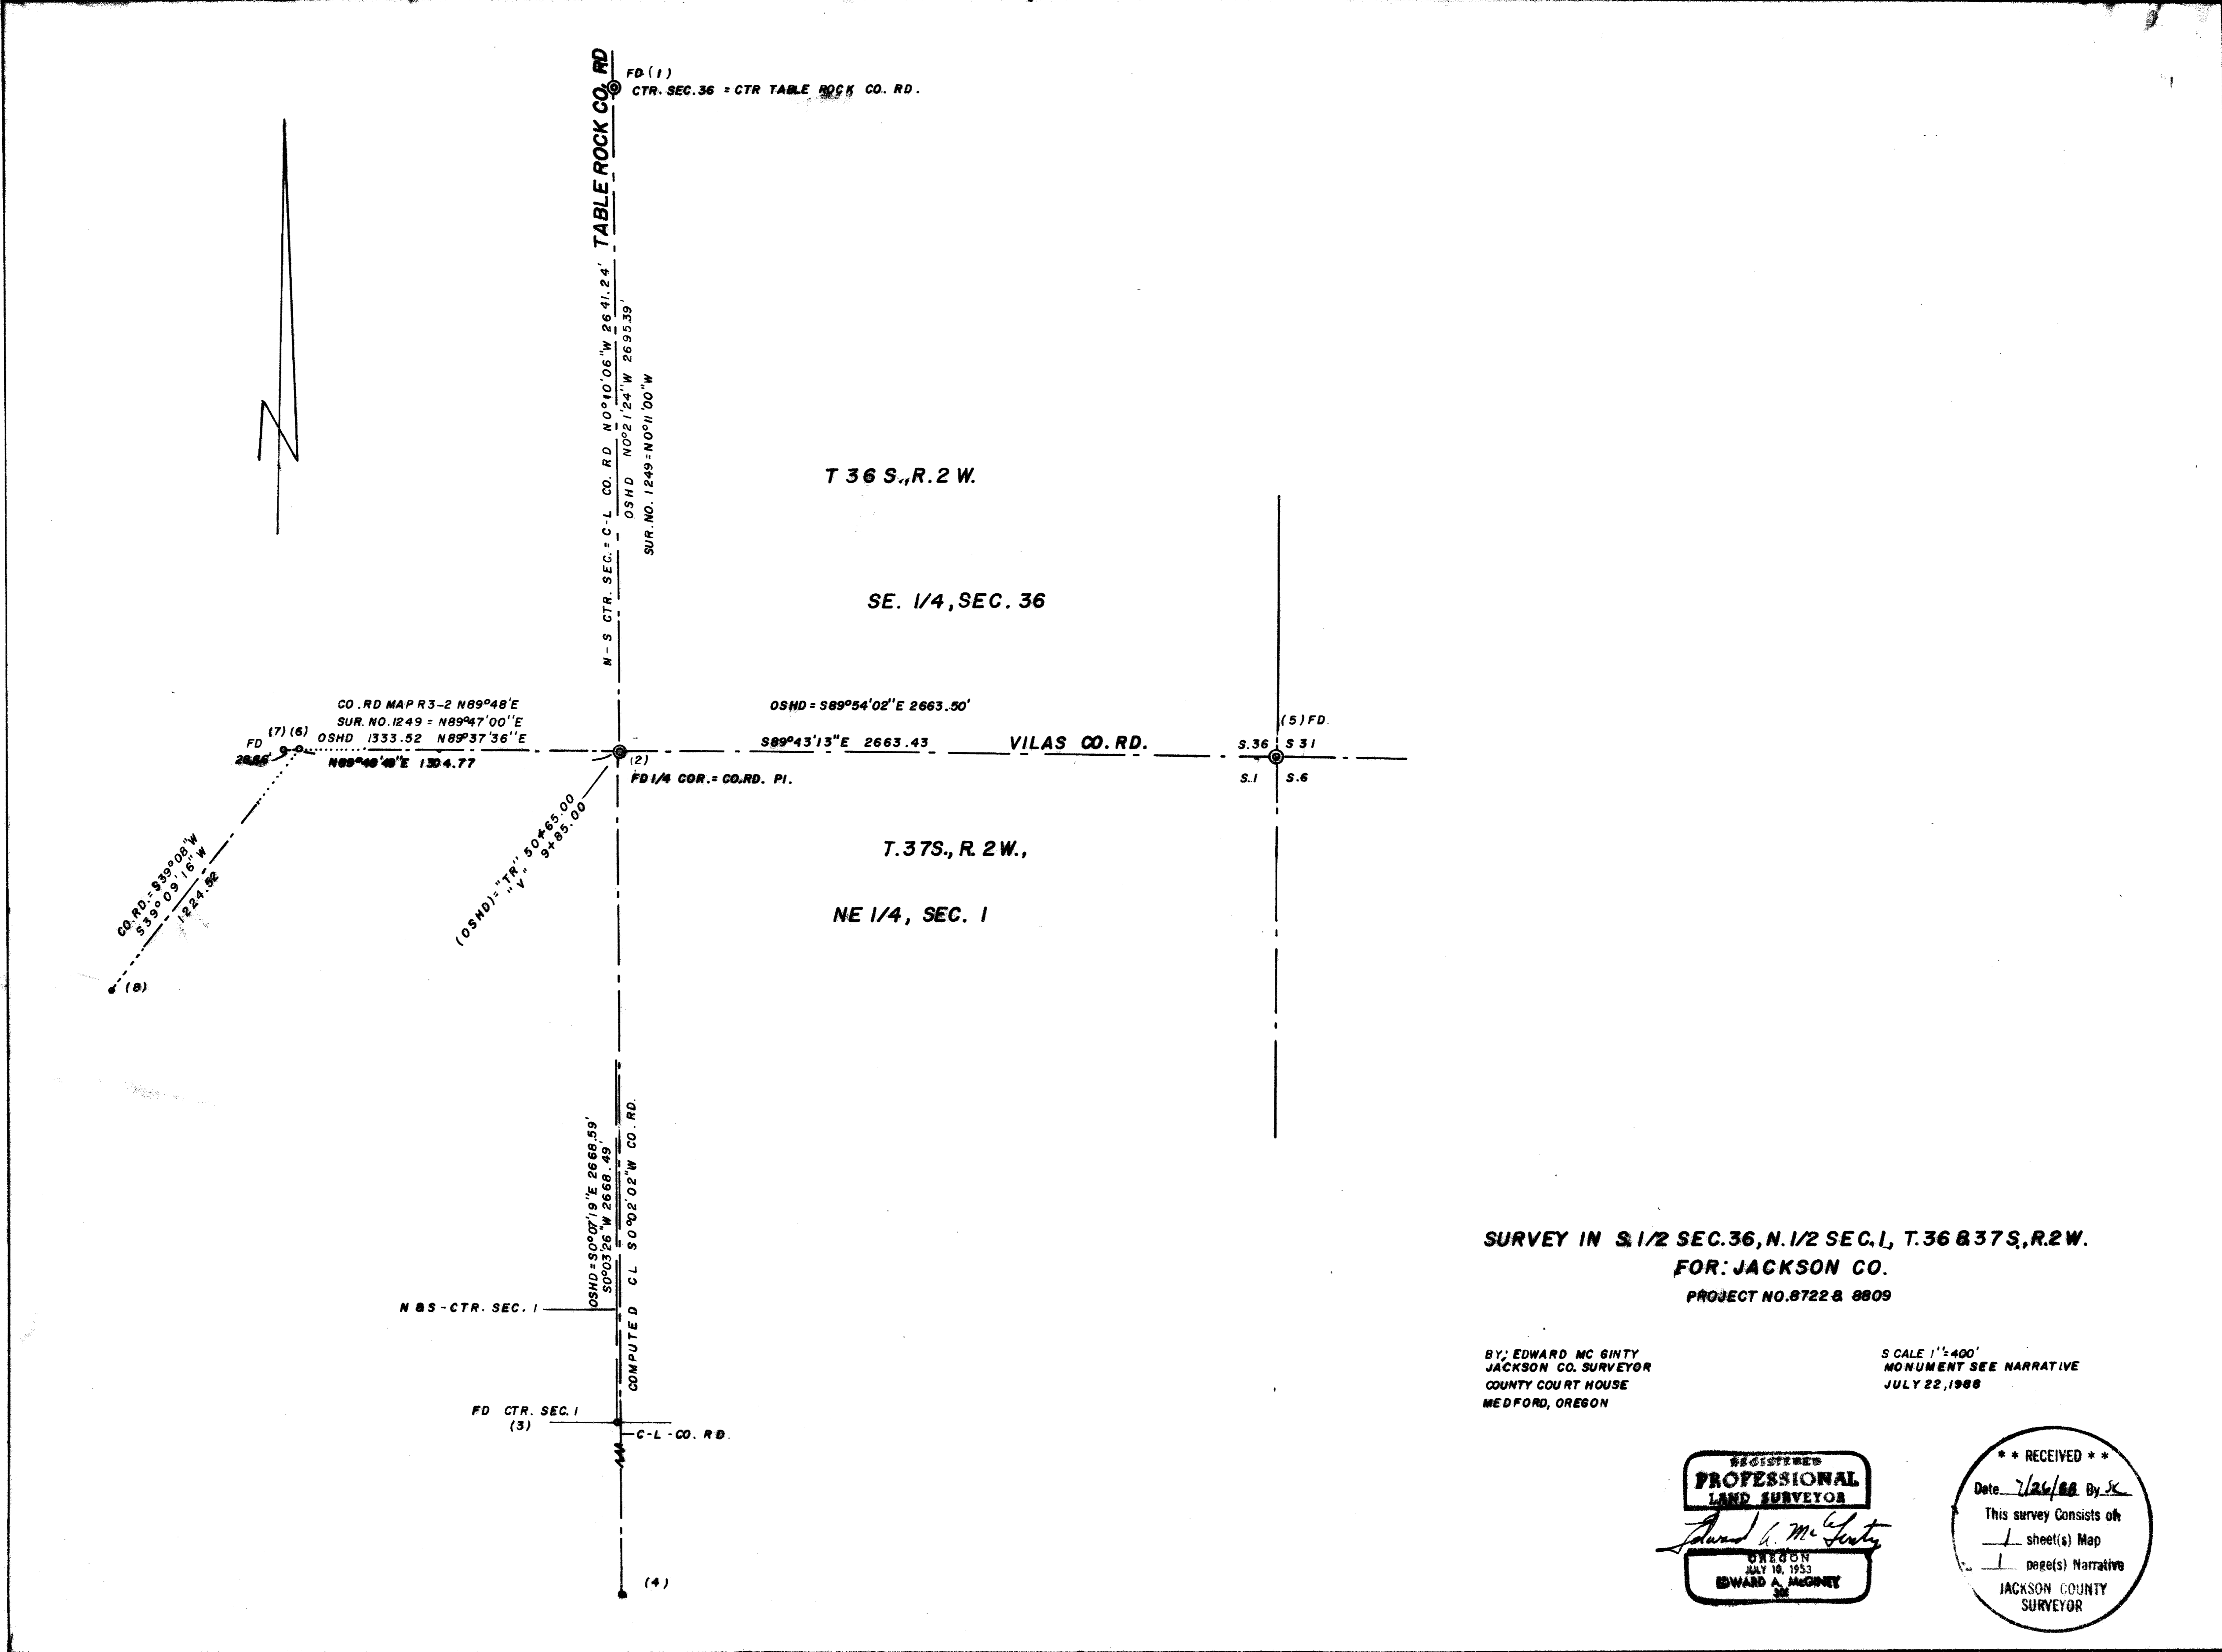
LOCATION: South half of Section 36, Township 36 South, Range 2 West and  
the North half of Section 1, Township 37 South, Range 2 West  
of the Willamette Meridian in Jackson County, Oregon.  
Vilas and Table Rock County Roads.

In order to preserve evidence and to verify the certain findings from older  
surveys, a resurvey was made as shown at the intersection of Vilas and Table  
Rock Roads. The location of points 4 and 8 were determined from old previous  
co-ordinates.

- (1). Center of Section 36, found stem of brass cap bent slightly.
- (2). Quarter corner of Sections 36 and 1; found 3/4" pipe approximately  
10" deep, (see official re-establishment notes), now a brass cap  
and concrete monument.
- (3). Center of Section 1; found brass cap, 10" deep. (Now brass cap  
monument, flush, see official re-establishment notes).
- (4). Computed location from previous co-ordinates. S0°02'02"W, 8772.60 ft.  
(Record brass cap on center of Table Rock and shown on Survey No.  
2287).
- (5). Corner of Sections 1, 6, 31 and 36 found with monument case and concrete  
monument with brass disc, 6" deep.
- (6). County Road PI (Map R-3-2). Found 3/4" I. Pin 4" deep.
- (7). Found 1" I. Pin approximately 10" deep as shown on county map R-3-2.
- (8). Computed location from 1975 traverse being a 3/4" pipe set flush,  
county road PI.

The OSHD data shown on this map was computed from co-ordinates shown on Oregon  
State Highway Division drawing No. 1A-18-30.
