## SURVEY NARRATIVE TO COMPLY WITH PARAGRAPH 209.250. OREGON REVISED STATUTES

Purpose: To survey and monument the lands described within Deed Document 99-28027.

PROJECT: 07-08
TAX LOT REF. 35-4W-16D 2800

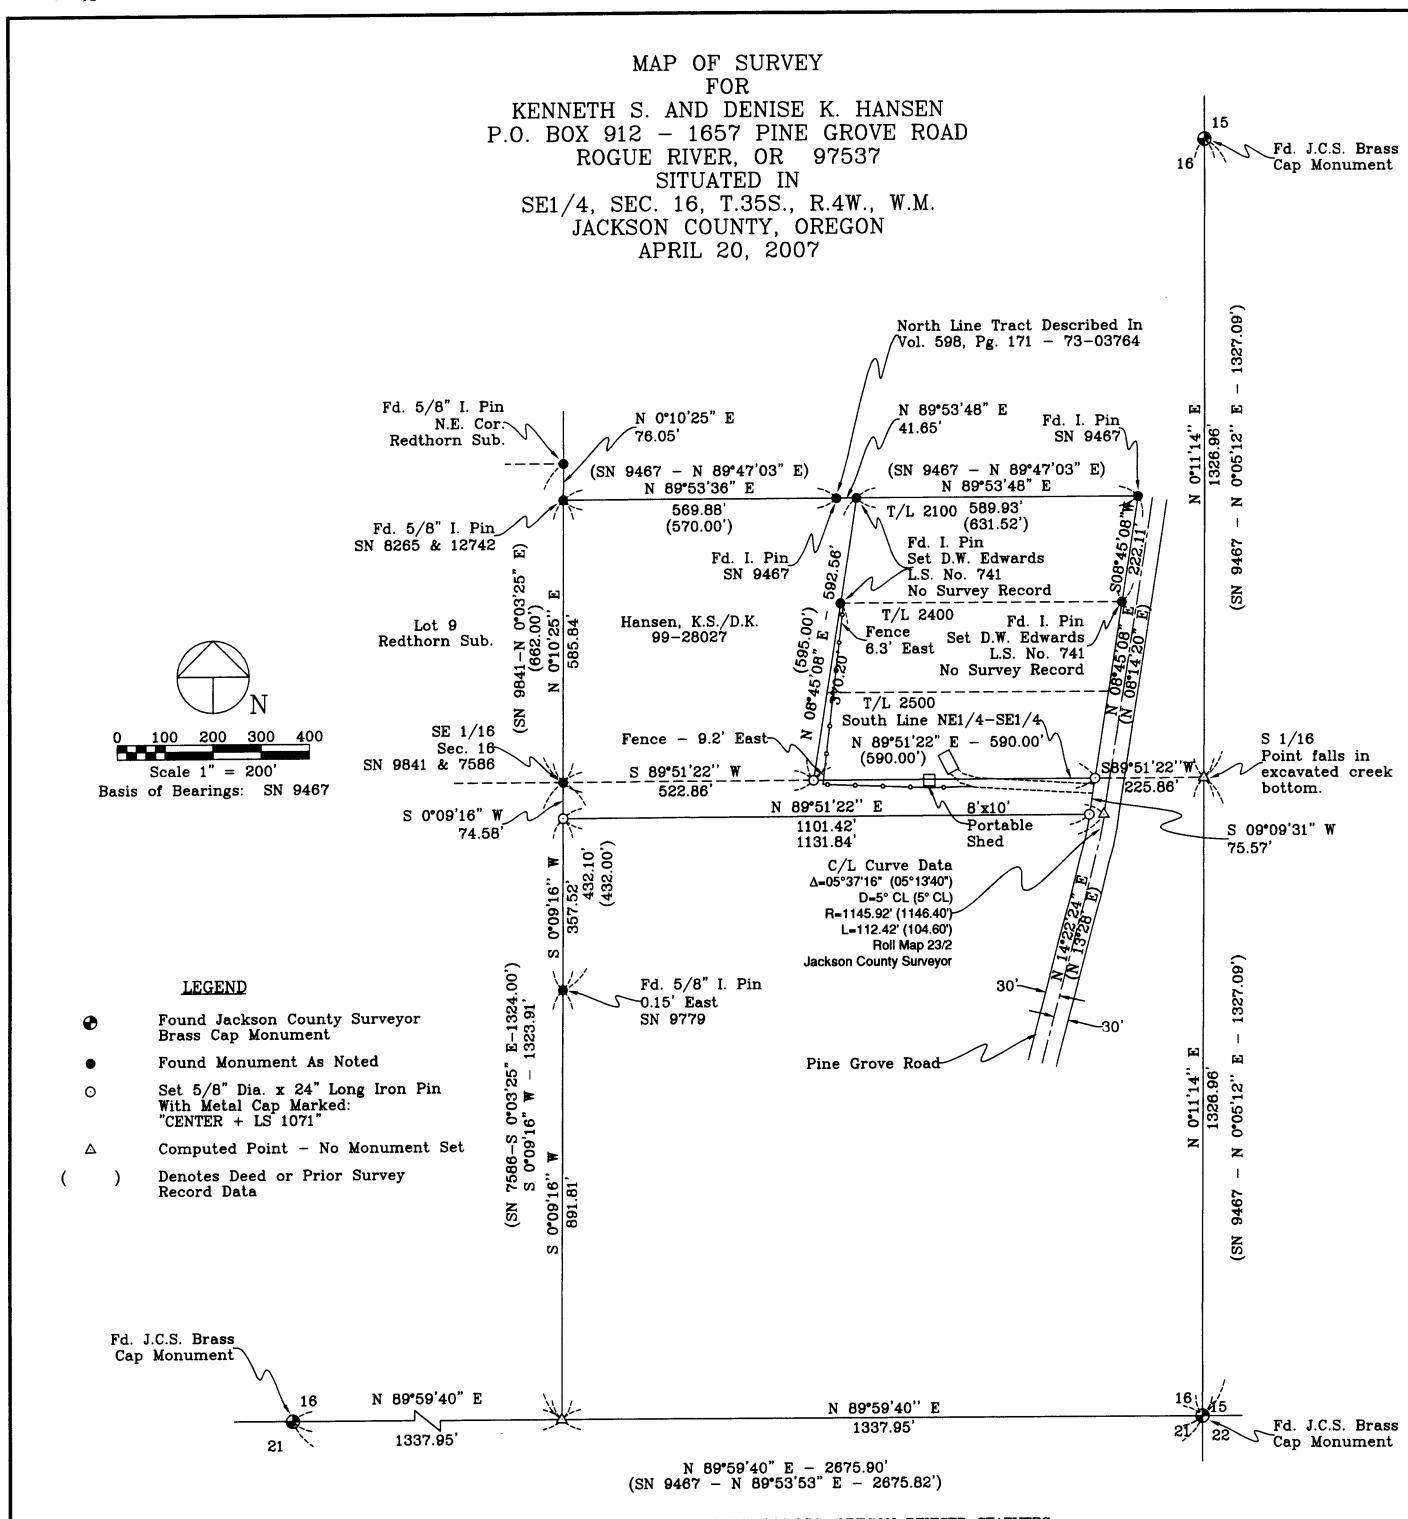
Procedure: Performed survey ties to controlling section corners and recovered corners established by prior surveys. I verified the position of recovered corner points and established corner monuments as shown on the attached map of survey. The alignment of Pine Grove Road was determined from previously established monuments recovered on the westerly right-of-way line and the existing painted centerline alignment. This alignment was utilized to control the East line of my client's property. Fence, driveway, access to Tax Lot 2500 and portable storage shed encroach on Tax Lot 2800. Current owner of Tax Lot 2500 indicated he utilized the fence between Tax Lots 2400 and 2500 to determine fence and driveway. Said fence not situated on the property line leading to the encroachment.
