BOUNDARY LOCATION
PROPERTY SITUATE

JACKSON LOT 15 GERDES TERRACE IN THE
JAN 27 1953 SE 1/4 SEC. 20, T. 375, R I W. W. M.
JACKSON COUNTY, ORE.

J. H. CLABBY MEDFORD, OREGON GIVIL ENGINEER
AUGUST 1952

Survey Narrative to Comply with Section 87-330, 1947 Oregon State Laws.

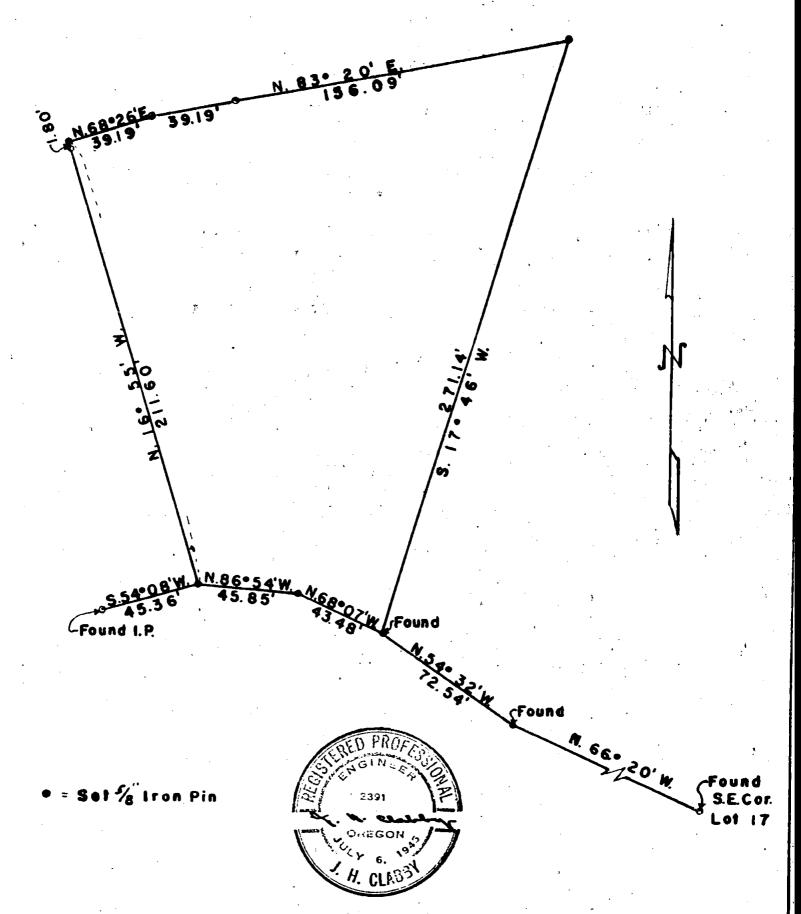
SCALE 1'= 50'

To survey and establish the property corners of Lot No. 15.

Found iron pin at a point 25 feet south of the Southeast corner of Lot 17. Found iron pin at the Northwest corner of Lot 17. Computed bearing and distance between said corners North 66° 20' West 283.48 feet. Ran North 54° 32' West 72.54 feet and found iron pipe at Southeast corner of Lot 15, thence North 68° 07' West 43.48 feet to angle point, thence North 86° 54' West 45.85 feet to Southwest corner Lot 15, thence South 54° 08' West 45.36 feet and found an iron pipe which checked for bearing and distance.

With transit on Southwest corner Lot 15 ran North 16° 55' West 209.80 feet to an iron pipe. Continued on same bearing for a distance of 1.80 feet and set on iron pin for the Northwest corner of Lot 15. From the Southeast corner of Lot 15 ran North 17° 06' East 267.3 feet for the Northeast corner of Lot 15. This failed to close by approximately 10 feet and the distance and bearing were therefore adjusted to North 17° 46' East 271.14 feet which fits the existing points within reasonable limitations.
