## SURVEY NARRATIVE TO COMPLY WITH ORS 209.250 OREGON REVISED STATUTES

Jackson County et al

LOCATION:

October 2, 1984

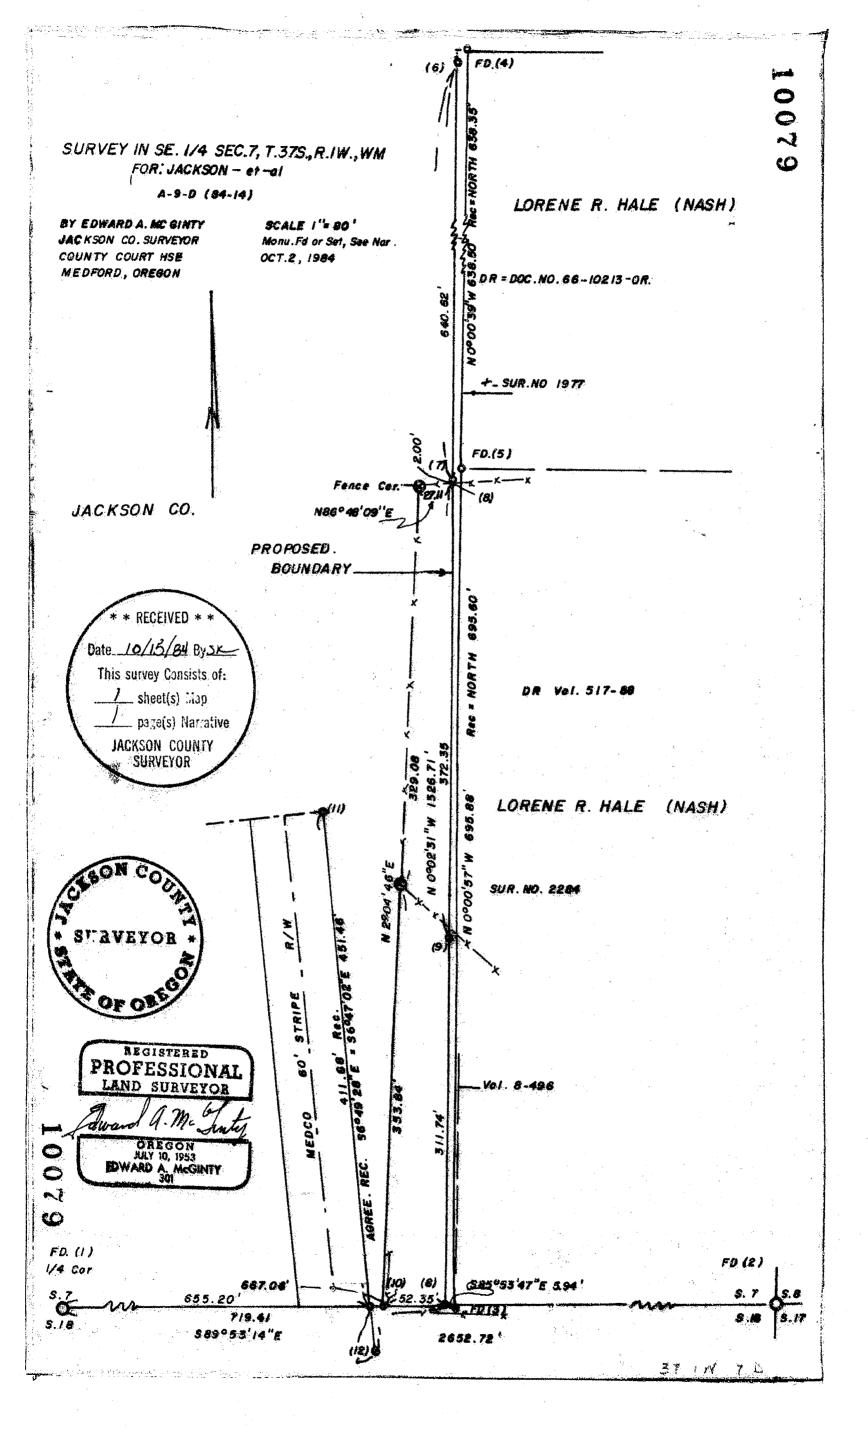
- (10) Set 5/8" x 30" iron pin with plastic cap mkd. Jackson Co. Surveyor, (flush with surface).
- (11) Set 5/8" x 24" iron pin with plastic cap mkd. Jackson Co. Surveyor, (flush with surface).
- (12) Set 5/8" x 24" iron pin with plastic cap mkd. Jackson Co. Surveyor, (flush with surface).

This survey is made in conjunction with Survey No. 10078 for the same basic reason; to resolve uncertainties of the boundary between Jackson County and the Hale property (previously Nash).

## MONUMENTS:

- (1) See narrative on Survey No. 10078. Found an iron pipe with bronze cap.
- (2) Found an iron bolt approximately 2" deep in monument case (see official records of Jackson County Surveyor, page 98).

- (3) Found 5/8" iron pin, flush. Established on Survey No. 1516 and shown on Survey Nos. 1977 and 2284.
- (4) Found a badly bent and twisted ½" rebar established on Survey No. 1977, this pin was removed and replaced with ½"x18" pin in same hole. Probable accuracy is plus or minus 0.10 feet of original location. (Original pin set alongside).

- (5) Found badly bent 5/8 iron pin established on Survey No. 1516 and shown of Survey No. 1977. This iron pin was straighten and reset in previous hole (plus or minus 0.05 ft of its original position).
