SURVEY NARRATIVE TO COMPLY WITH PARAGRAPH 209,250 OREGON REVISED STATUTES

SURVEY FOR:

JACKSON COUNTY

The Northwest quarter of Section 24, Township 38 South, Range 1 West, Willamette Meridian, Jackson County, Oregon.

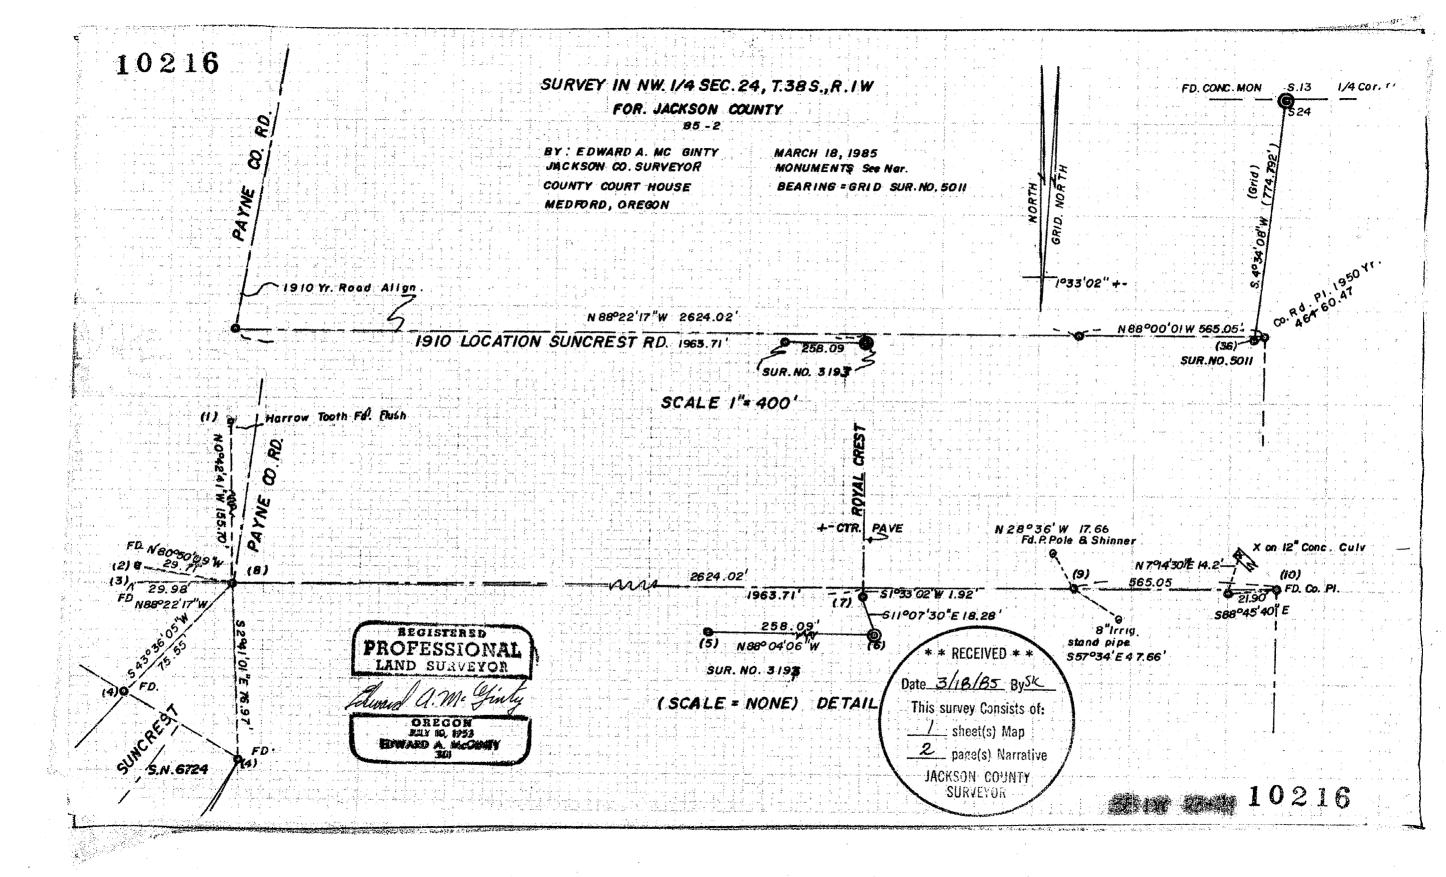
Survey No. 5011 between the quarter corner and point No. 36. This is a grid bearing (State Coordinate South Zone 1927). Rotated bearings counter clockwise by 1°33'02" to the true bearing. Distances are shown as being unadjusted horizontal distances. Also this survey was an open ended traverse.

At the quarter corner between Sections 13 and 24, T38S,RIW, found a concrete mon. with brass disc, 10 ins. deep.

- 1) Found harrow tooth, 2" deep, southeast of fence. Corner being same as monument identified as an iron pin on Survey No. 731.
- 2) Found iron polt 6" deep bent. This bolt was straighten and reset at or near its original position. The origin of this is not positively identified. (See Co. Rd. notes).
- 3) Found original angle iron in good condition and approximately 2" deep. This was set on Survey of Roads No. 56 (Suncrest now) in 1910. See Book 4 page 33.
- 4) Found 5/8 inch pins flush set by Co. Road Dept. at station 43+00, as shown on Survey No. 6734.
- 5) Found 5/8 inch pin flush, set on Survey No. 3193.
- 6) Found 11 inch iron pipe, 12 ins. deep identified as fd. on Survey No. 3193.
- 7) Set 5/8 ins. iron pin flush (with plastic cap mkd. CS Jackson Co.) on approx. centerline of pavement.

- 8) Found a 5/8 inch iron pin 12 inches deep at 1910 PI.
- 9) Found original spike which was identified by a 1950 County road survey as the 1910 road survey. This was 6 ins. deep and now is now replaced with a 5/8 inch iron pin with plastic cap (mkd. CS Jackson County), flush.
- 10) At PI of County road station 46+60.47 as shown on the 1950 survey (also shown on Survey No. 5011) fd. a 3/4 inch iron pin 15 inches.
- 36) Traverse station designated as 36 on Survey No. 5011, fd. 3/4 inch iron pin flush.
