**SURVEY FOR:
SOUTHERN OREGON FEDERAL CREDIT UNION**

LOCATED IN THE S.E. 1/4 OF SECTION 13, D.L.C. NO. 60 AND
D.L.C. NO. 61, T.37S., R.2W., W.M., MEDFORD, OREGON

JANUARY 21, 1986

Survey No. 10462

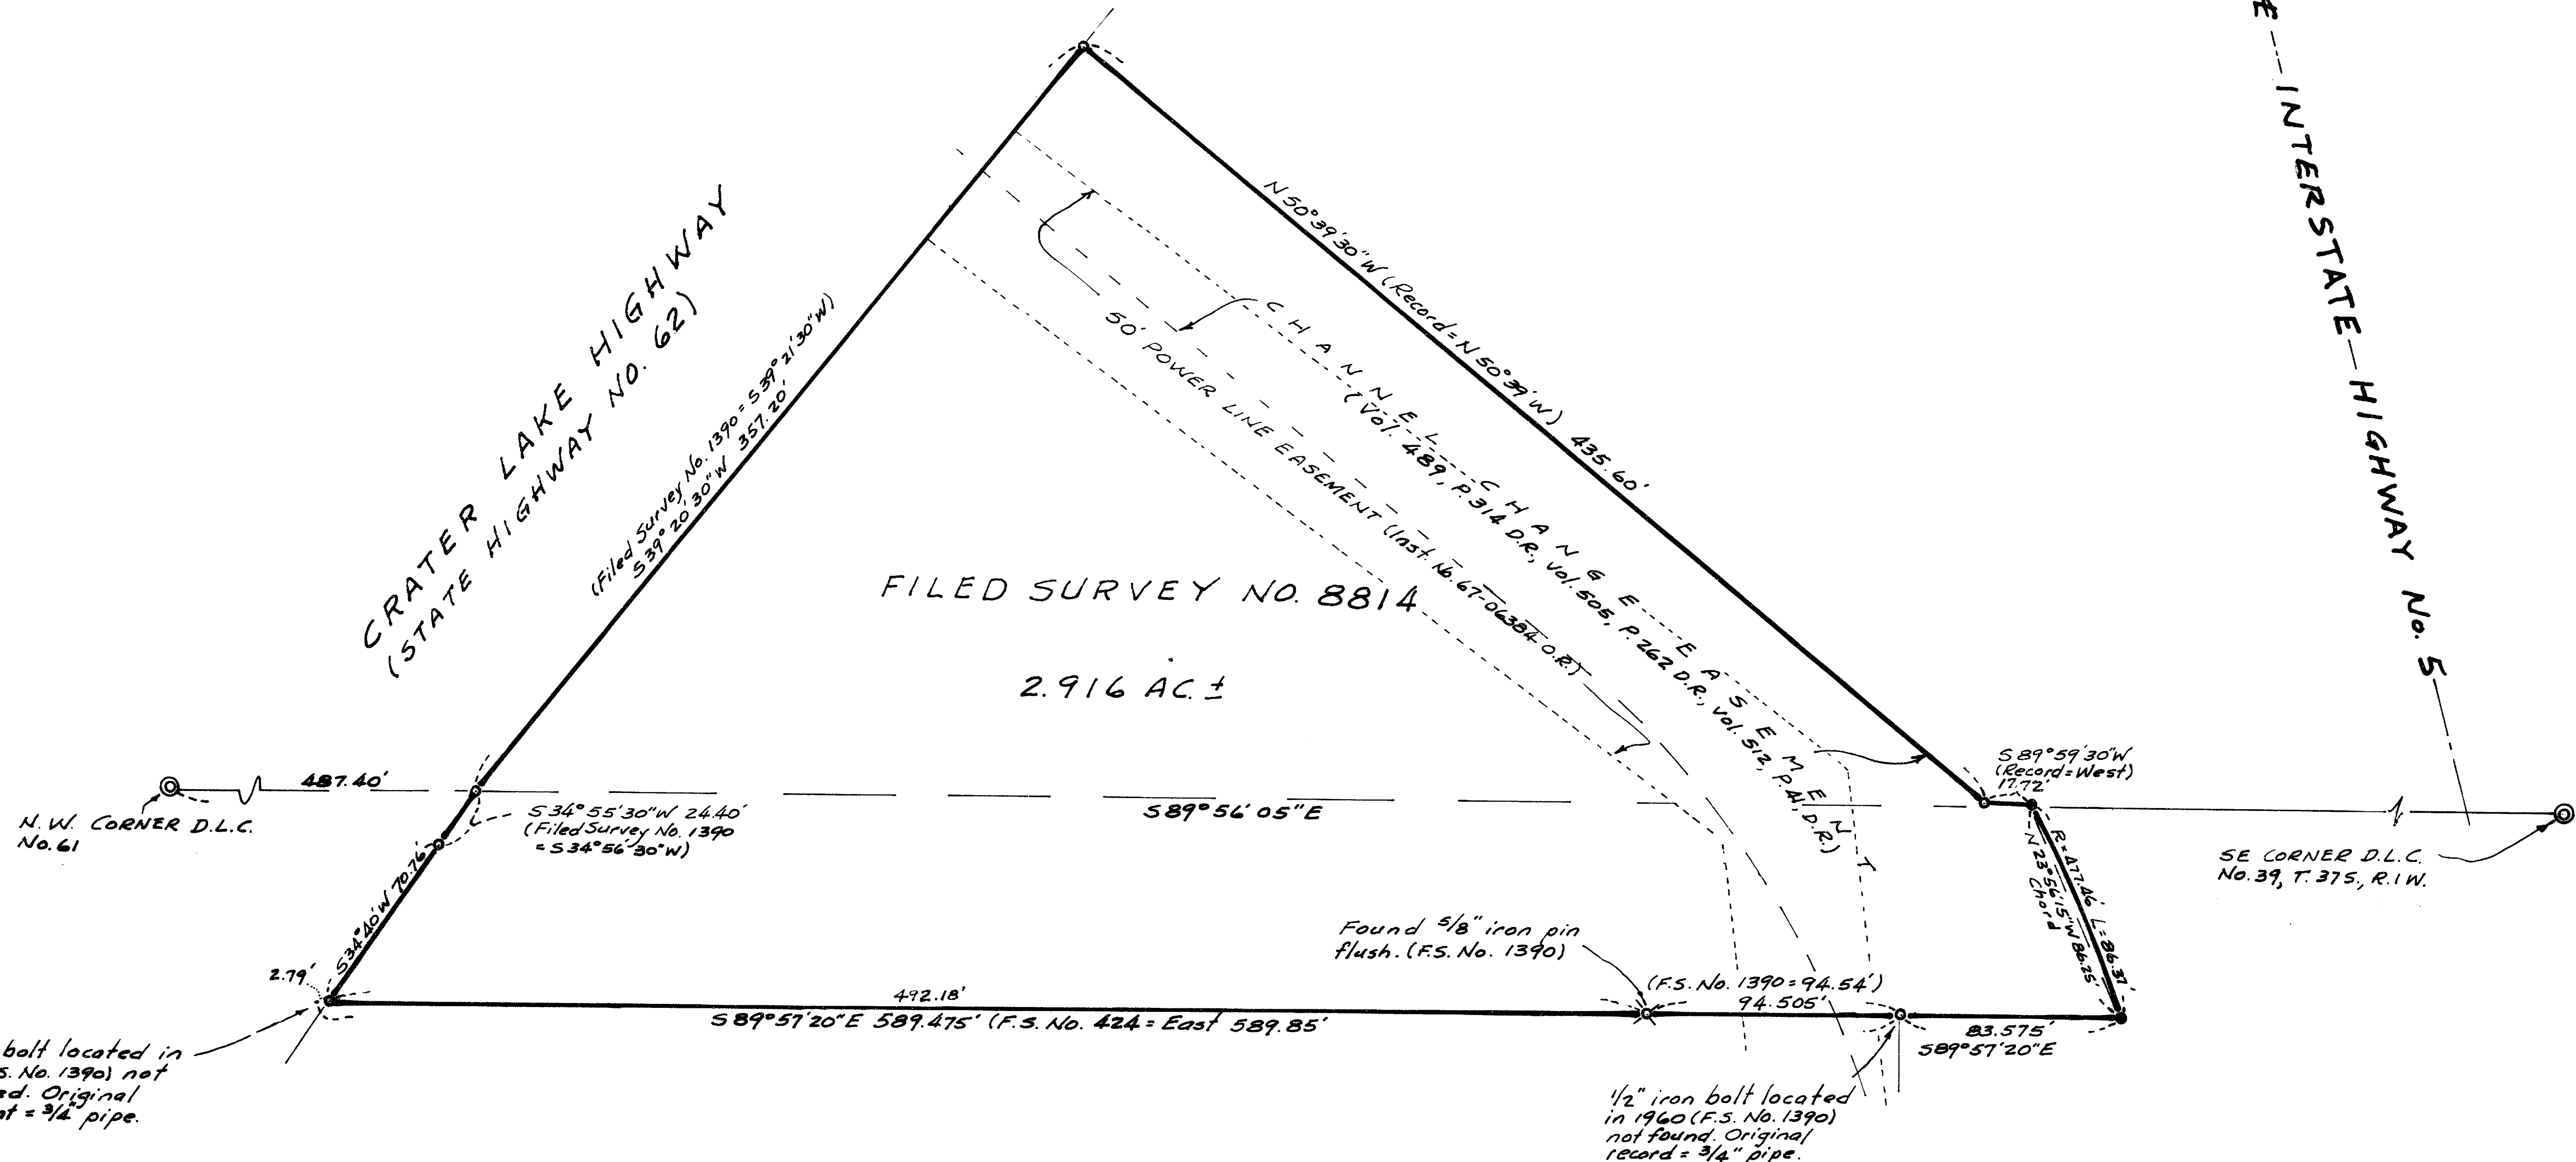
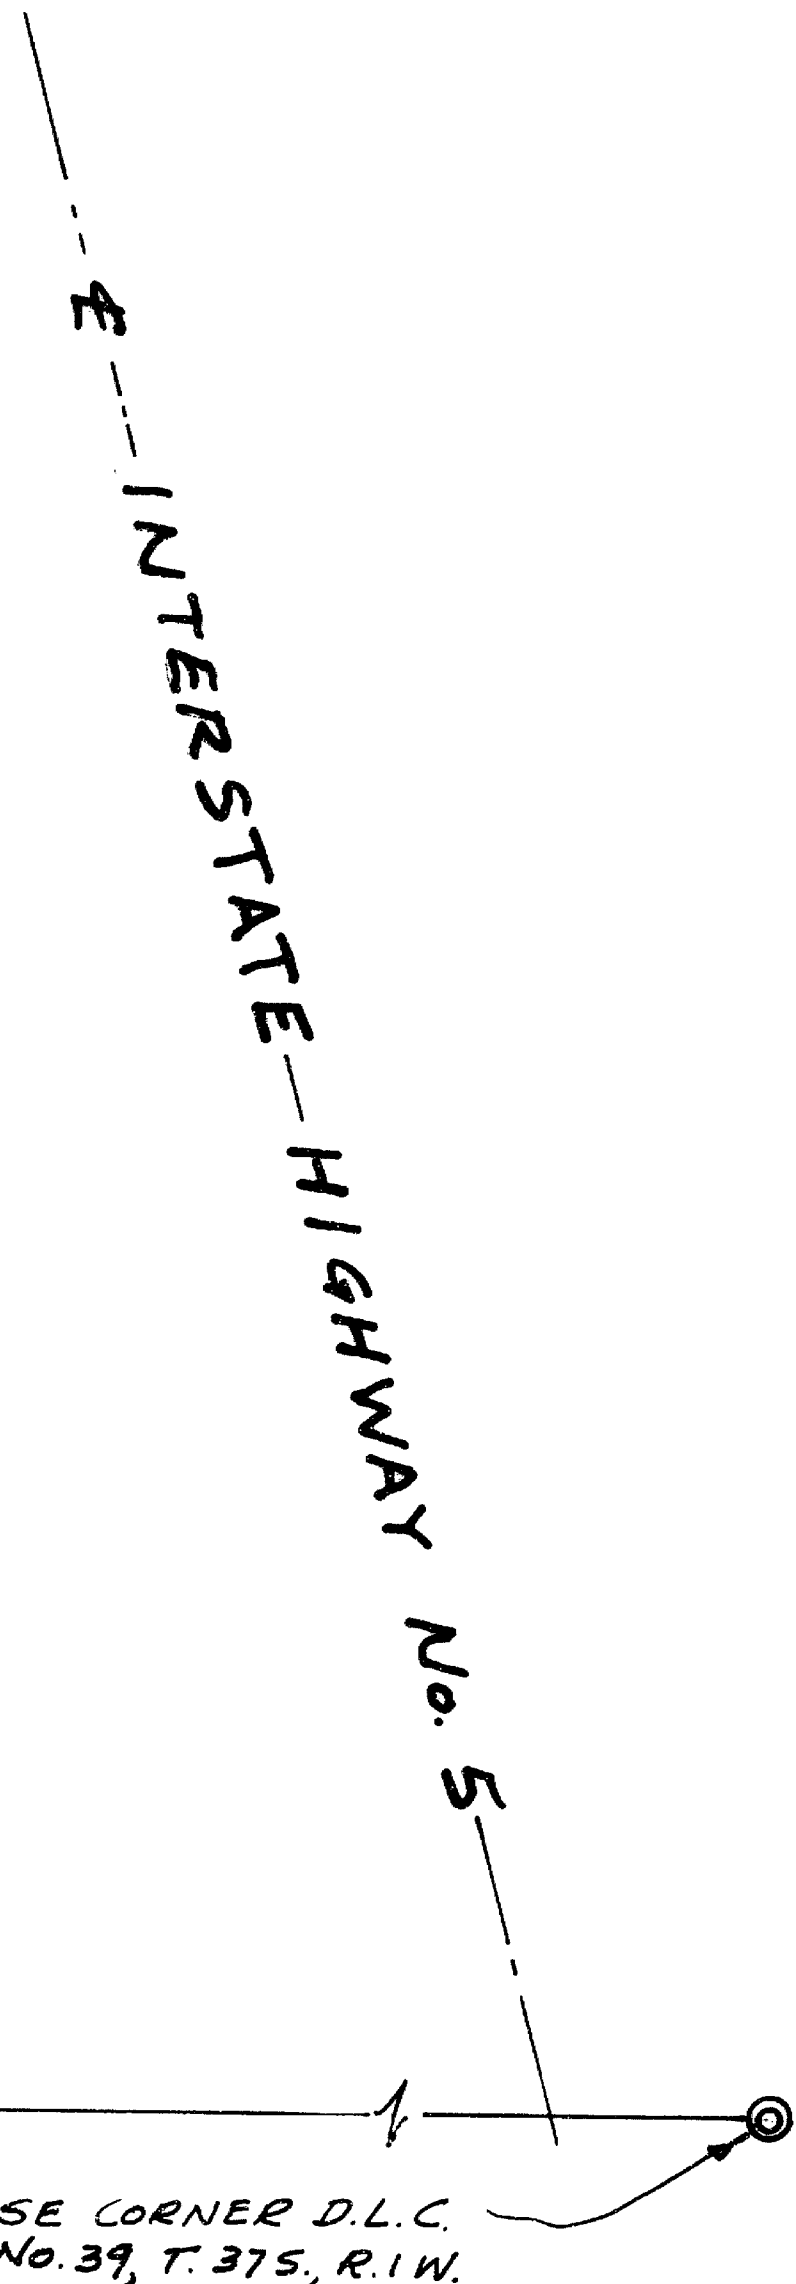
1/2" iron bolt located in 1960 (F.S. No. 1390) not recovered. Original monument = 3/4" pipe.

Found 5/8" iron pin flush. (F.S. No. 1390)

1/2" iron bolt located in 1960 (F.S. No. 1390) not found. Original record = 3/4" pipe.

SCALE: 1" = 50'

BASIS OF BEARINGS
FILED SURVEY NO. 8814

PURPOSE: To locate and flag existing monuments found or set
on Filed Survey No. 8814 as shown on the annexed
map. Also to monument the two most Easterly corners
not previously monumented.

PROCEDURE: Ran a closed-loop EDM traverse around the subject
tract tying existing monuments and setting the two
most Easterly monuments as shown. The N.W. corner of
D.L.C. No. 61 and the S.E. corner of D.L.C. No. 39
were not tied.
