SURVEY OF THE T. R. LAMBERT ET AL PROPERTY IN THE SW 1/4 NW 1/4 OF SECTION 10, T 33S, R 2E, W. M., JACKSON CO., OR.

SURVEY OF THE T.R. LAMBERT ETAL PROPERTY  
IN THE SW $\frac{1}{4}$ NW $\frac{1}{4}$  OF SECTION 10, T33S, R2E, WM. MER.,  
JACKSON CO., OREGON

Narrative Description to comply with Par. 209.250, O.R.S.

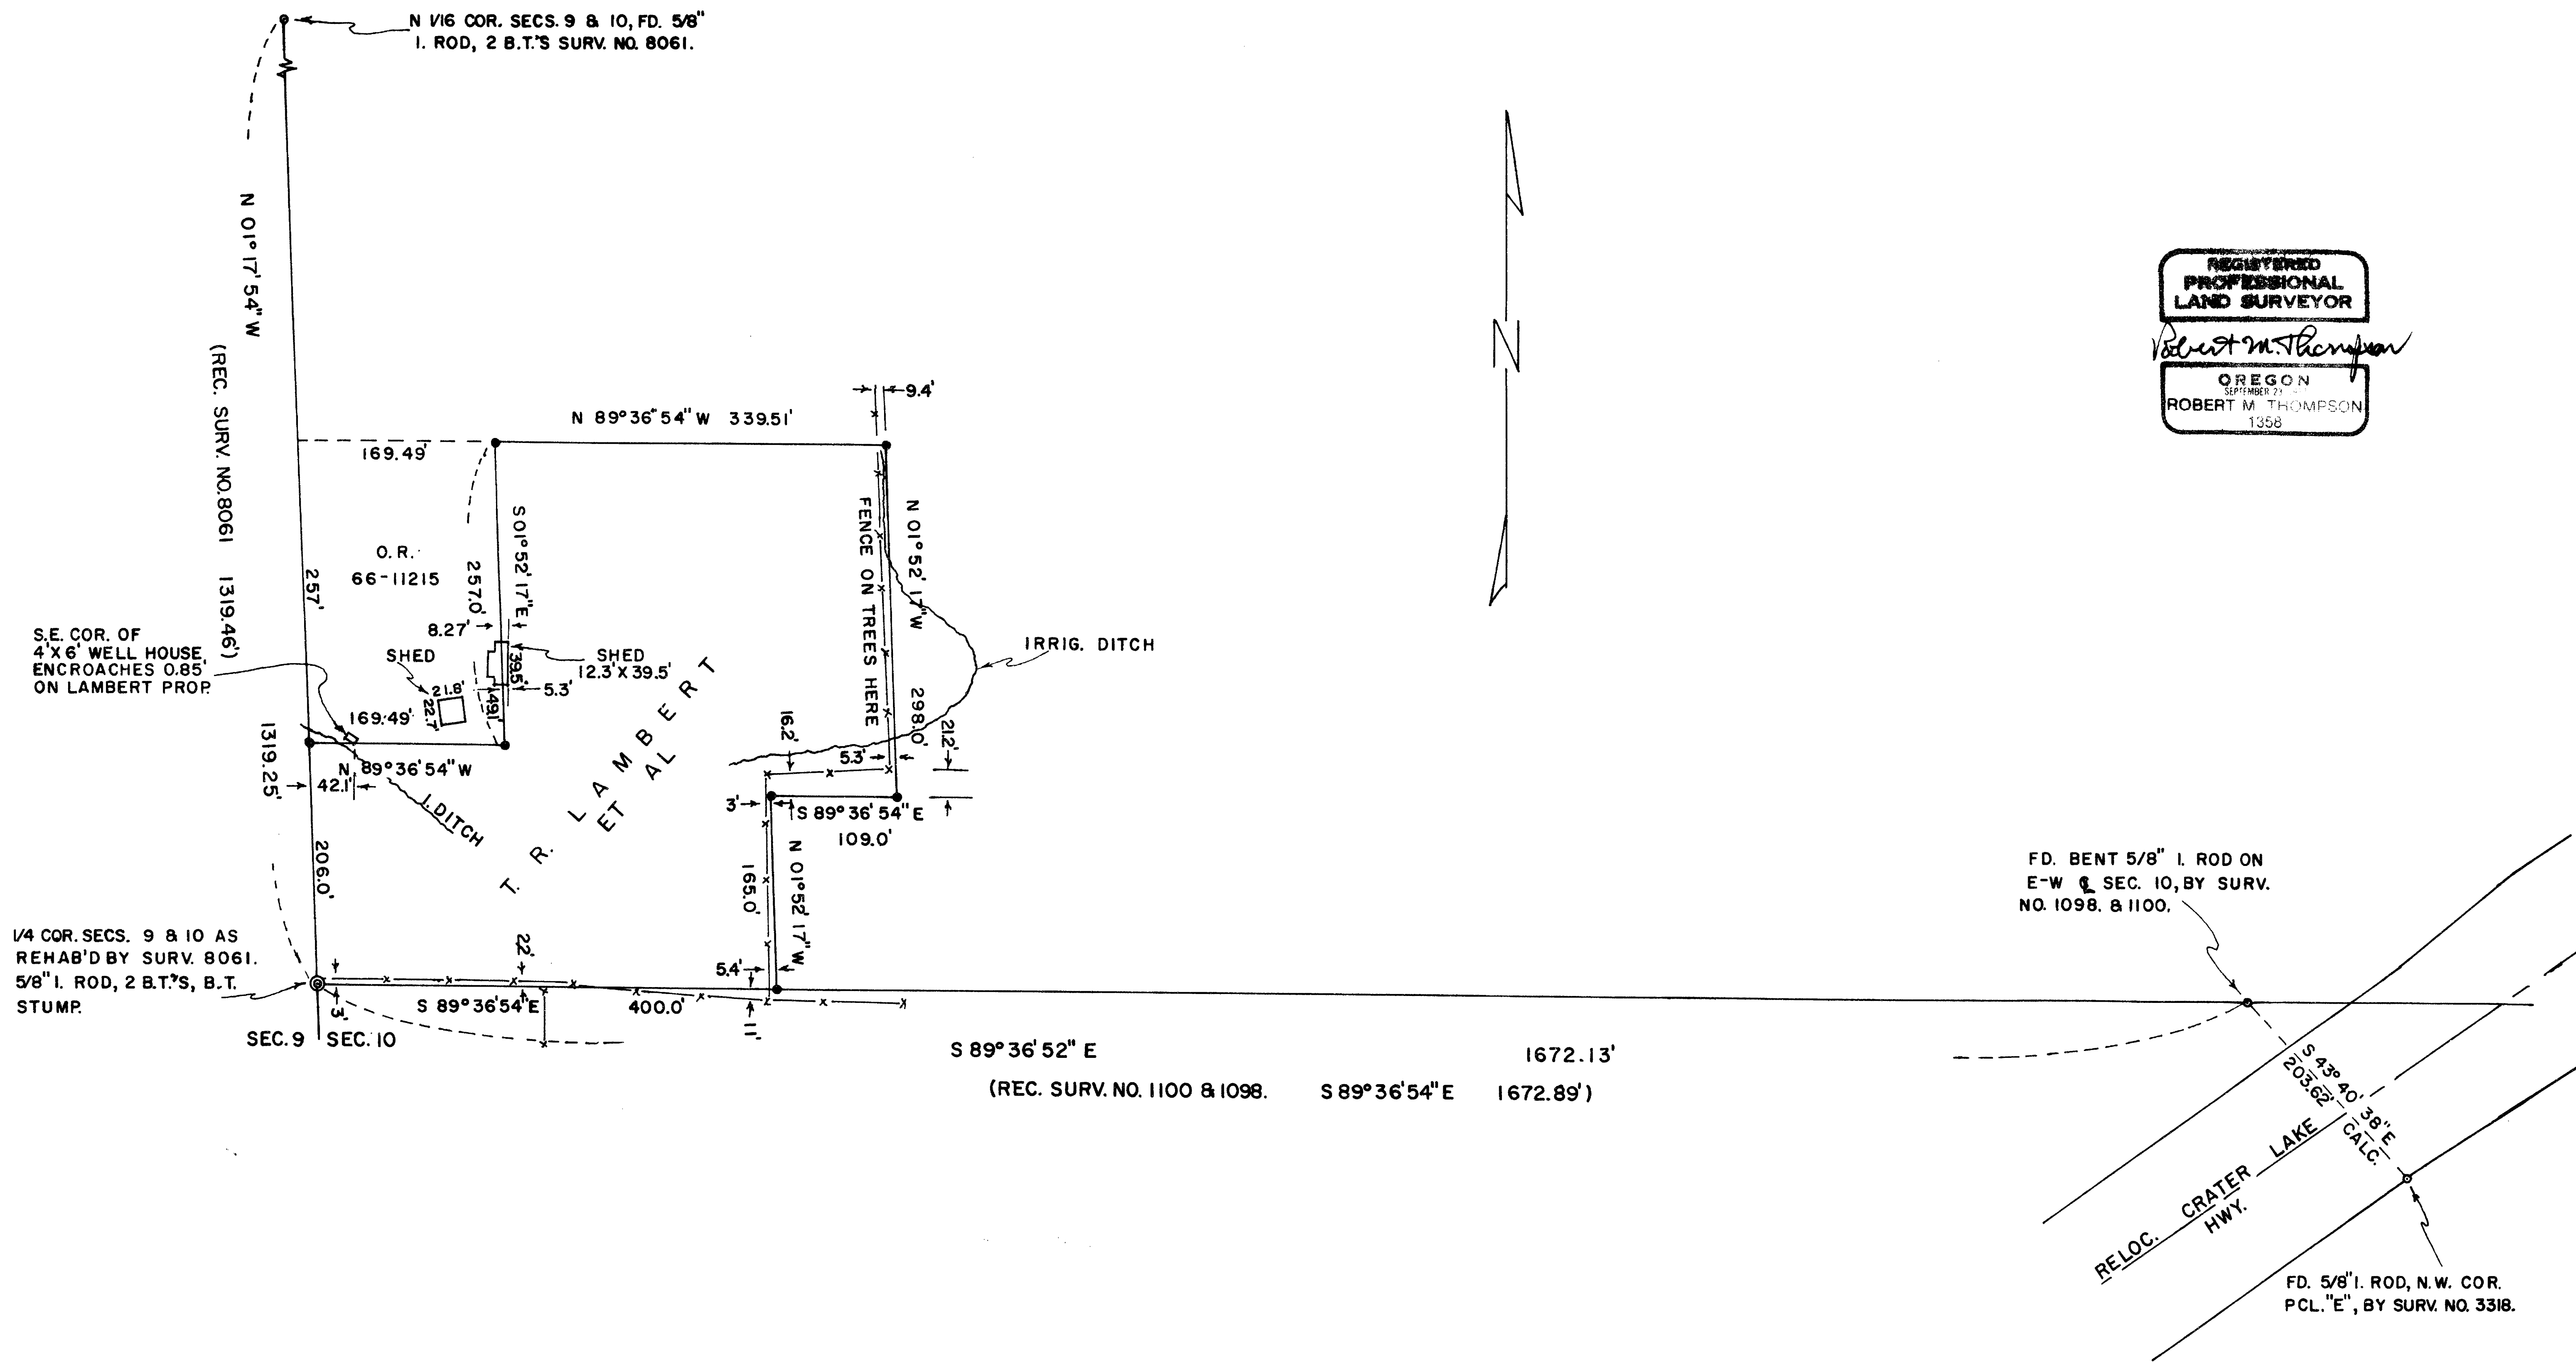
- SET 5/8" X 30" I. ROD EXP. 2-4" W/YEL. CAP. MKD. "THOMPSON."
  - FOUND MONUMENT.
  - X—X 3-4 STRAND BARBED WIRE FENCE.
- SEPARATE NARRATIVE ACCOMPANIES MAP.  
THIS SURVEY & MAP WAS COMPLETED FOR THE EXCLUSIVE USE OF T. R. LAMBERT ET AL, OWNERS.  
BEARING BASIS—SURVEY NO. 4721 & W. LINE OF SW 1/4 NW 1/4 PER SURV. NO. 8061 MONS. SET.

SCALE: 1 INCH = 100 FEET

Procedure: My previous Survey No. 8061, with bearings based on Survey No. 4721, had rehabilitated the Quarter Corner and set the North 1/16 Corner, for Sections 9 & 10. Survey Nos. 1098 and 1100 had "crossed out" the center lines of Section 10, setting Center  $\frac{1}{4}$  Corner and establishing a 5/8" iron rod on the East-West center line, record 910.1 feet westerly of said Center  $\frac{1}{4}$  Corner. Although a disagreement exists between Survey Nos. 4721 and 1098 regarding the Southwest Corner of Section 10, this would not affect the location of the East-West center line of Section 10.

The Lambert property description called all its bearings "North, South, East, and West" etc. With the property adjoining both the Section 10 West line and East-West center line, my survey elected to use the bearings of said 2 lines for bearing control, in order to preserve the apparent intent of local deeds. My survey began by traversing northerly from the  $\frac{1}{4}$  Corner for Sections 9 & 10 to the North 1/16 Corner for said sections, to establish a bearing basis for this survey. Then traversing Easterly from said Quarter Corner of Sections 9 & 10, and being unable to find said Survey Nos. 1098 & 1100 Center Quarter Corner of Section 10, I elected to use their 5/8 inch iron rod, found on (and as evidence of) said East-West center line, as shown on my map. My survey then traversed around the boundaries of the Lambert property, tying in improvements that were possible visible encroachments. The Lambert true corner positions were then computed and set, using 5/8" x 30" Iron rods (exposed 2-4 inches) with yellow caps marked "Thompson", as shown on my map. Locations of said improvements, relative to said corner monuments, are as shown on my map.

Bearing tree referenced corners found were:

- $\frac{1}{4}$  Corner Sections 9 & 10, found flush 5/8" I. rod w/yel. cap mkd. "Thompson" as set in Survey No. 8061, and B.T.'s:
  - 9" W.Oak S 64°E 5.28', faces badly axed & rotted, poss. O.B.T.
  - 19" Y. Pine S 10°W 114.81', scribe visible
  - 13" Y. Pine stump S 80 $\frac{1}{2}$ °E 38.78', scribe visible

- North 1/16 Corner Sections 9 & 10, found 5/8" I. rod exp. 2" w/yel. cap mkd. "Thompson", & B.T.'s:
  - 25" Madronna S 30°W 28.75', scribe visible
  - 12" I. Cedar S 85°E 18.30' (rec. 18.03'), scribe visible
