SURVEY IN NE.1/4SEC.19 T.36S.R2W.WM.
 & TOLO SUB-DIVISION
 FOR: JACKSON COUNTY
 FILE NO. 86-15

EDWARD A. MC GINTY
 JACKSON CO. SURVEYOR
 COURT HOUSE
 MEDFORD OREGON
 OCTOBER 1 1986

SURVEY NARRATIVE TO COMPLY WITH PARAGRAPH 209.250
OREGON REVISED STATUTES

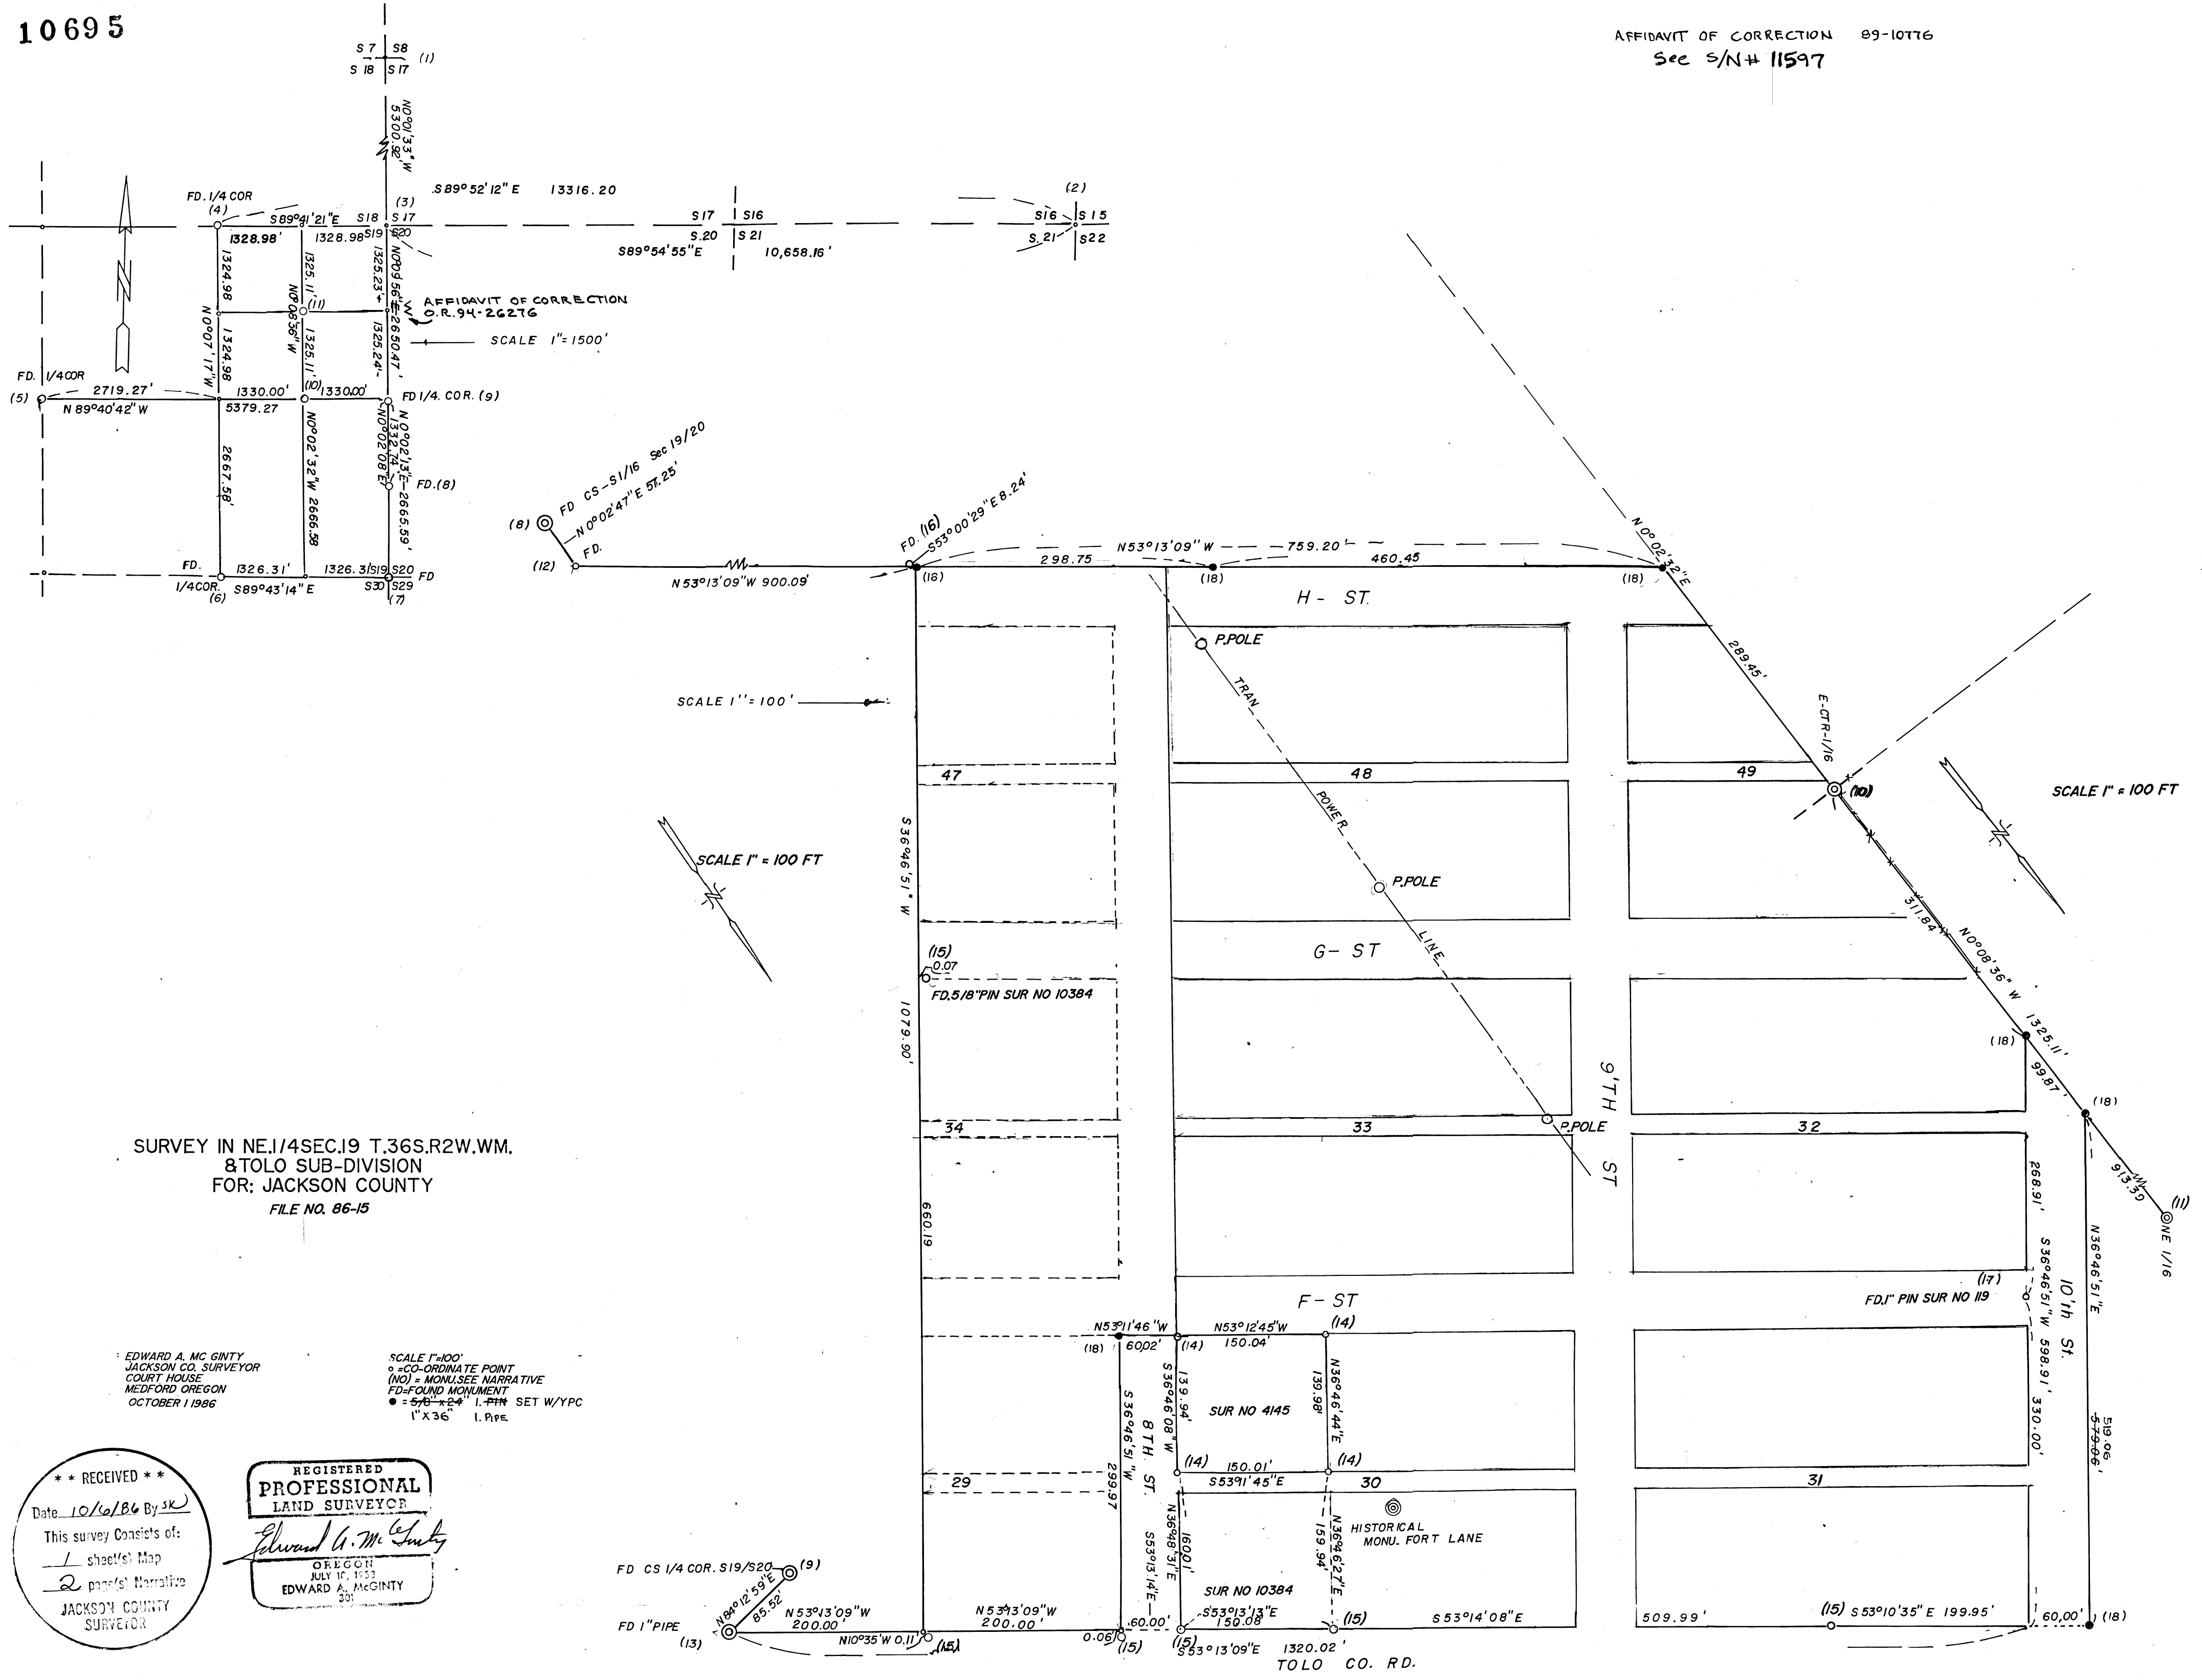
SCALE 1"=100'
 ○ = CO-ORDINATE POINT
 (NO) = MONUMENT NARRATIVE
 FD = FOUND MONUMENT
 ● = 5/8" x 2" I. PIPE SET W/ YPC
 1" x 3/8" I. PIPE

BASIS OF BEARING: The bearing was determined from 1980 Aerial Mapping Traverse
Stations C-5 and C-6. These points located in Tolo County
Road.

- (1) & (2) Are section corners and having previous known co-ordinates.
- (3) Computed and proportion position of corner to Sections 17, 18, 19 and 20.
- (4) The quarter corner between Sections 18 and 19, now a 2 ins. iron pipe. See re-establishment notes 1986.

- (5) The West quarter corner of Section 19, found 1 ins. pipe exposed 6 ins. with brass cap. See re-establishment notes 1979.
- (6) The South quarter corner of Section 19, found capped, 1 3/4 ins. diam. See re-establishment notes 1985.

- (7) The corner of Section 19, 20, 29 and 30 found a pipe, 1 ins. diam. with brass disc, exposed 6 ins. See Re-establishment notes. 1979.
- (8) CS South one sixteenth corner between Sections 19 and 20, fd. a pipe 1 ins. diam., 6 ins. below surface.

- (9) The quarter corner of Sections 19 and 20, fd. a pipe 1 ins. diam., with brass cap exposed 6 ins.
- (10) The East center sixteenth corner of Section 19, a pipe 1 ins. diam. capped with a brass disc, set approx. flush. See re-establishment notes.

- (11) The Northeast one sixteenth corner of Section 19, a pipe, 1 ins. diam. with brass disc set approx. flush.
- (12) Fd. 1 ins. pipe. See recorded survey No. 119.

- (13) Fd. 1 ins. pipe. See recorded survey No. 119.
- (14) Fd. iron pin 5/8 ins. diam., approx. flush with surface.
- (15) Fd. iron pin 5/8 ins. diam., with yellow plastic cap by D. Edwards as shown on Survey No. 10384, set approx. flush.

- (16) Same as (15) Not shown on said survey.
- (17) Fd. iron pin, 1 ins. square (harrow tooth?) approx. 2 ins. deep, as shown on Survey No. 119.
- (18) Set ^{1"}~~5/8~~ ins. iron ^{PIPE 36}~~pin~~, 24 ins. long, with yellow plastic cap stamped Jackson C.S.

That certain bearing on the east line of Section 19 which presently reads N0°09'56"E, should be corrected to read N0°09'56"W.
