**SURVEY SECTION LINE 15 & 16, T.36S, R.4 W.**  
**PINE ST., CITY OF ROGUE RIVER**

FOR: OSH.D. and JACKSON CO.  
87-51

BY: EDWARD A. MC GINTY  
JACKSON CO. SURVEYOR  
COUNTY COURT HOUSE  
MEDFORD, OREGON  
MAY 8, 1987

## SURVEY NARRATIVE TO COMPLY WITH PARAGRAPH 209.250

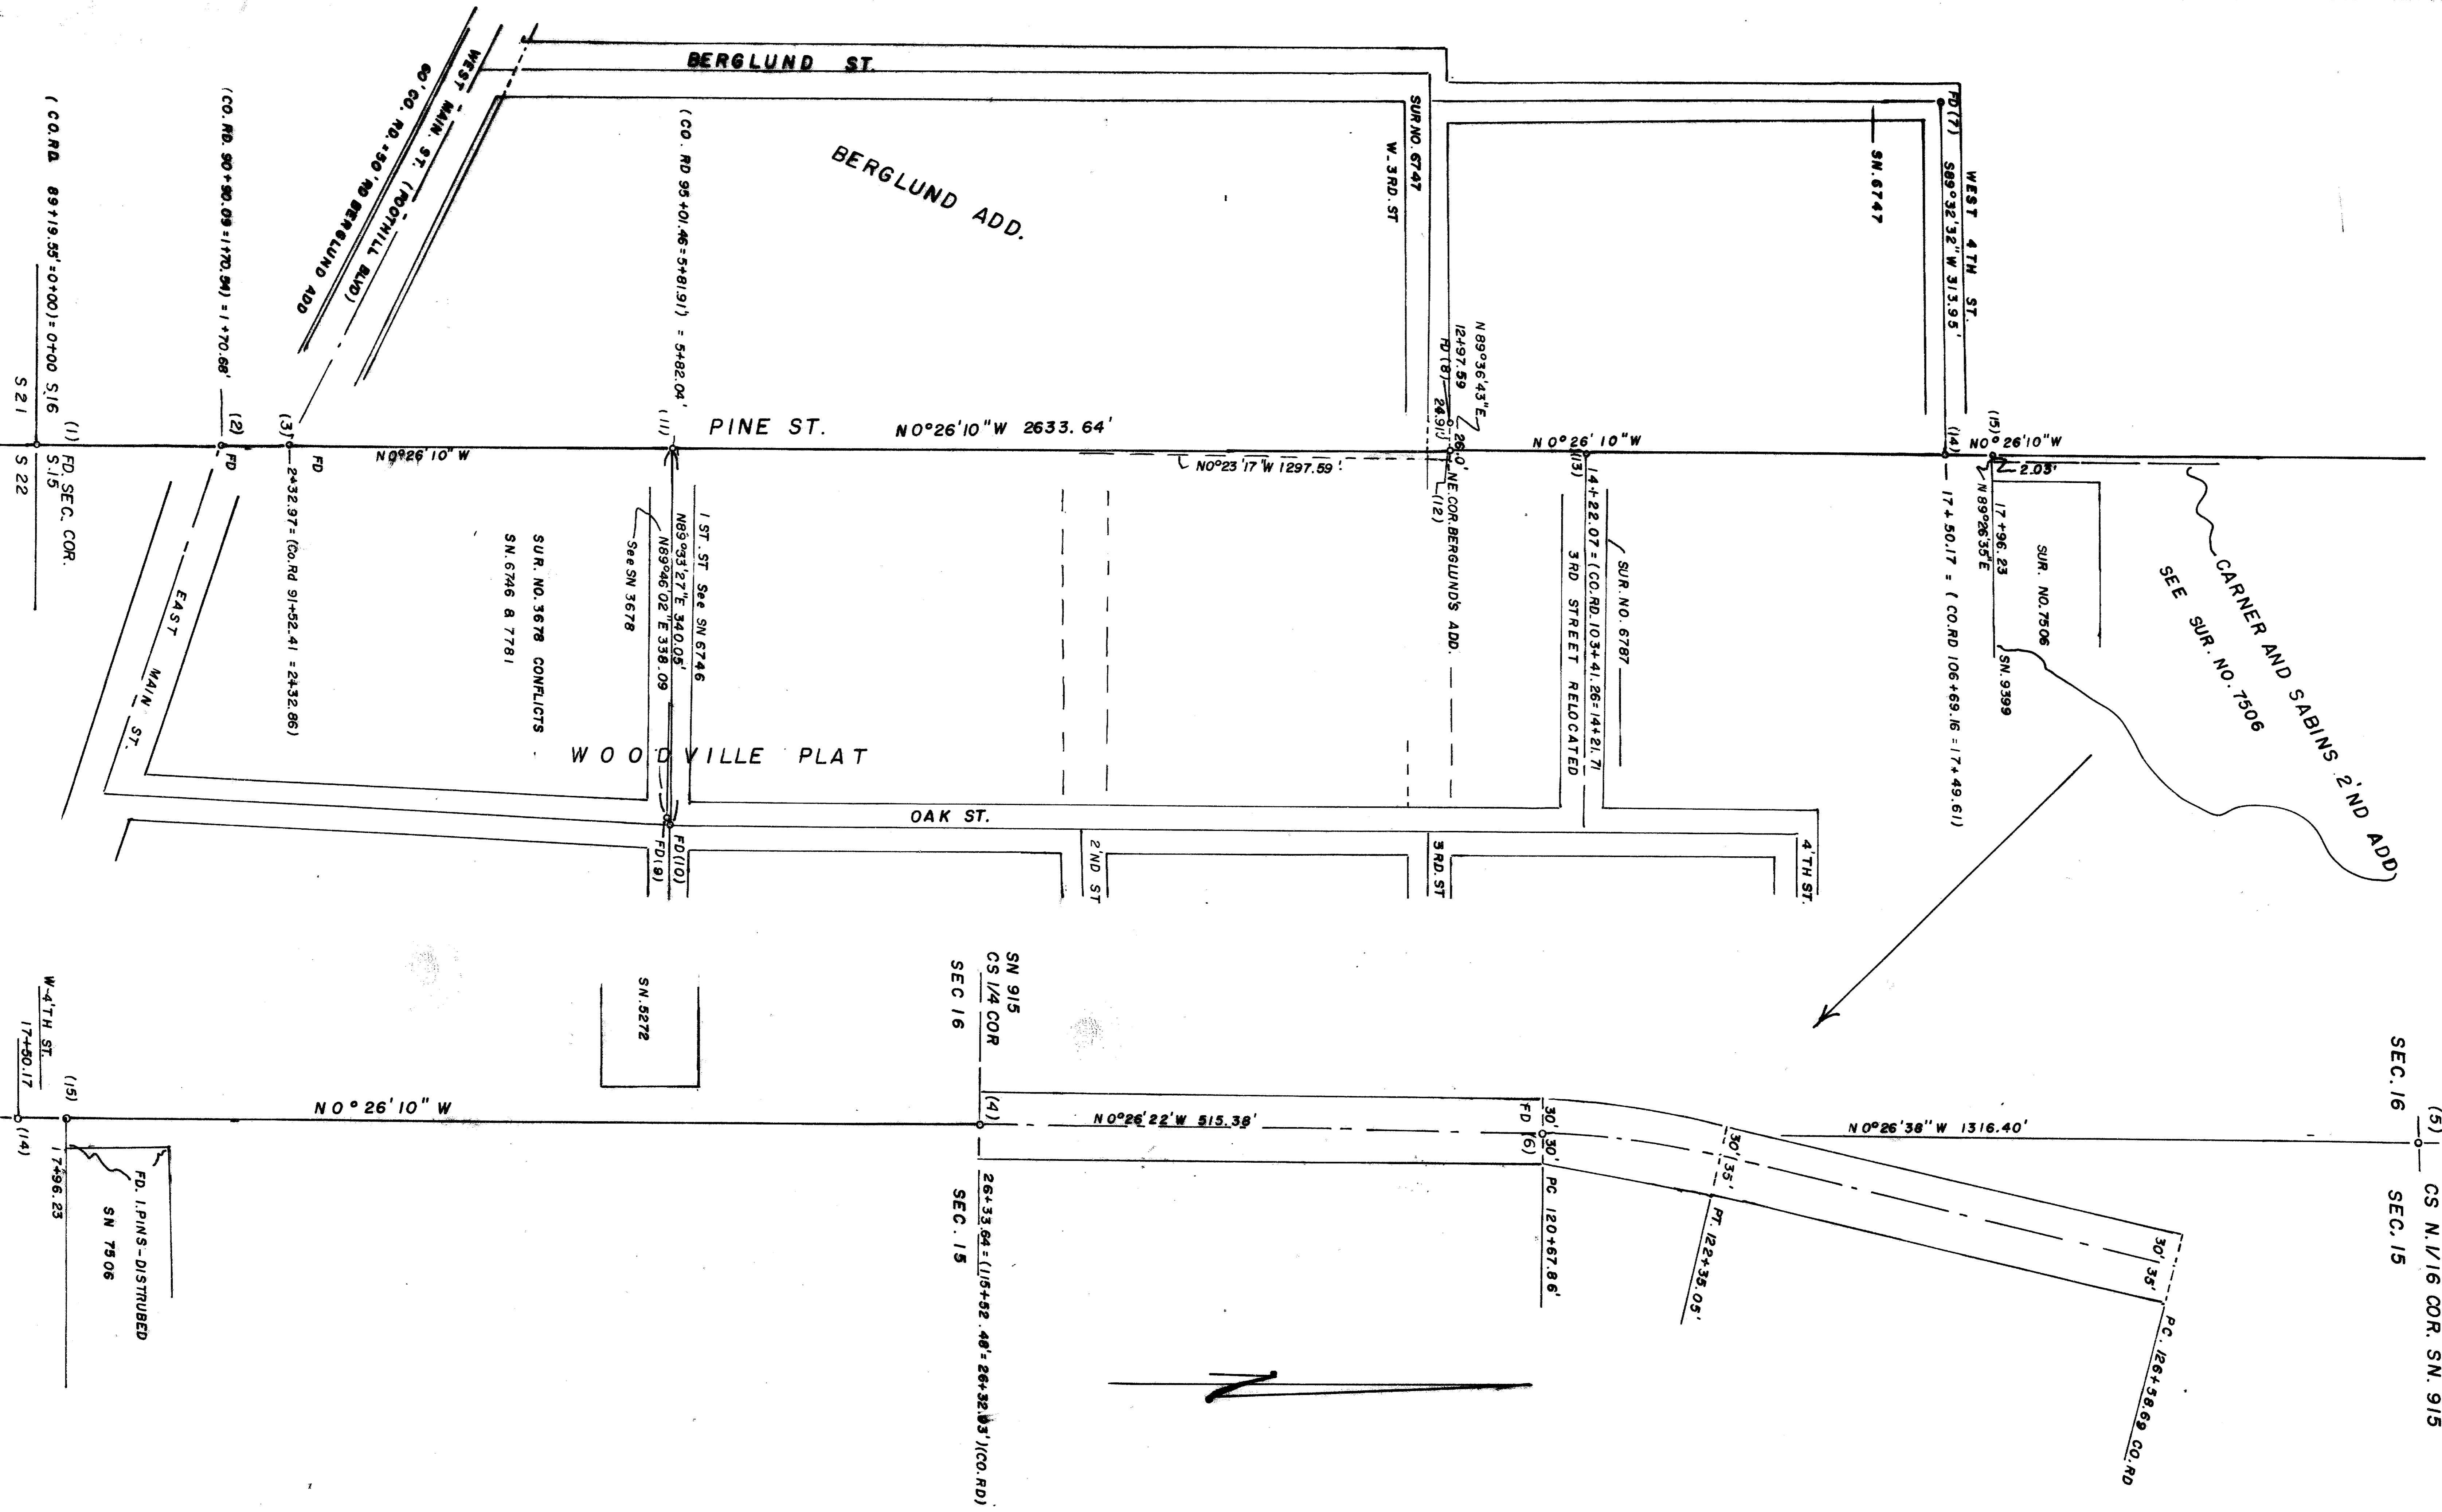
SCALE 1" = 100'  
FD = FOUND MONUMENT  
(NO) SEE NARRATIVE

The purpose of the survey was to replace some of the monuments which were destroyed during the Oregon State Highway Department's reconstruction of Pine Street in the City of Rogue River. The intention of this survey was to relocate and set monuments at or to the nearest possible original position. This is not an endorsement of the previous surveys or their procedures as to how they determined the location. Most of these monuments are shown on Survey numbers 6746, 6747 and 6787.

During this survey, I found that only one intersection had two reference points by the county (except for the quarter corner). Most references were destroyed by the adjoiners or O.S.H.D. reconstruction. The center station by Jackson Co. Road Dept. is shown in brackets, beginning at section corner and then actual remeasurement is shown alongside.

- 1) Fd. brass cap in concrete monument. See County Survey re-establishment.
- 2) Intersection of E. Main and Pine. Fd. original monument shown on survey No. 3678 being brass cap 10 ins. deep in concrete and inside of mon. case. This monument was raised with brass cap set flush with the pavement.

- 3) Fd. 5/8 ins. iron pin with yellow plastic cap, approx. 1 ins. deep as shown on Survey No. 6747.
- 4) At the quarter corner fd. county road reference points and one CS reference point (see re-establishment). The distance to section corner in agreement with previous Survey 7506, set brass cap in concrete flush with pavement.

- 5) CS North 1/16 corner between Sections 15 and 16, fd. undisturbed 3/4 ins. pipe approx. 6 ins. deep.
- 6) Fd. a punched 1/2 ins. (spike?) set by County Rd. Dept. flush, (county survey in 1977 at beginning of curve station 120+67.86).

- 7) Fd. 5/8 ins. iron pin 2 ins. deep with a plastic cap set on Survey No. 6747.
- 8) Fd. 1 1/2 ins. iron pipe, 12 ins. deep, a recognized monument on the north line of Berglunds Addition and shown on some of surveys of record.

- 9) Fd. brass cap in concrete in mon. case approx. 6 ins. deep, origin being Survey No. 3678. This intersection conflicts with subsequent intersection on Survey No. 6746.

- 10) Fd. 5/8 iron pin with battered yellow plastic cap, approx. 1 ins. deep. See Survey No. 6746 and comments on No. 9.
- 11) Set a 5/8x6 ins. iron pin flush with yellow plastic cap, mkd. Jackson C.S. This is at or near monument shown on Survey No. 6746 and near mean distance.

- 12) Set a 5/8x6 ins. iron pin on computed bearing (90°00') from Berglund's east line which computes N0°23'17"W.
- 13) This monument was set 0.06 feet west of taped intersection from county road dept. reference points. This location is almost identical with previous private records. This monument is brass cap, 2 ins. diam., set flush in pavement.

- 14) Set a 5/8x6 ins. iron pin with yellow plastic cap mkd. Jackson C.S. approx. flush with pavement. This location is approx. .05 ft. west of one taped county reference point and in agreement with private records at distance previous southerly from Carner-Sabin Second Add. and at distance northerly from the section corner.

- 15) Set a 5/8x6 ins. iron pin a distance south of quarter corner of Sections 15 and 16 and north of section corner. This would be on the South line of Carner and Sabins Second Addition. Monuments shown near the East line of Pine Street per survey No. 7506 both were disturbed by lots of paving and grading.
