## SURVEY NARRATIVE TO COMPLY WITH PARAGRAPH 209.250 OREGON REVISED STATUTES

SURVEY FOR:

Jackson County

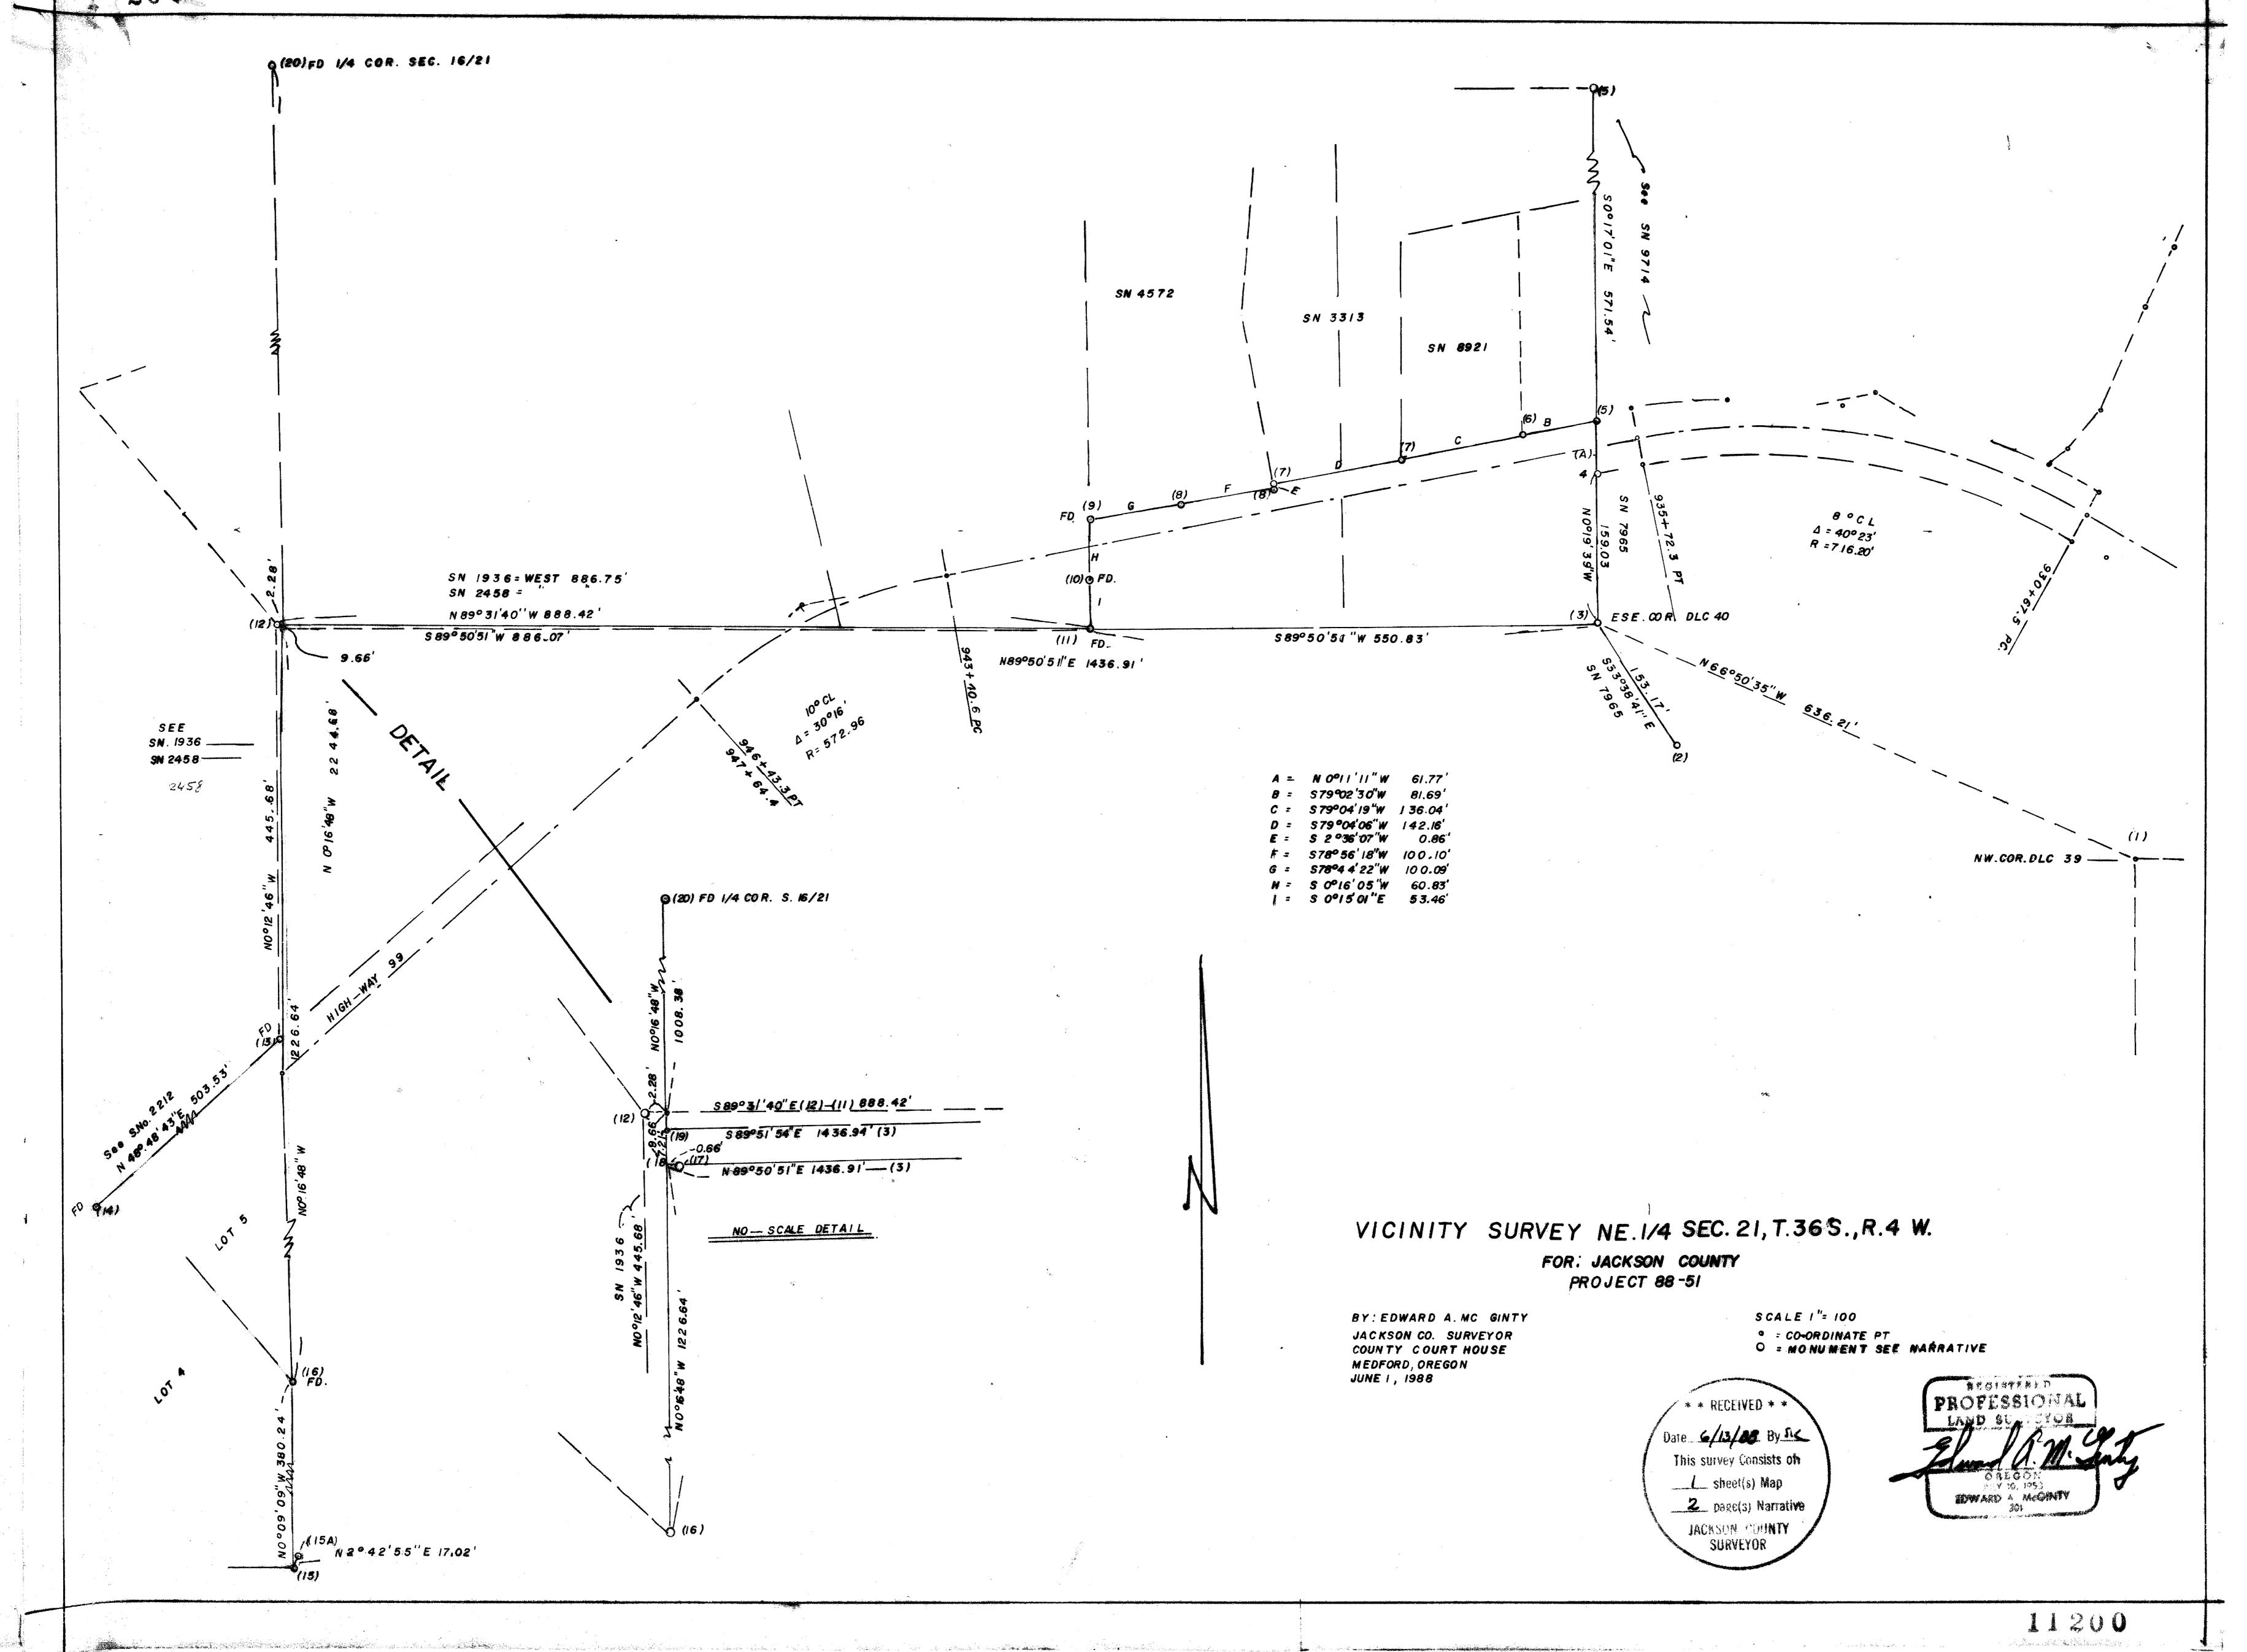
## **MONUMENTS:**

- 1. NW DLC 39 Co-ordinate point.
- 2. Found  $1\frac{1}{2}$ " pipe, approximately flush. (See Survey No. 7965)
- 3. ESE Corner of DLC 40, found a 5/8" I.Pin approx. 3" deep, set in a 1½" pipe approx. 12" deep.

- 4. Found a 5/8" T.Pin, approx. flush. (See Survey No. 7956).
- 5. Found a 5/8" I.Pin with yellow plastic cap mkd. by Max Hull, 3" below surface. (See Survey No. 9714)

- 6. Found rail spike 1" deep. (See Survey No. 8921)
- 7. Found 5/8" I.Pin, 5" deep. (See Survey No. 3313).
- 8. Found 5/8" I.Pin, 5" deep, with yellow plastic cap of Masters. (See Survey No. 4572). Note: discrepancy for highway alignment in survey No. 3313.

- 9. Found 5/8" I.Pin with Master's yellow plastic cap, approx. 3" deep. (See survey No. 4572).
- 10. Found 1½" pipe approx. 4" southerly of northwest corner of concrete block wall and 6" deep. This probably is the same monument shown on Survey No. 635.

- 11. Found 3/4" pipe approx. 8" deep set probably by White and commonly accepted by different surveyors as the lot corners. Computations indicate this is not an original lot corner.

- 12. Found 3/4" pipe set in concrete, 6" deep, set by M.Boyden, to perpetutate the location as shown on Survey No. 1936. Note: this location shown does not compute as being on the centerline of the section by Rhodes or according to distance and bearing west of a 3/4" pipe. Discussed the location of monument with M.Boyden, in general, he has considerable reservations about the procedure of survey and had some doubt as to the location as to why it didn't show on a previous survey by him. I have recovered evidence indicating that a monument, in the near vicinity, existed prior to Survey No. 1936, which presents the monument questionable or in a conflicting location. That survey, by White, indicates on line with the North quarter corner of section. Note: Both monuments apparently destroyed at same time by the telephone company's construction. The existing monument falls approx. 1 ft. north of steel post and 6" deep. Also see Survey Nos. 2458, 4973 and 8246.

- 13. Found 3/4" pipe approx. 3" deep southeast of a steel post marked "Warner" on brass washer.
- 14. Found 1½" pipe approx. 3" high with brass washer marked "Warner" south of steel post. Survey No. 2212.

- 15. Found 1½" pipe 10" high a few feet above top cut bank of road. Center of section per Rhodes survey as shown on Riverdale Tracts.
- 15A. Found a 2" pipe, 8" deep in road bed shown as the center of section according to Survey No. 5607.

- 16. Found  $1\frac{1}{2}$ " I.Pipe, 3" deep recognized as the southerly lot corner between lots 4 and 5 of Riverdale Tracts.
- 17. A 1"x30" pipe, 5" below surface, with yellow plastic cap marked Jackson C.S. set as a reference point only as to perpetuate this survey traverse for future use.

- 18. Computed intersection of Rhodes and shows relationship only.
- 19. Computed position on a prorated distance north and south on Rhodes centerline of section being at or near Rhodes' original Southwest corner of Lot 6.

- 20. Found monument, at the north quarter corner as re-established by Jackson C.S. being a pipe, 1" diameter, with yellow plastic cap marked Jackson C.S.

BASIS OF BEARING: Derived from traverse points on Survey No. 9827, N85°07'27"W; from a set rail spike and a found rail

The purpose of this vicinity survey is to obtain a much evidence as deemed necessary to re-establish the East Southeast corner of Donation Land Claim No. 40. On a 1961 survey, in the process of searching for the Northeast corner of said DLC, considerable evidence for the East Southeast corner of DLC 40 was found by me personally.
