SURVEY NARRATIVE TO COMPLY WITH PARAGRAPH 209.250
OREGON REVISED STATUTES

LOCATION: Section 34, Township 32 South, Range 1 East of the Willamette Meridian, Jackson County, Oregon.

PURPOSE: To monument the boundary corners and post line markers along that portion of the Elk Creek Project Boundary being in Section 34, as shown on Segment 3 of the Corps of Engineers Elk Creek Lake Real Estate drawings. The survey was performed during February 1988 through July 1988.

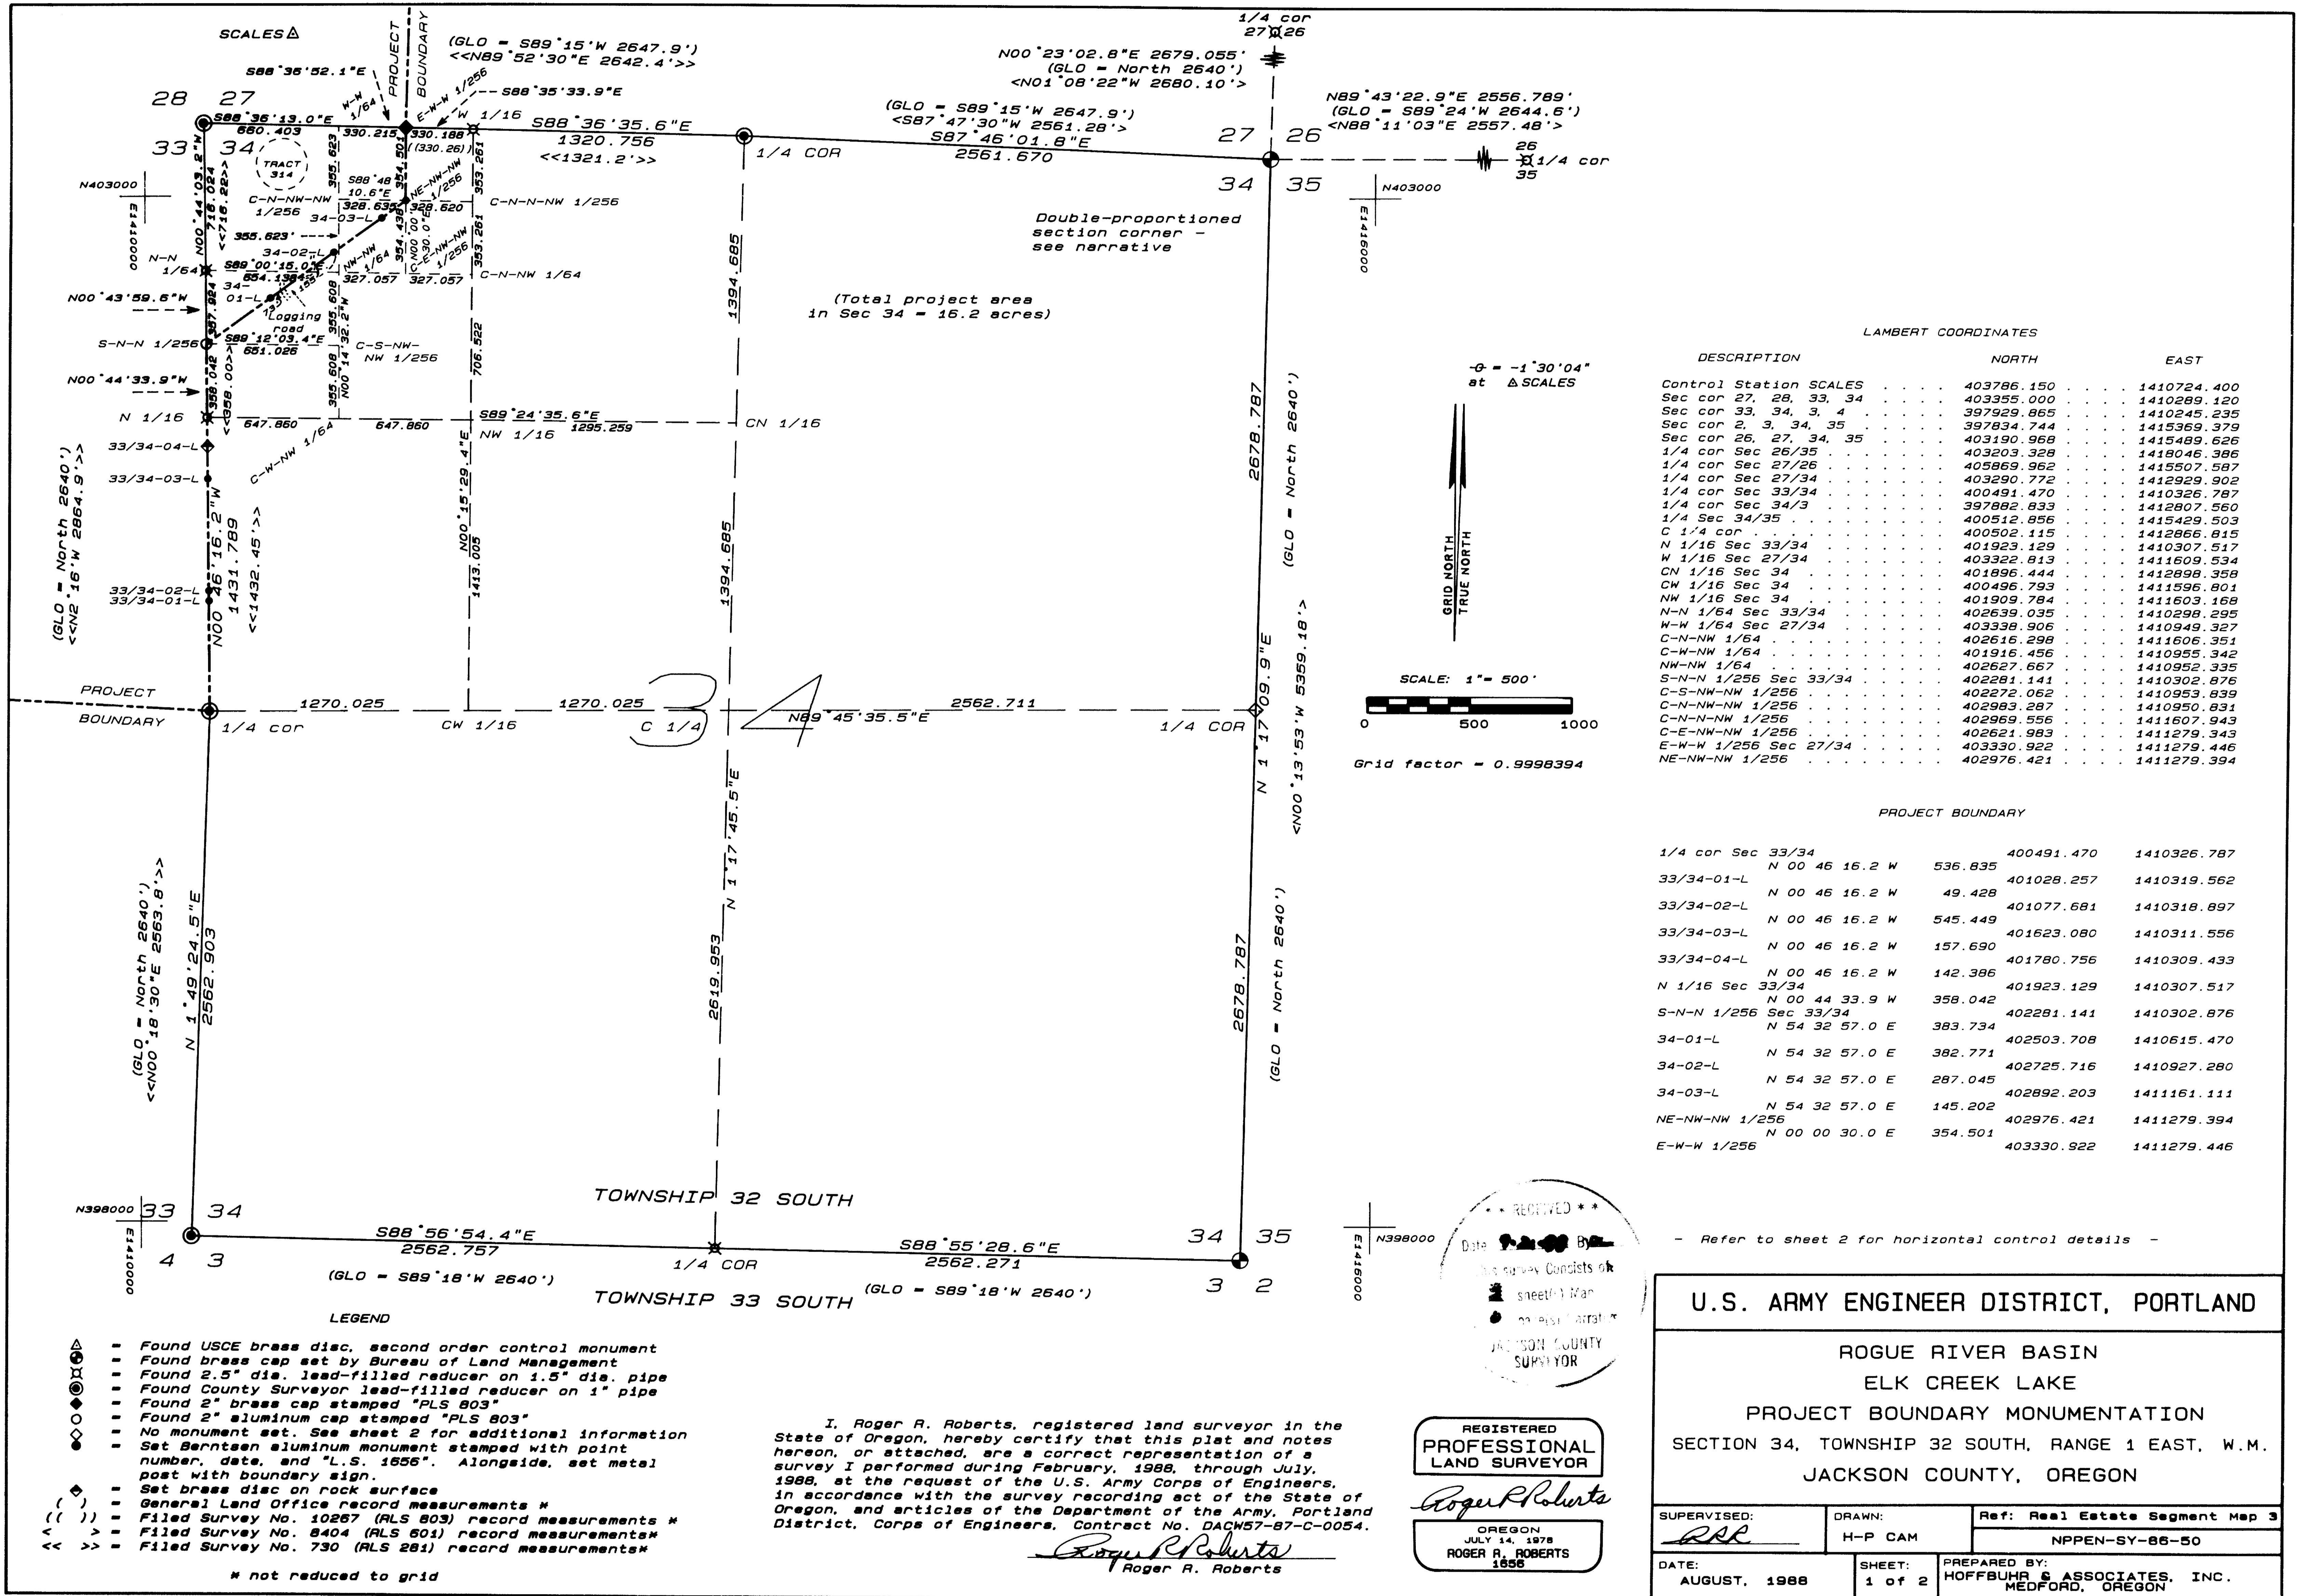
All bearings and distances shown are on State Plane Coordinate grid. Coordinates and distances are shown to .xxx feet and bearings to .x seconds for mathematical consistency only and are not intended to imply accuracy of survey. An average latitude and elevation were used to compute a single grid factor for each individual survey traverse. The grid factor at Station SCALES is:
Scale factor (latitude N 42°45'12") = 0.9999207
Elevation factor (1700') = 0.9999187
Combined (grid) factor = 0.9998394
All horizontal control established by this survey meets requirements of 3rd Order, Class 1, National Oceanic and Atmospheric Administration specifications for geodetic control.

The project boundary within Section 34 is dependent upon section subdivision and subsequent metes and bounds description. A series of traverses were run, using an electronic "total station" 1 second theodolite and distance meter, to locate the controlling section monuments and establish coordinates.
