MINOR LAND PARTITION  
for  
TERRILL WALKER

located in  
Lot 6, Block 1 of FOOTHILL SUBDIVISION  
Southwest 1/4 of Section 16, T 37 S, R 1 W, WM.  
City of Medford, Jackson County, Oregon

( LDP 89-21 )

HOFFBUHR & ASSOCIATES, INC.  
219 NORTH OAKDALE AVENUE  
MEDFORD, OREGON

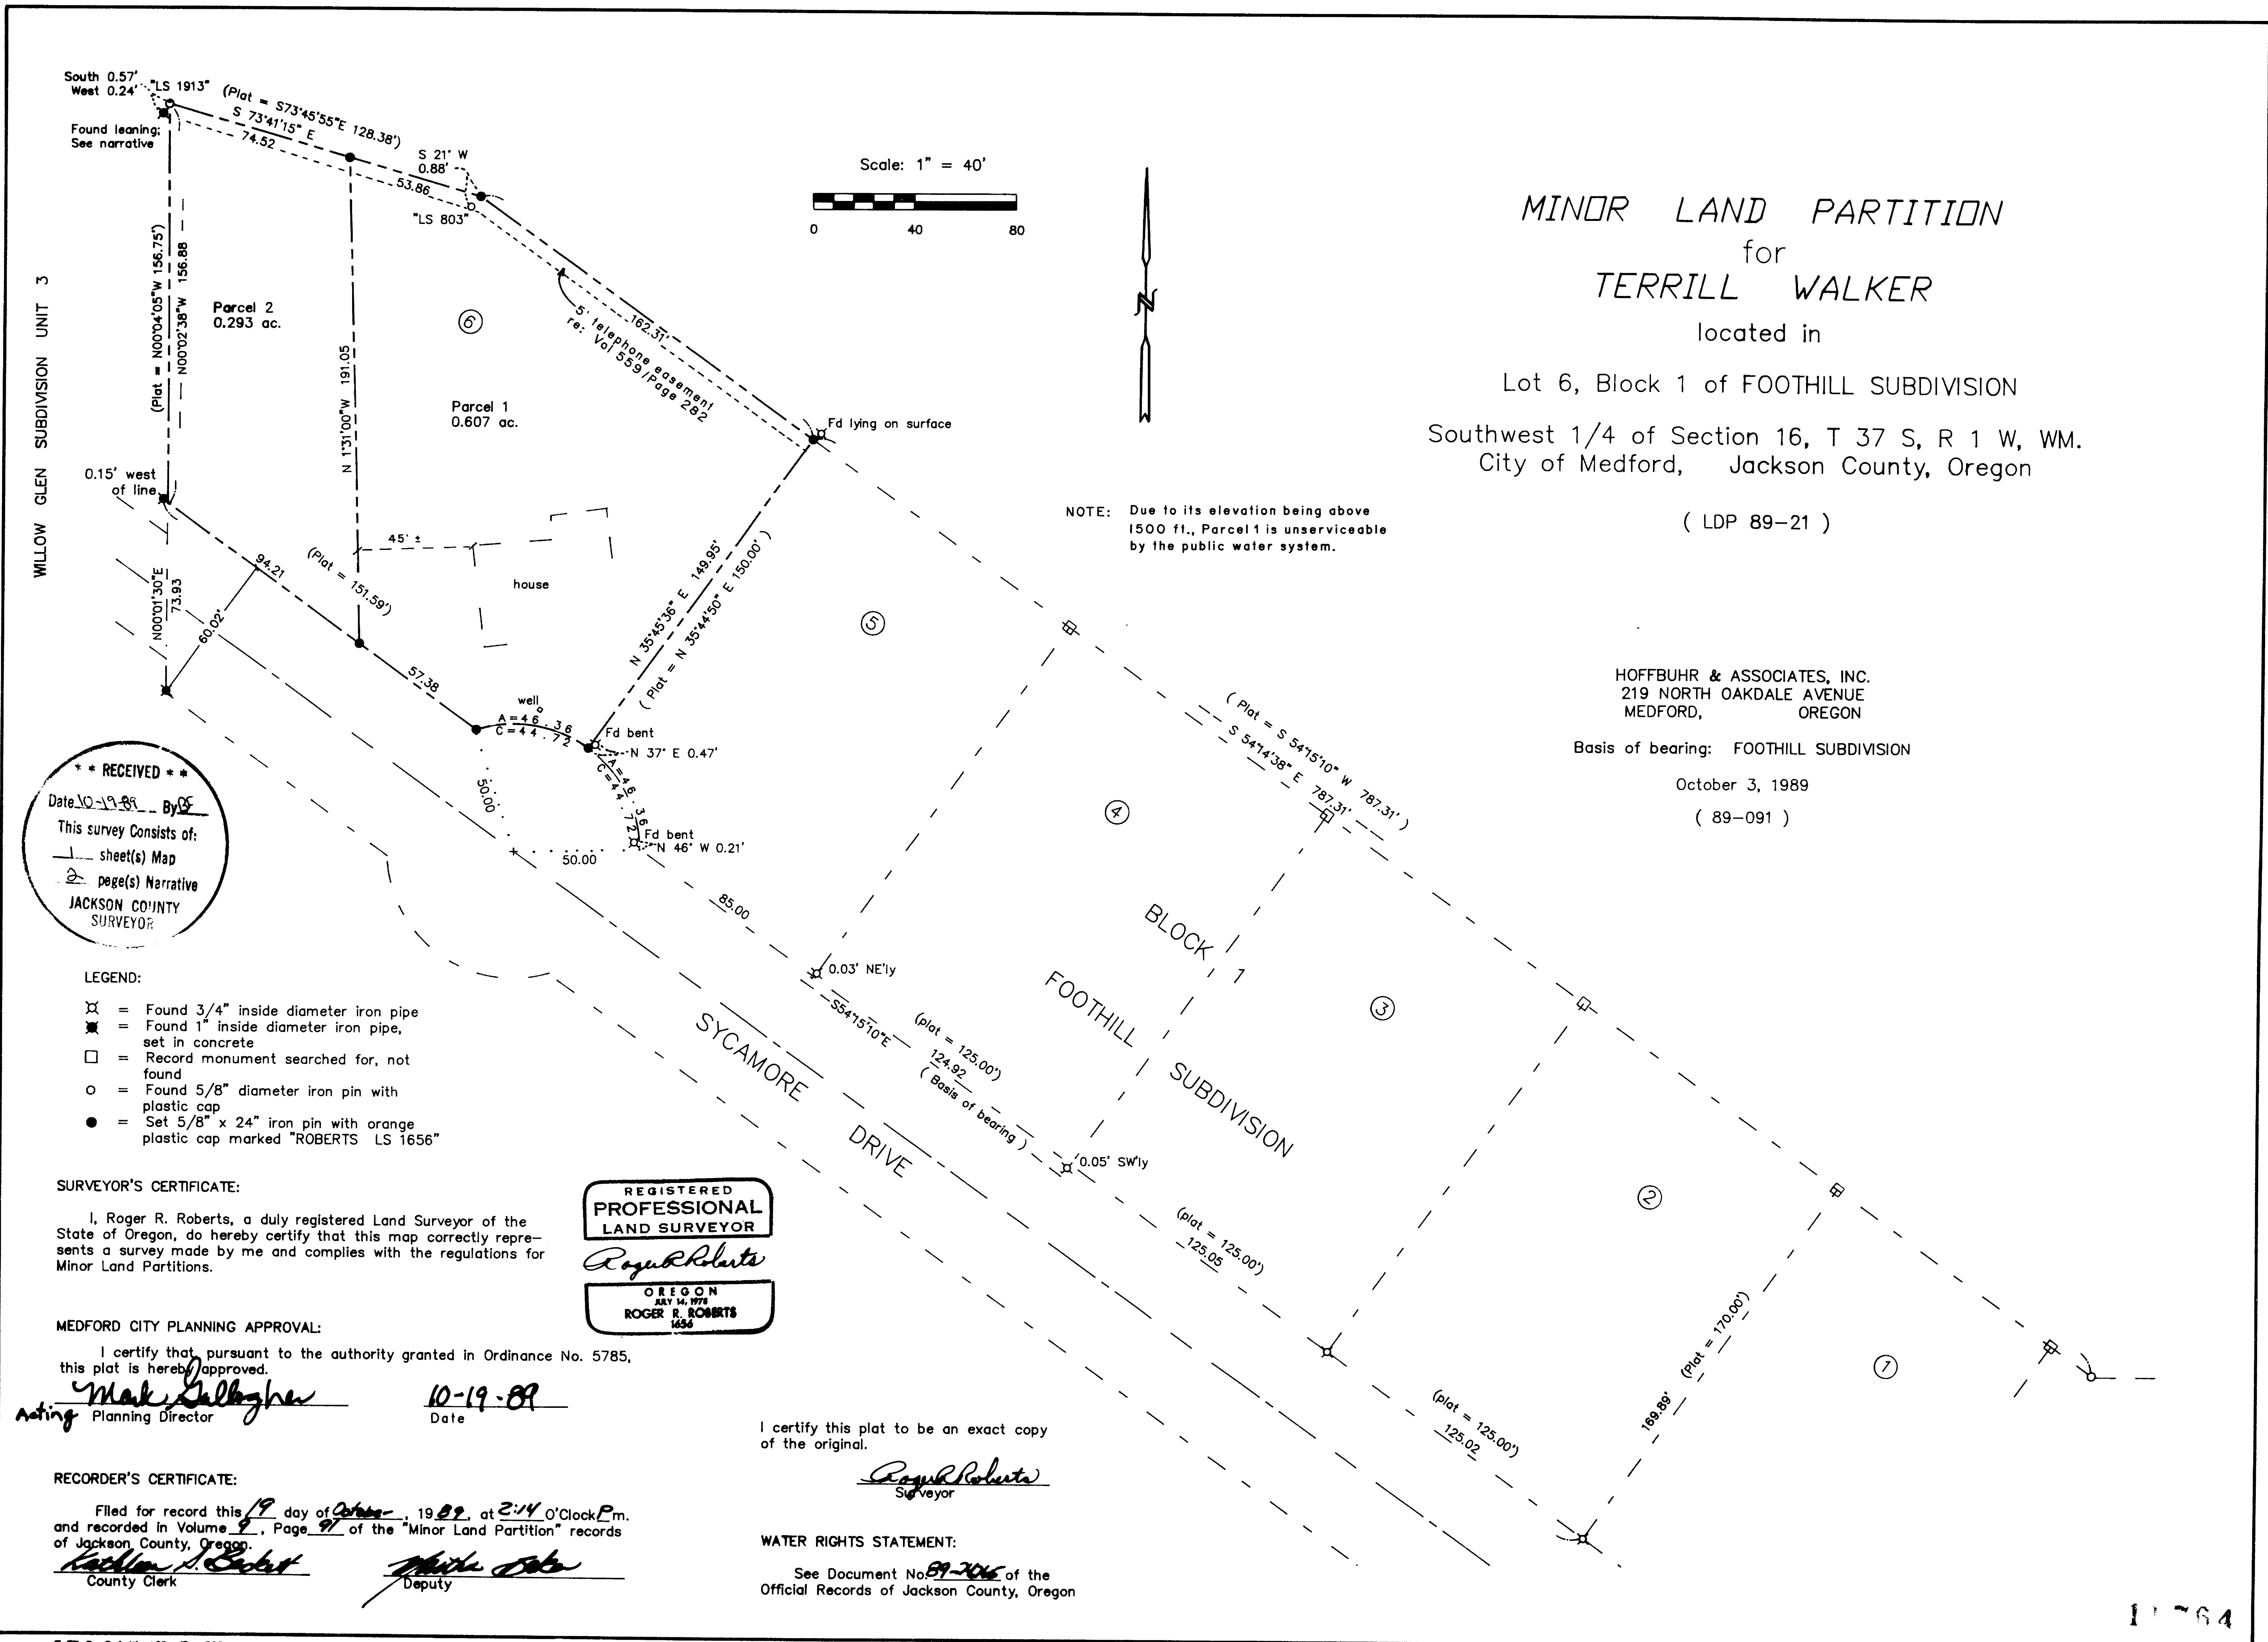
Basis of bearing: FOOTHILL SUBDIVISION

NOTE: Due to its elevation being above 1500 ft., Parcel 1 is unserviceable by the public water system.

- ⊗ = Found 3/4" inside diameter iron pipe
- ⊠ = Found 1" inside diameter iron pipe, set in concrete
- = Record monument searched for, not found
- = Found 5/8" diameter iron pin with plastic cap
- = Set 5/8" x 24" iron pin with orange plastic cap marked "ROBERTS LS 1656"

PROCEDURE: An extensive search was made for the original monuments in Block 1. Those found along the northeasterly boundary of Sycamore Way were used for the basis of bearing, using plat record. The original monuments along the northeasterly boundary of Lots 1 through 5 have evidently been recently destroyed by the clearing for and construction of a new fence in conjunction with the adjoining golf course development.

The  $\frac{5}{8}$ " diameter pin found at the northwest corner of Lot 6 was recently established during the monumenting of WILLOW GLEN SUBDIVISION UNIT 3, at the location as determined and described in Minor Land Partition No. 11687. As stated in the narrative for that particular partition, the location disagrees with that used by Survey No. 10709. I found the 1" pipe in concrete as described by the previous surveys. I also observed the following:

A. The pipe is exposed 7" out of the concrete. The concrete is exposed 5" above natural ground, meaning the pipe is exposed 12" above ground level.

B. The concrete is smoothed off on top. The pipe is leaning southerly, but the top of the concrete is level. Evidently the pipe was leaning at the time the concrete was placed around it.

C. The top edges of the finished concrete are straight, with 4 squared corners, except for the north edge. The north face of the concrete has a large, half circle indentation, which appeared to be where a wooden fence post used to stand. Digging below this indentation revealed decayed wood and fine soil in a circular area, which contrasted with the rocky soil surrounding this circle.

E. The  $\frac{5}{8}$ " iron pin positioned by the "broken boundary" method of Survey No. 11687 sits in the approximate center of the circular area.

I is my conclusion that the 1" pipe was probably leaned southerly by Catalano so that he could place the fence corner post at the corner position. After placing the post, the concrete was placed around the leaning pipe and against the south side of the post. Since the pipe has evidently been leaning out of position for many years, I cannot accept it as the original corner location. Although I disagree with the "broken boundary" method used by Survey No. 11687, I do agree with the resultant position marked by the

5/8" pin. I have therefore accepted it for this survey. It should be noted here that construction activity at the adjoining WILLOW GLEN SUBDIVISION UNIT 3 has disturbed both the pipe in concrete and the 5/8" pin since the initial measurements were taken for this survey.

Having accepted the position of the 5/8" pin for the northwest corner of Block 1, this left the 5/8" pin in the vicinity of the angle point on the northerly boundary of Lot 6 unacceptable. A comparison of several methods revealed that establishing the angle point by distance/distance intersection gave results closest to the record measurements, and was therefore used.
