Survey Narrative To Comply With O.R.S. 209.250

Survey For:

John E. McCaw Jr. 5400 Carrillion Point Kirkland, WA 98033

The N.W. 1/4 and the S.W. 1/4 of S.4 and the N.E. 1/4 and the S.E. 1/4 of S.5 of

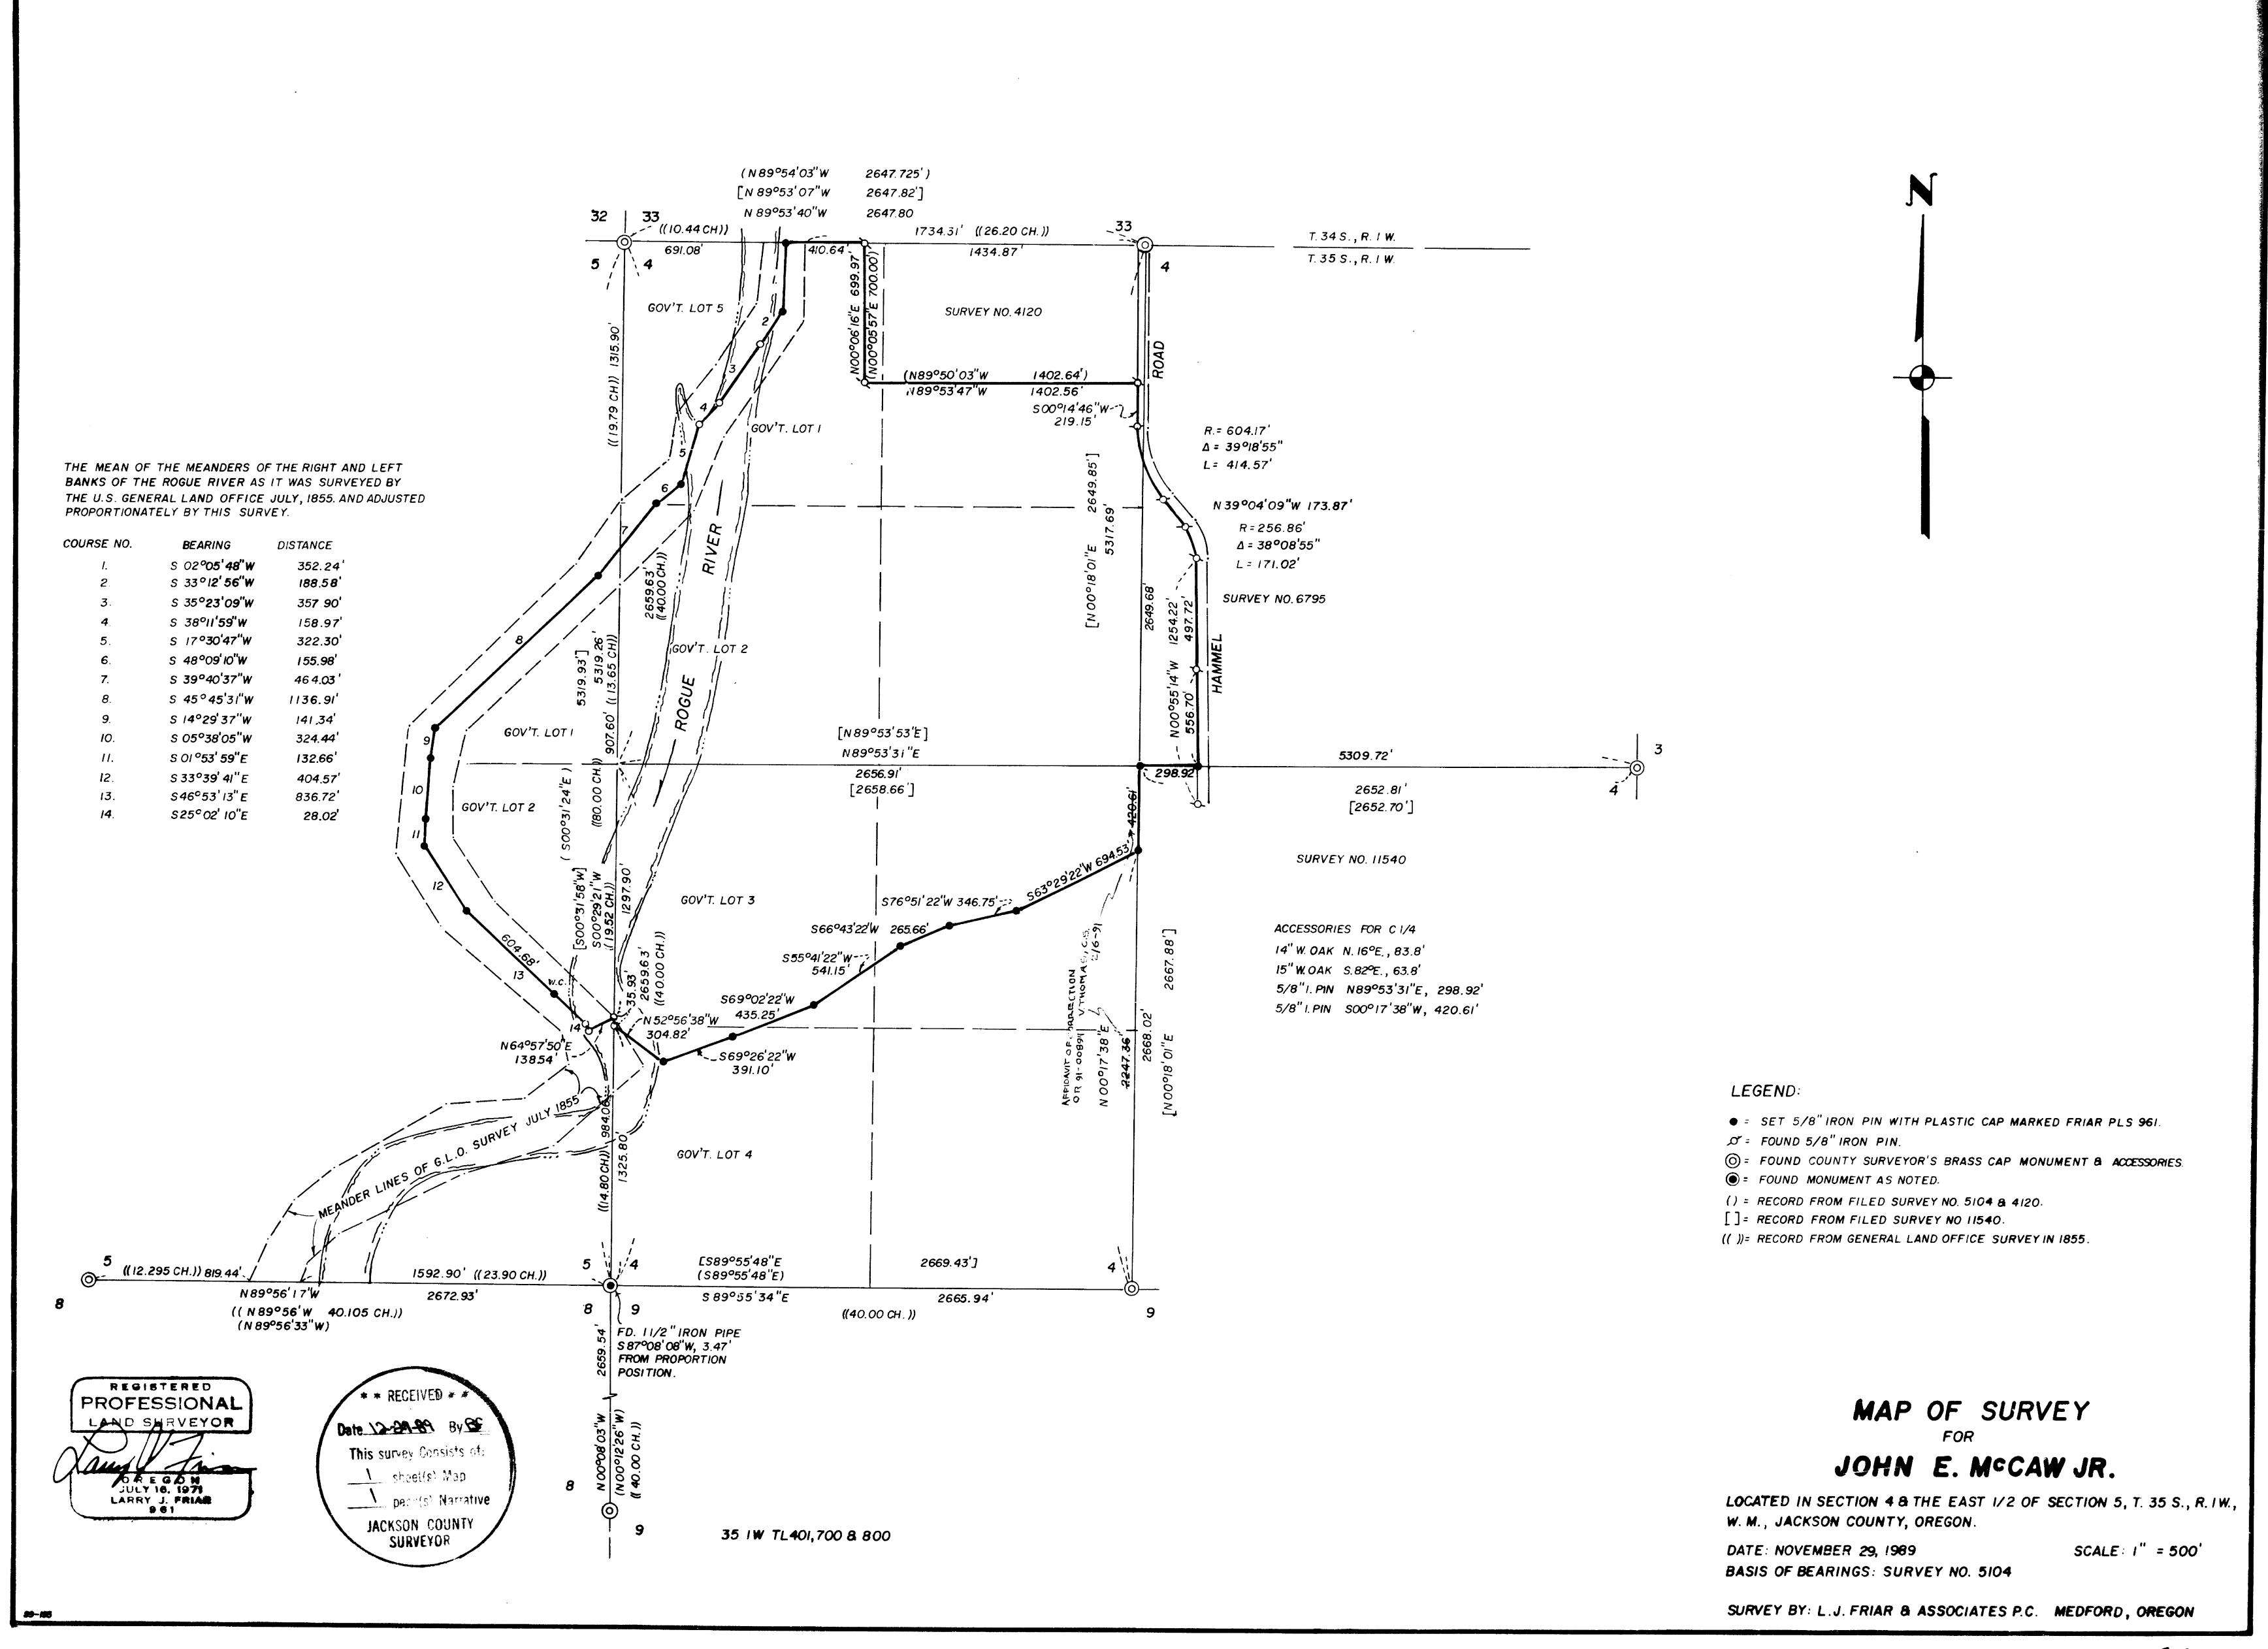
To survey and monument the tract of land shown on the annexed map according to the legal descriptions furnished in the

The controlling Section and one-quarter Section corners were tied to in a closed traverse network and the location of the fractional section lines were calculated. The Southwest corner of Section 4 was found to be out of position as shown on Survey No. 5104 due to an apparent error in the measurement between the controlling corners to the East and West The position of this corner was determined in proportion to Original Government distances to the nearest controlling Section and one-quarter corners to the North, South, East and West.

The West line of the property along the river was determined to be the center of the river as it existed at the time of the original Government Survey in 1855. Due to such a large and perceptible change in the location of the river, the change was determined to be caused by avulsion. The property line was located under the rules governing avulsion, where the change of the channel does not change the boundary, but remains as it was in the center of the old channel.

The meander lines from the original Government survey in 1855 were proportioned and adjusted by Compass Rule and a mean of the meanders of the left and right banks was calculated. This mean was surveyed and monumented (where possible).

The Southerly line was established by holding the Deed distance and rotating the bearing to match the bearing of the North-South centerline of Section 4.

The monuments found and those set are as shown on the annexed map with the addition of a steel post set by each property corner monument.
