Resurvey of Lots 2 & 3, Block 1 & Lots 1 & 2, Block 2 of
REGAR SUBDIVISION (not officially recorded)
Located in Secs. 25 & 26, T.37S.R.2W., W.M.
By: Mark E. Boyden Dec. 1957.

Survey Narrative to Comply With Paragraph 209.250
Oregon Revised Statutes

PURPOSE: To re-monument the boundaries of Lots 2 and 3 of Block 1 and Lots 1 and 2 and the South 200 feet of Lot 1 of Block 2 of REGAR SUBDIVISION (not officially recorded) located in Sections 25 and 26, Township 37 South, Range 2 West.

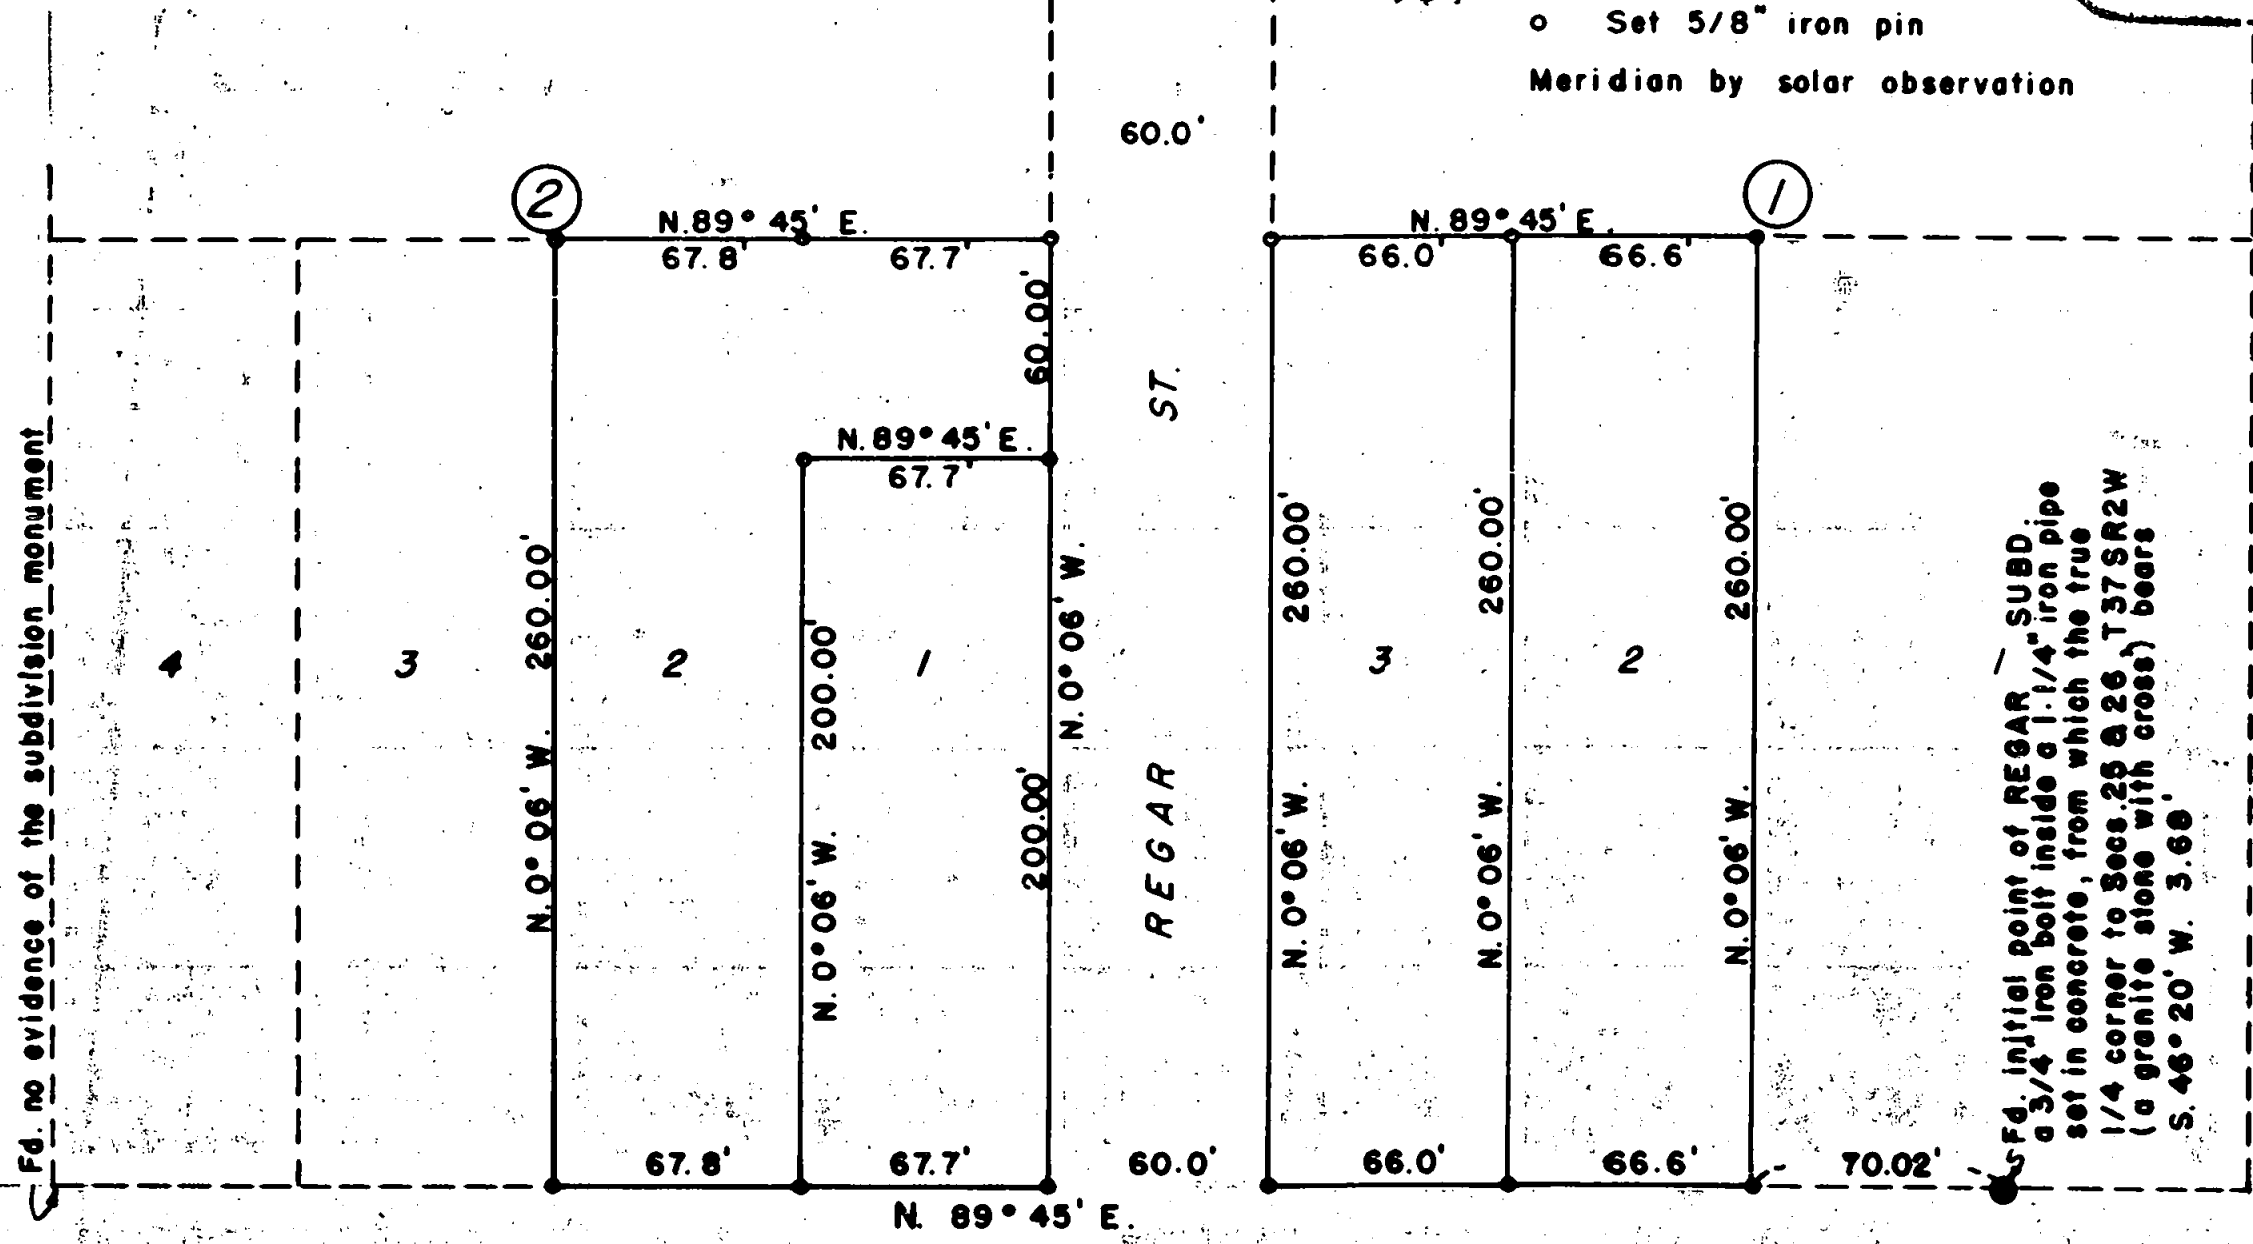
o Set 5/8" iron pin
Meridian by solar observation

STATE HIGHWAY NO. 238

Monumented the tract as shown on the map to accompany this report.

the lines are coincident with several interior subdivision fence lines and agree with the original boundaries as were known to exist by the older area residents.
