### MAP OF SURVEY

Located in  
 Donation Land Claim No. 41, SW 1/4 Sec 4,  
 SE 1/4 Sec 5, NE 1/4 Sec 8, NW 1/4 Sec 9  
 T 38 S, R 1 W, WM., Jackson County, Oregon

for  
**Gail Marie Brown-Arend**  
 (a.k.a. Gail Brownmiller)  
 and  
**Kennett G. Sublette**

LANDMARK SURVEYING  
 Roger R. Roberts  
 205 West Ninth Street  
 Medford, Oregon 97051  
 (File 90-025)

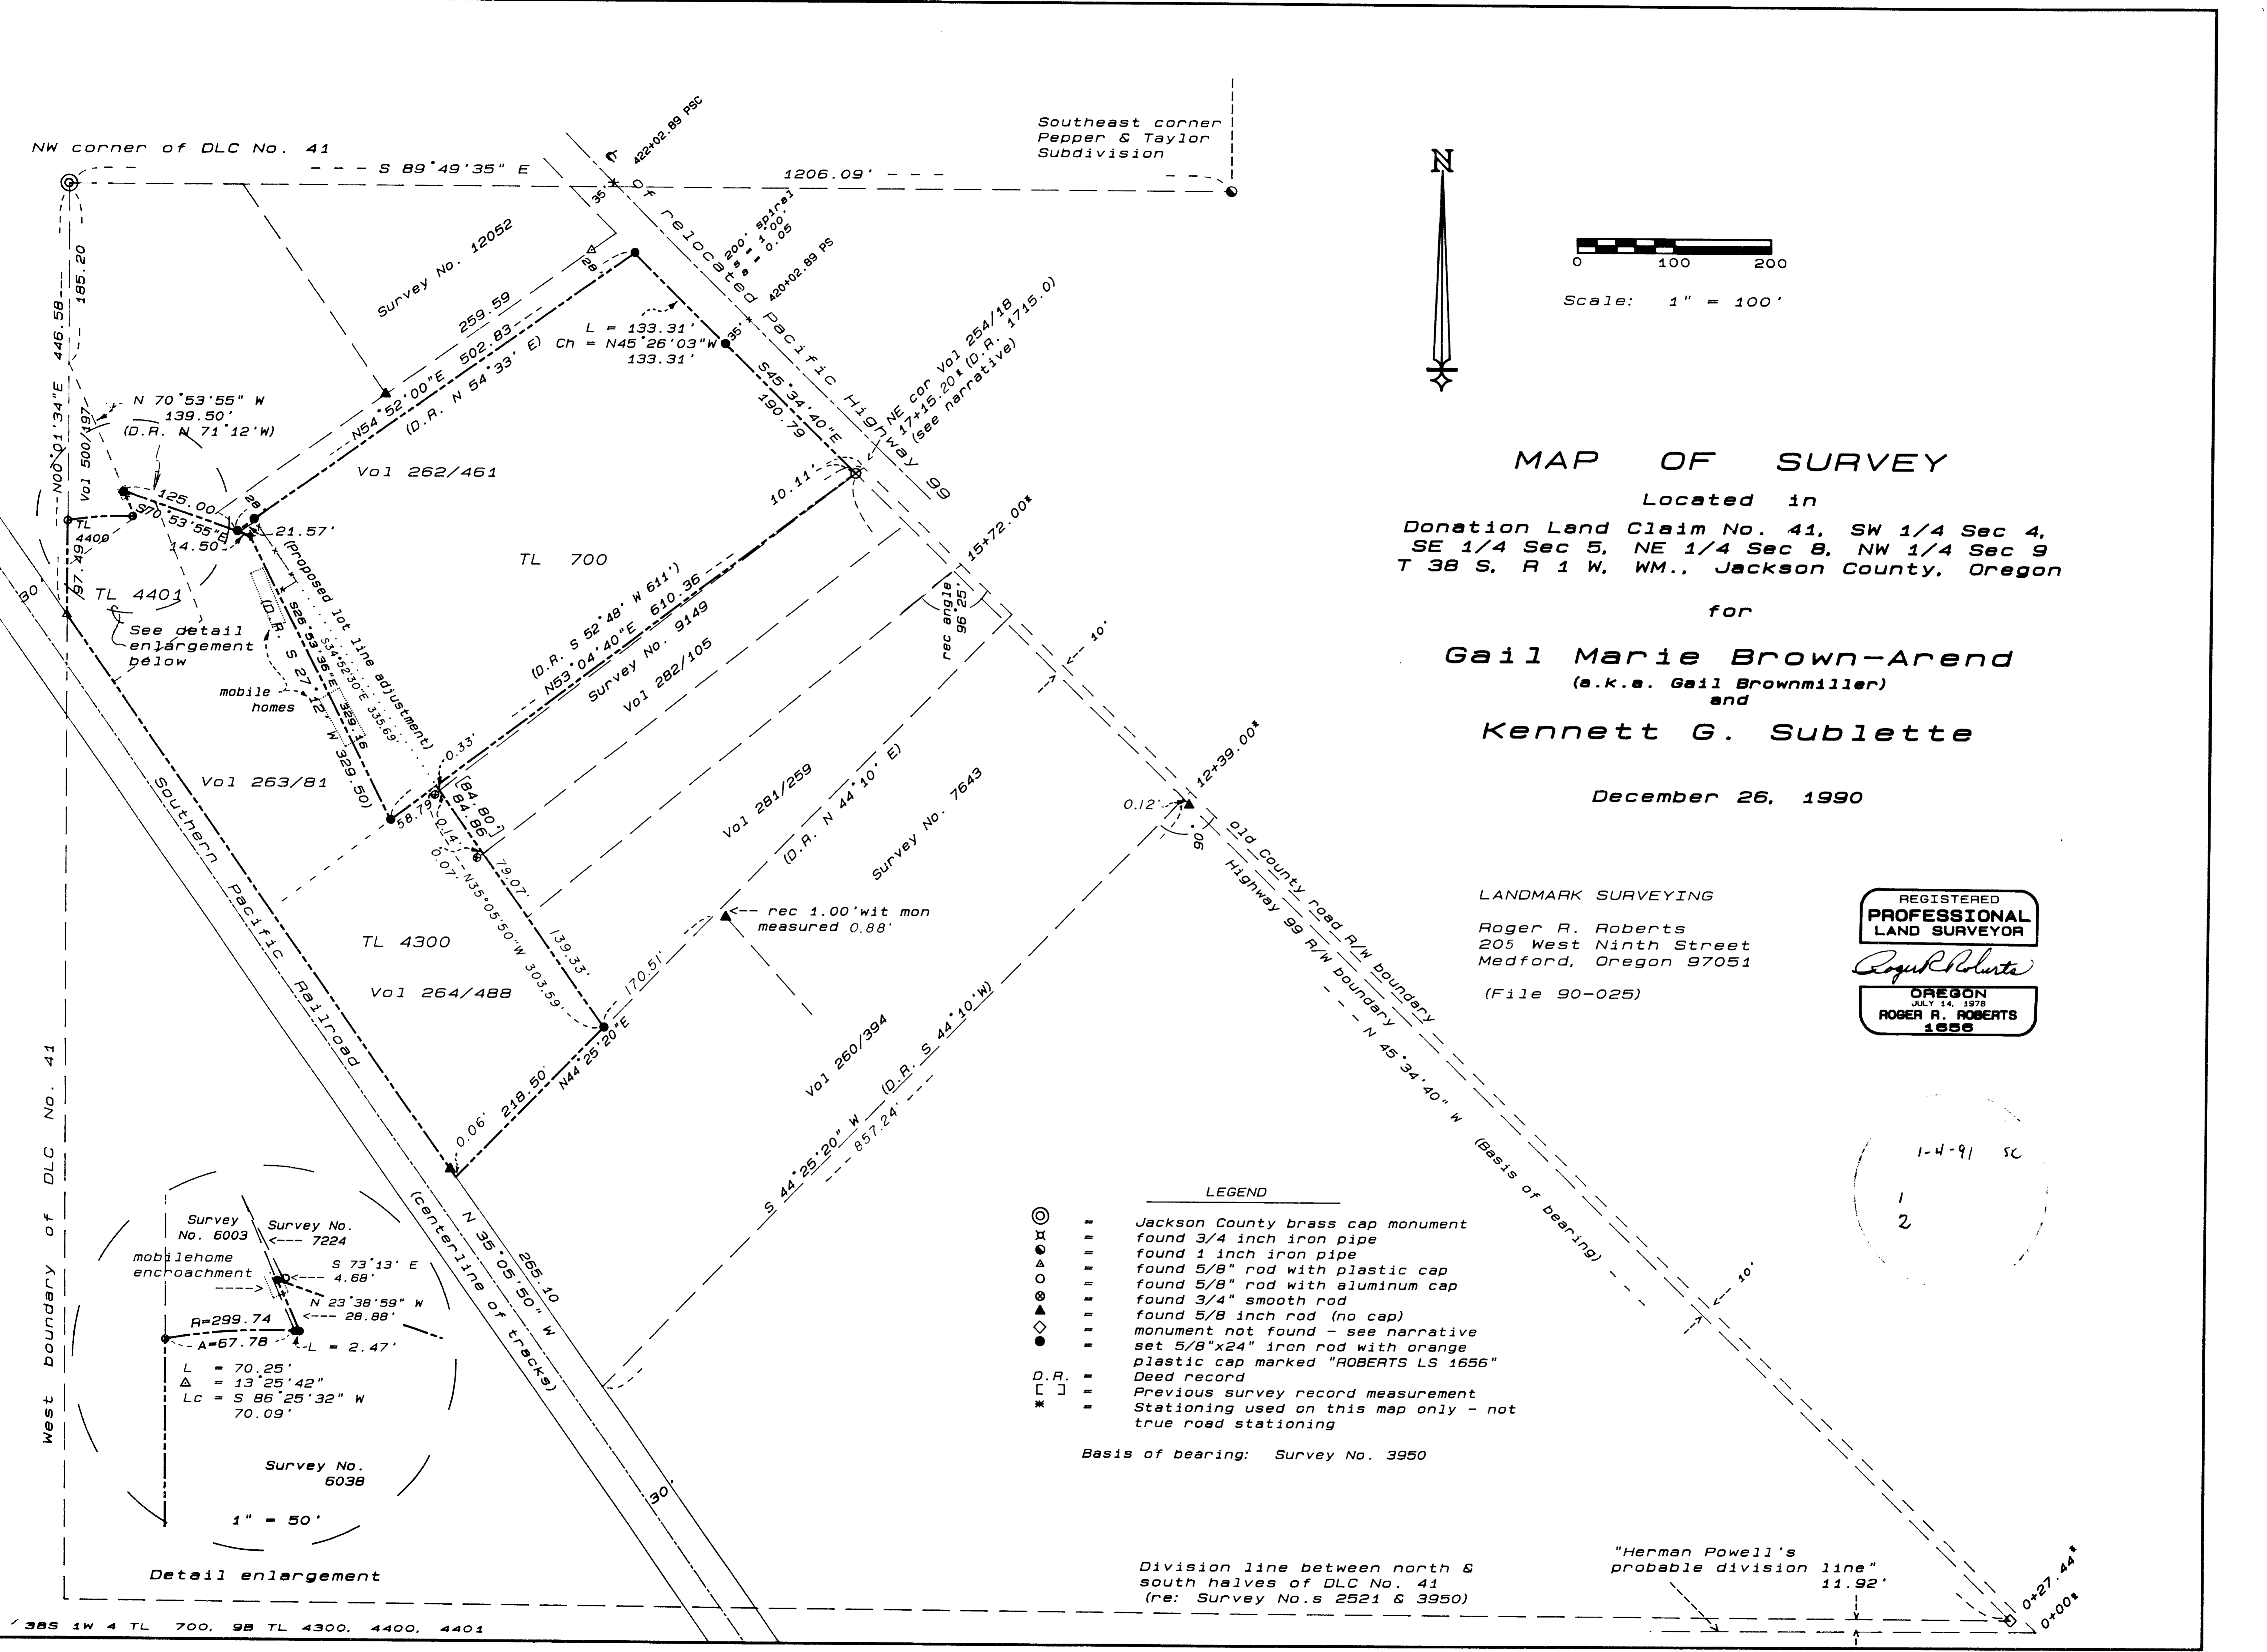
Basis of bearing: Survey No. 3950

Division line between north & south halves of DLC No. 41 (re: Survey No.s 2521 & 3950)

"Herman Powell's probable division line" 11.92'

The southeasterly boundary of Tax Lot 4300 was first created by Volume 260/Page 394 of the Deed Records, and the northeasterly boundary was created by Volume 264/Page 488. These lines were determined as shown on the map, and monumented accordingly.

The northeasterly corner of Tax Lot 700 was determined by the northeast corner of that tract described in Vol 254/Page 18 of the Deed Records, being 1715 feet northwesterly along the County road right of way from its intersection with the DLC division line. The narrative of Survey No. 3950 and the map of Survey No. 9149 indicates that this corner was evidently monumented with a pipe at one time, and that the pipe location is documented on a set of State Highway Department Construction Plans. Using the monumentation found from Survey No. 9149, this pipe location was determined, which produces a distance of 1715.44 feet along the county road right of way from the DLC division line. The description given in Vol 262/Page 461 described this corner as being marked with "... an iron pin heretofore established by H.D. Powell ...". This computed position of the monument was held for the purpose of this survey. Vol 262/Page 461 then continues "... thence South 52°48' West on established line 611 feet to an iron pipe...". No pipe was found. However, Survey No. 1598 shows finding a pipe. Information on that survey was used to determine the location of the missing monument and a new monument set.

The  $\frac{1}{4}$  inch pipe found near the northwest corner of Tax Lot 700 was used to determine the westerly boundary of that tract described in Vol 262/Page 461 of the Deed Records. The northerly boundary of Tax Lot 4400 was determined by the description of the tract in Vol 500/Page 197, and the corresponding monuments found as set in Survey No. 6003.

Because of the importance of the location of the DLC division line/road right of way intersection, an attempt was made to utilize the monument set by Lovejoy. However, the monument could not be found. A conversation with Jim Andrews, who is doing a boundary survey in the vicinity, revealed that the monument had been there only days earlier. Andrews provided his coordinates for the monument location, and a second inspection disclosed that the monument had evidently been recently replaced by a bus stop sign post.

This coordinated location for the missing monument and the  $\frac{1}{4}$  inch iron rod found at the most northerly corner of Survey No. 9149 were used to determine the westerly boundary of Highway 99. It should be noted that many monuments set along this right of way boundary by prior surveys were searched for, and that most of the monuments were missing or found in poor condition, most likely due to recent widening and improvements of the highway.
