# NARRATIVE OF SURVEY

SURVEY FOR:

Duane and Bonnie Noon

THE SPECIAL CONTRACTOR OF THE PROPERTY OF Township 39 South, Range 2 East, South one-half of the Northeast Quarter, Section 31 Willamette Meridian, Jackson County, Oregon (Tax Plat No. 395-2E-S31, Tax Lots 1500,1501, 409)

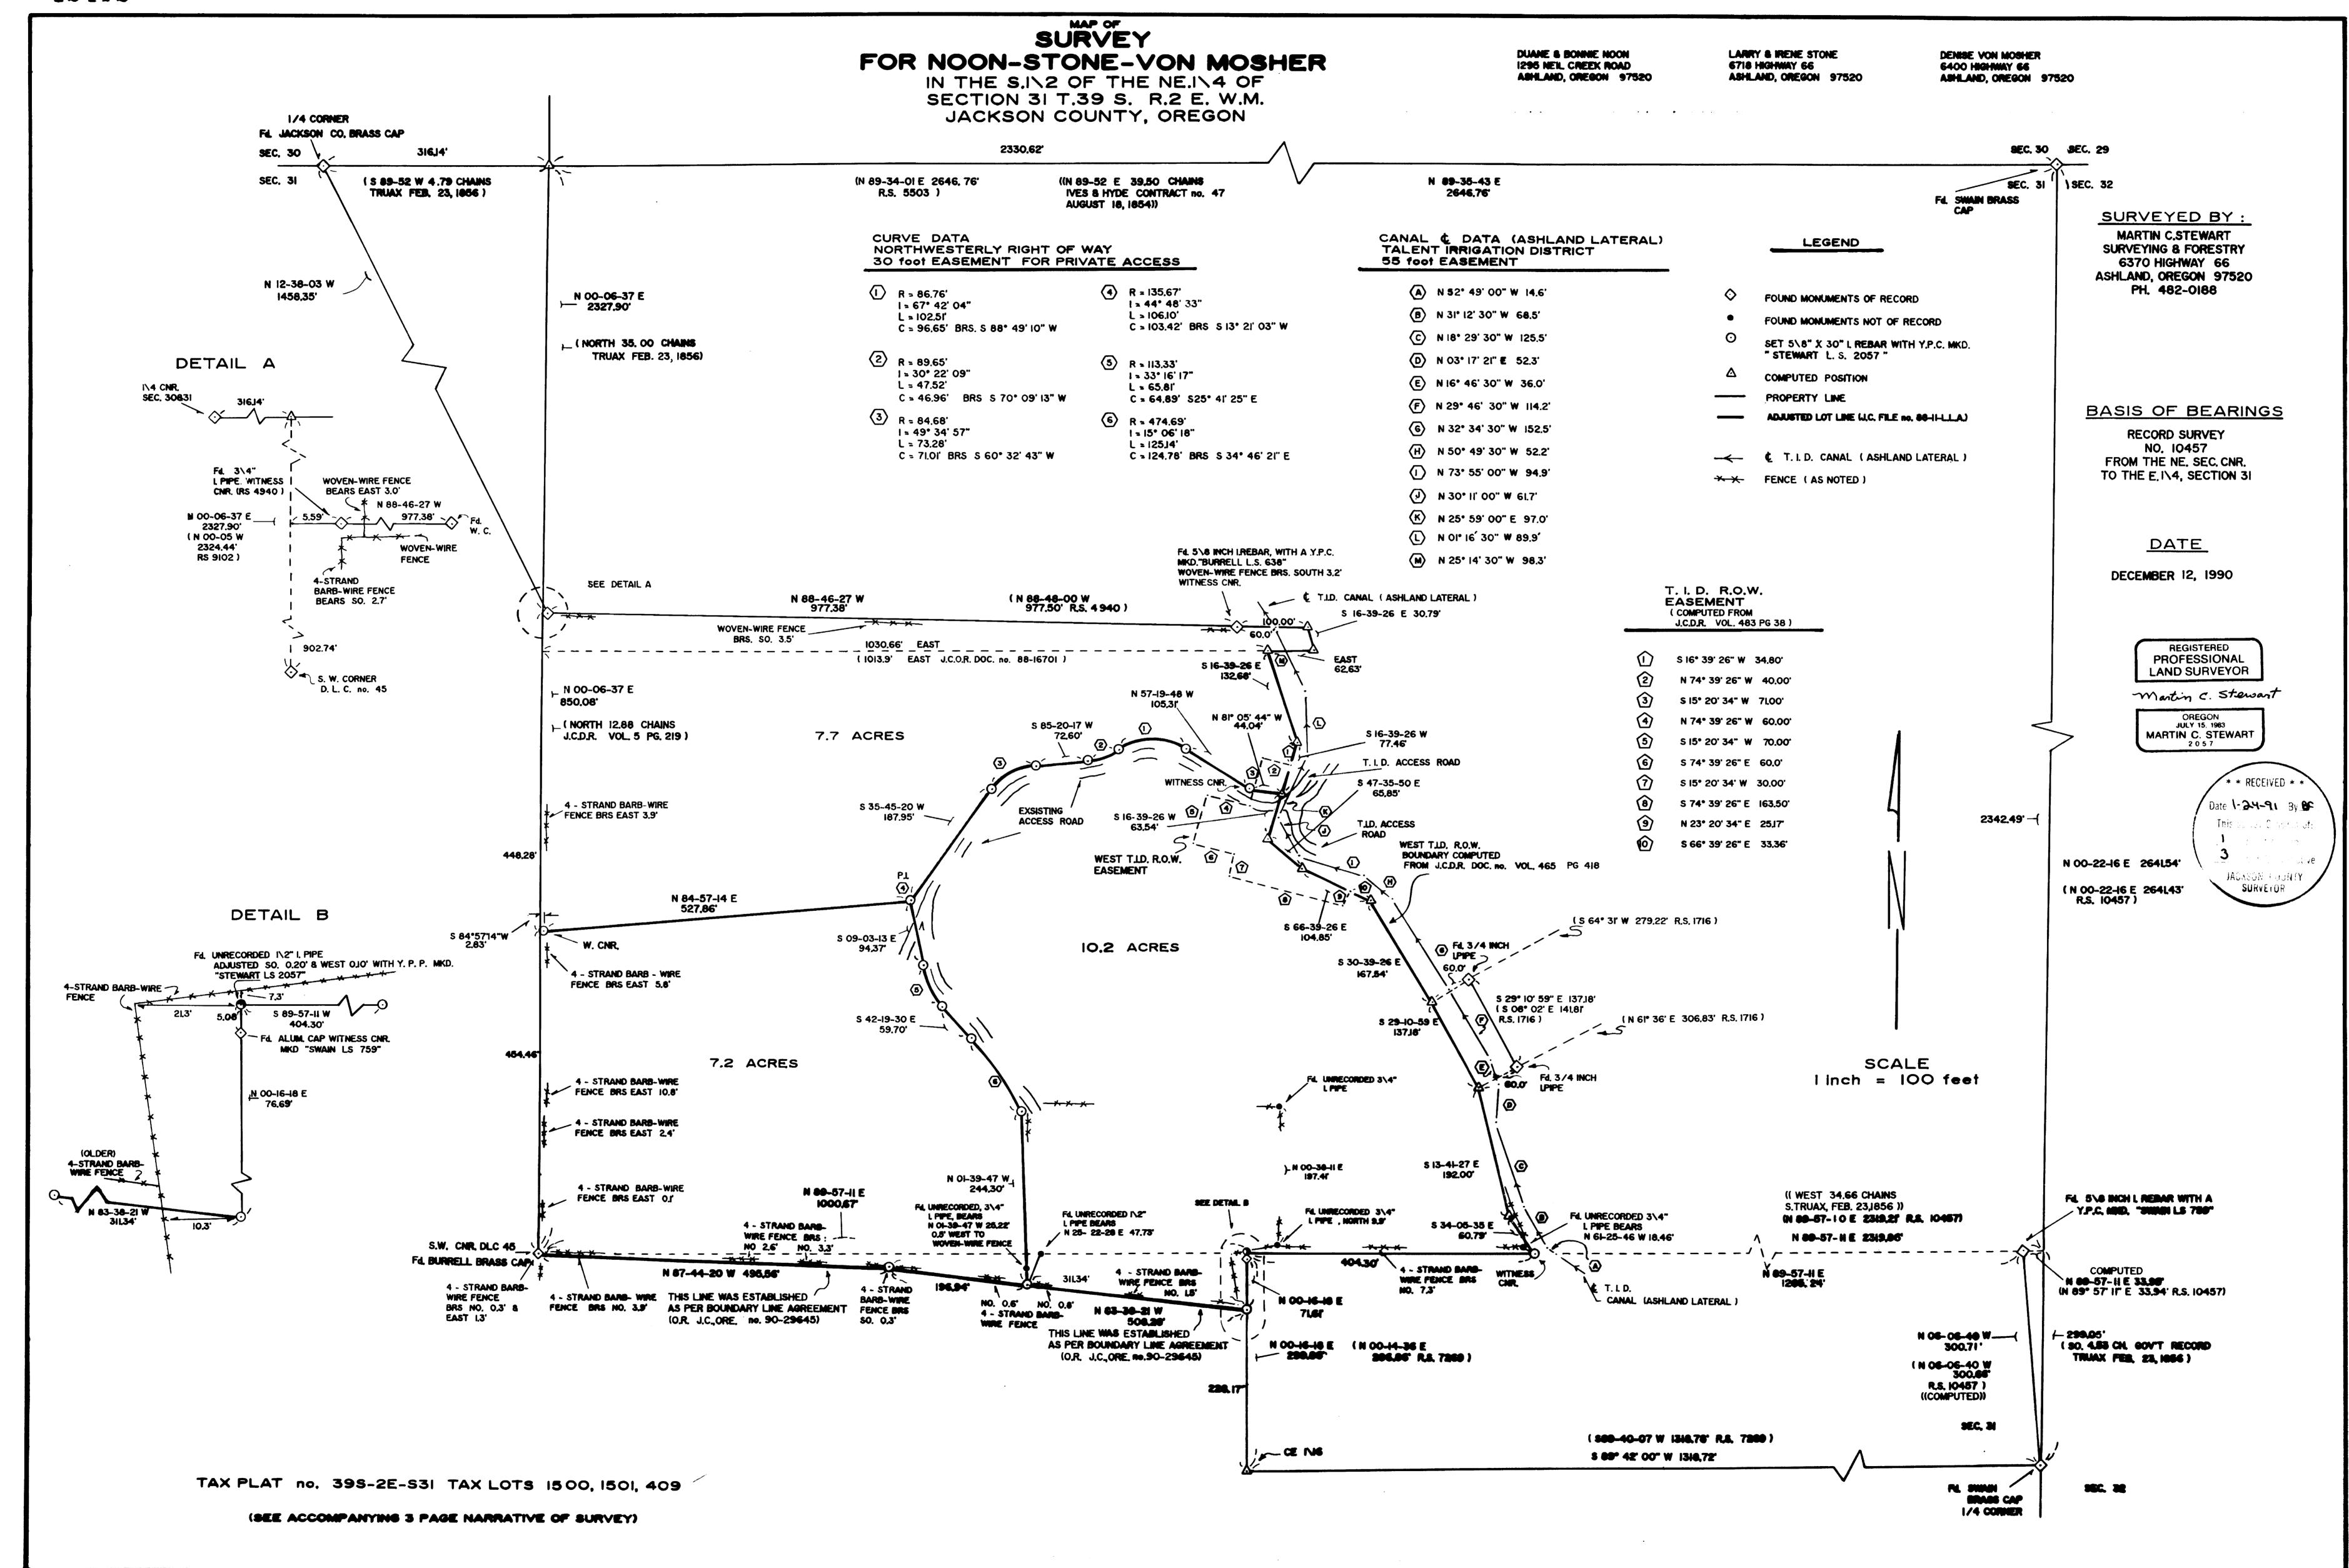
To monument a lot line adjustment (J.C. File No. 88-11), as well as to monument a Boundary Line Agreement (recorded as No. 90-29645 Official Records of (recorded as No. 90-29645 Official Records of Jackson County, Oregon).

additional controlling monumentation were corners set in unrecorded surveys s noted on map of survey, including two 2 inch iron pipes, one of which was adjusted as it was found in close proximity to the East-Northeast corner of Government Lot 2, Section 31; and other than the 3/4 inch iron pipe witness corner, (the most Northwesterly), found and noted in Record Surveys Nos. 1716, 4940, and 9102, the remaining 3/4 inch iron pipes source are unknown. The West line of D.L.C. No. 45 was not established by this survey, though the computed position fits favorably to existing improvements, there is still a need for research and evaluation, particularly, of possible accessory evidence established by surveys performed in the late 1800's, as the remaining corners common to D.L.C. No. 45 appear to have been at least obliterated if not lost

Accordingly, the South line of said D.L.C. No. 45 was computed to evaluate fence lines and improvements that were established apparently without benefit of a record survey, and were found to encroach on the adjoiner to the Southwest (that tract described in deed recorded as No. 74-05052 Official Records, Jackson County, Oregon), and a Boundary Line Agreement (recorded as No. 90-29645, Official Records, Jackson County, Oregon) was executed to resolve the location of these improvements, relative to titled lines.

The establishment of the interior adjusted lot lines were determined by client instructions as well as Jackson County Planning Staff, whose recomendations were that the existing private road was to access only two of the parcels, therefore it's Northwesterly right of way line was used as the Southeasterly boundary of the most Northwesterly tract, shown on map of survey. \*(see accompanying map of survey)
