SURVEY NARRATIVE TO COMPLY WITH PARAGRAPH 209.250 OREGON REVISED STATUTES

SURVEY FOR:

City of Ashland

To establish centerline control for Clay Street which is compatible with the control monumentation found prior to the year 1977.

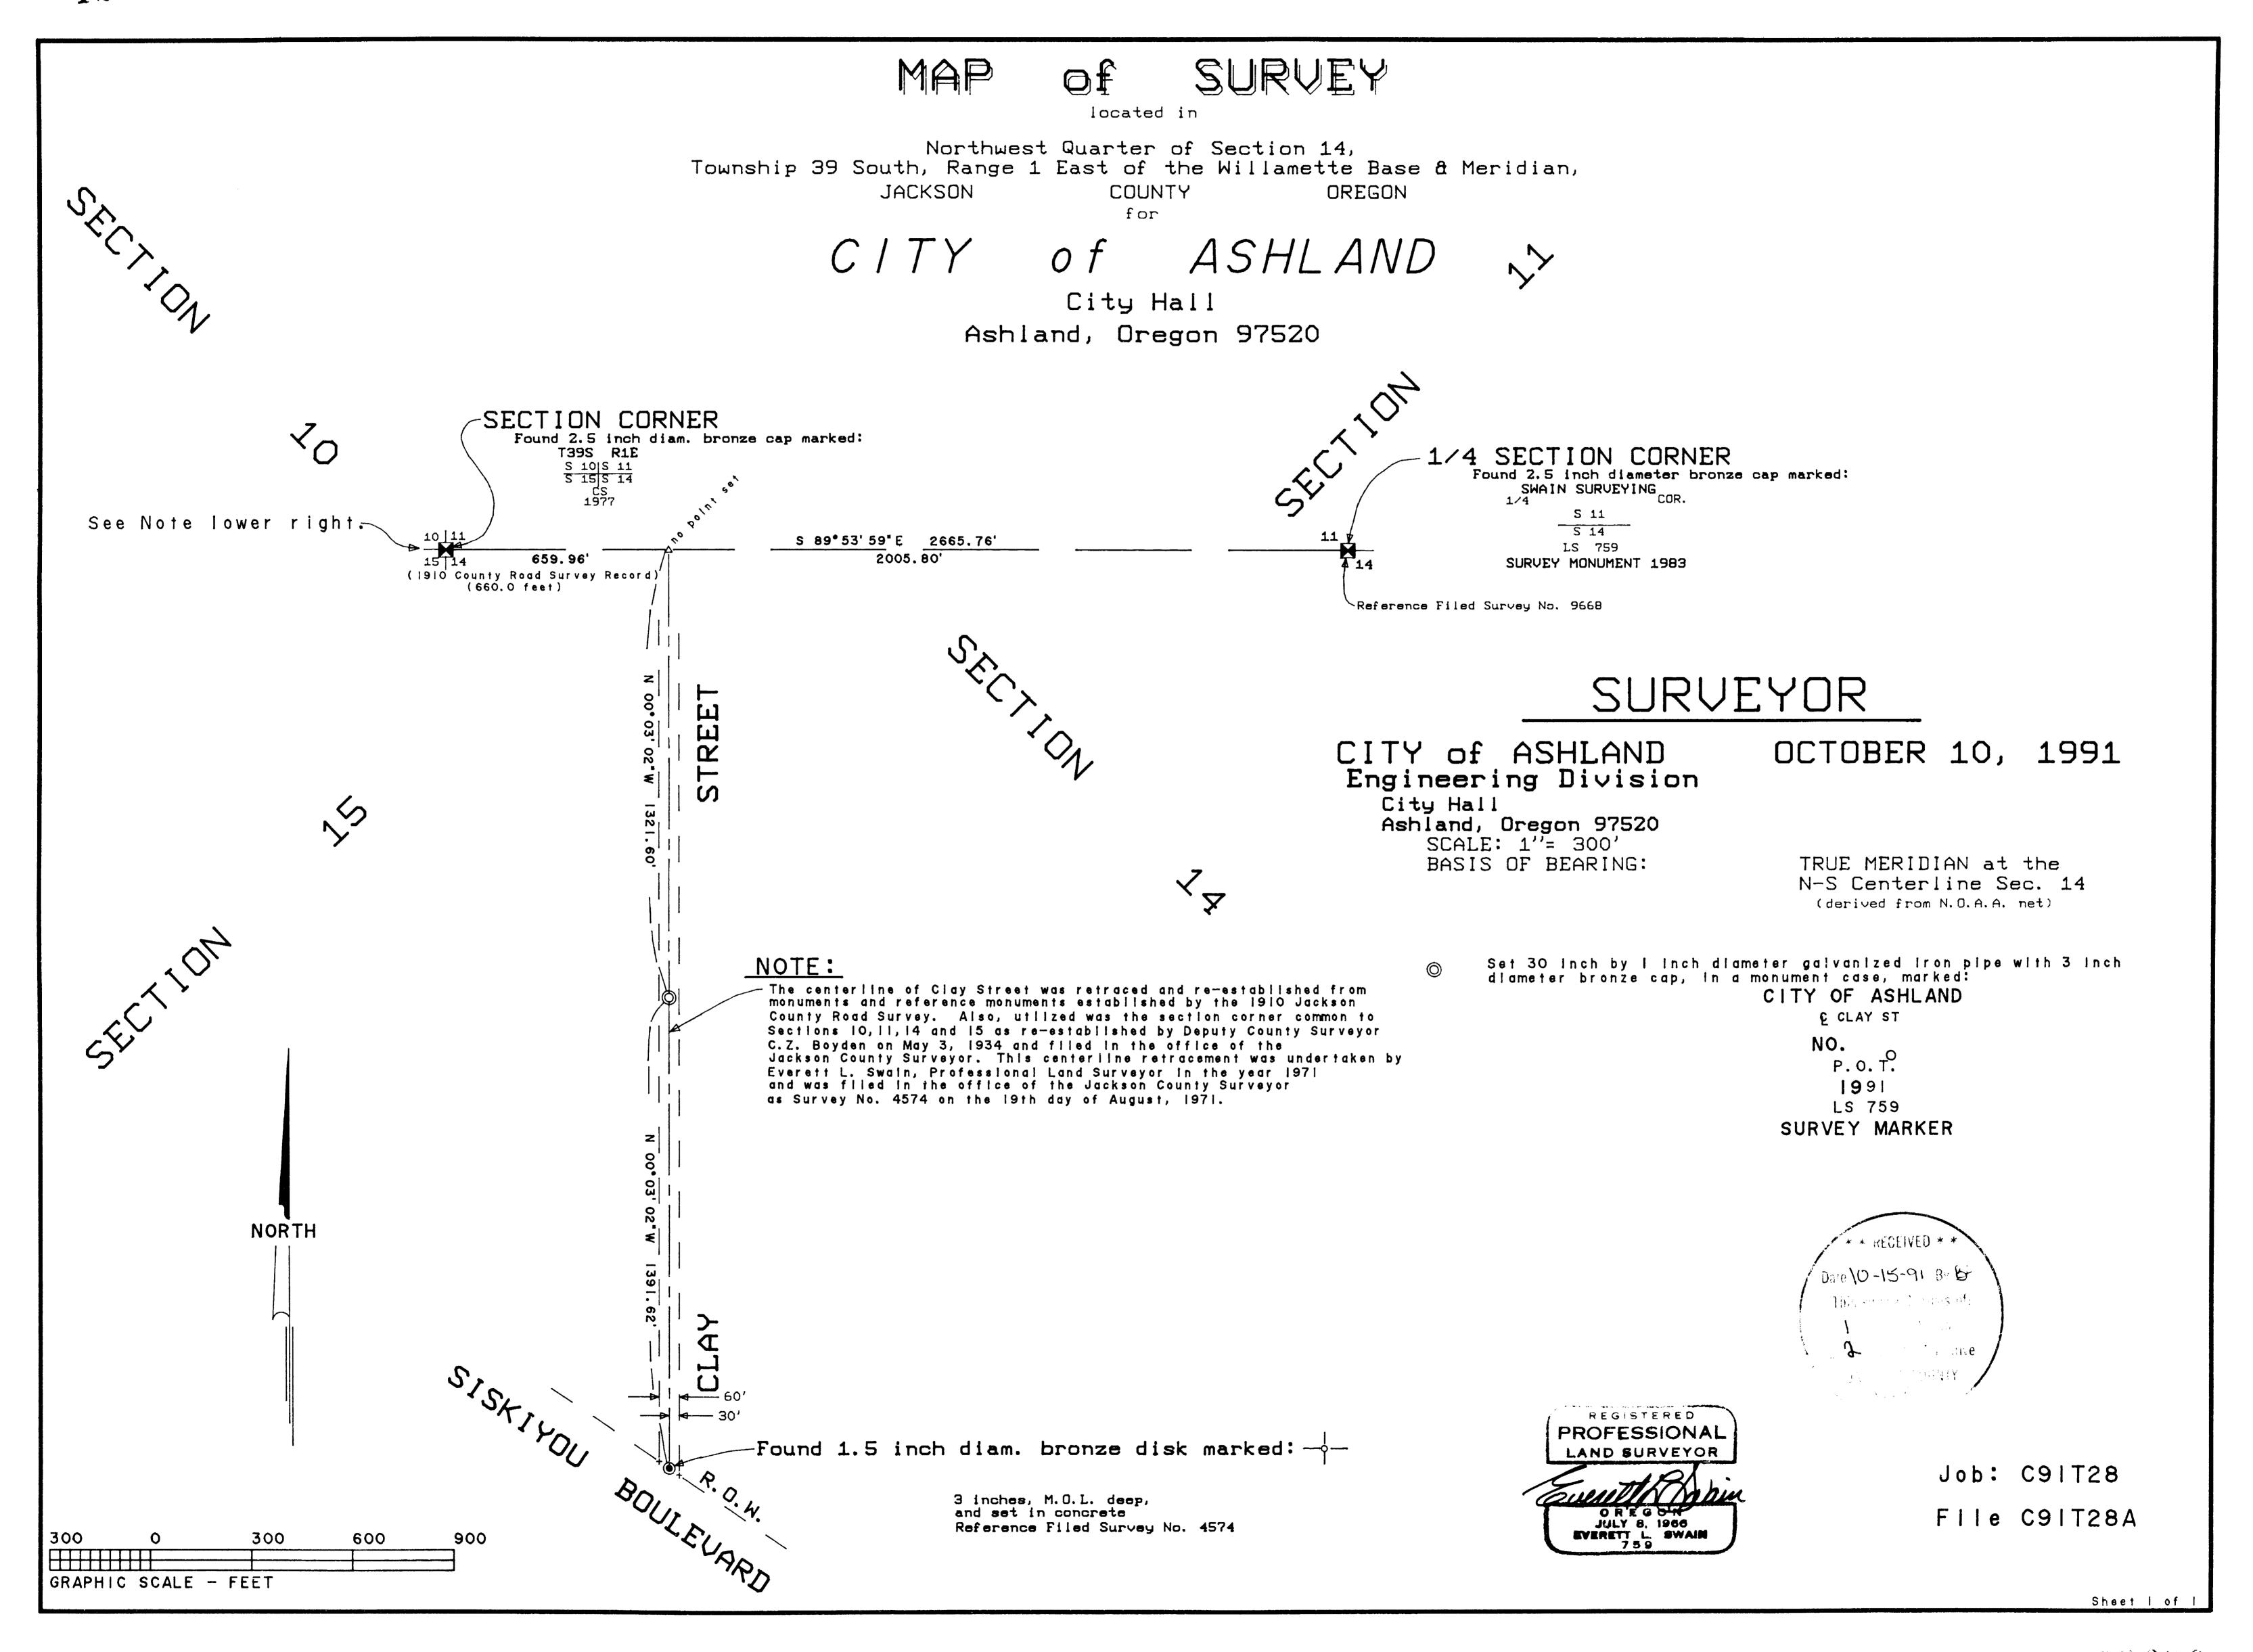
it is presently monumented. The results are as shown on the accompanying map. The retracement

distance of 659.96 feet versus the record distance of 660.0 feet is more than likely the result of the
