MAP of DEPENDENT RESURVEY

located in
SOUTH ONE-HALF of SECTION 31
TOWNSHIP 39 SOUTH, RANGE 2 EAST of the
WILLAMETTE BASE and MERIDIAN
JACKSON COUNTY OREGON

for
Richard and Joan Hill
1311 Neil Creek Road
Ashland, Oregon 97520

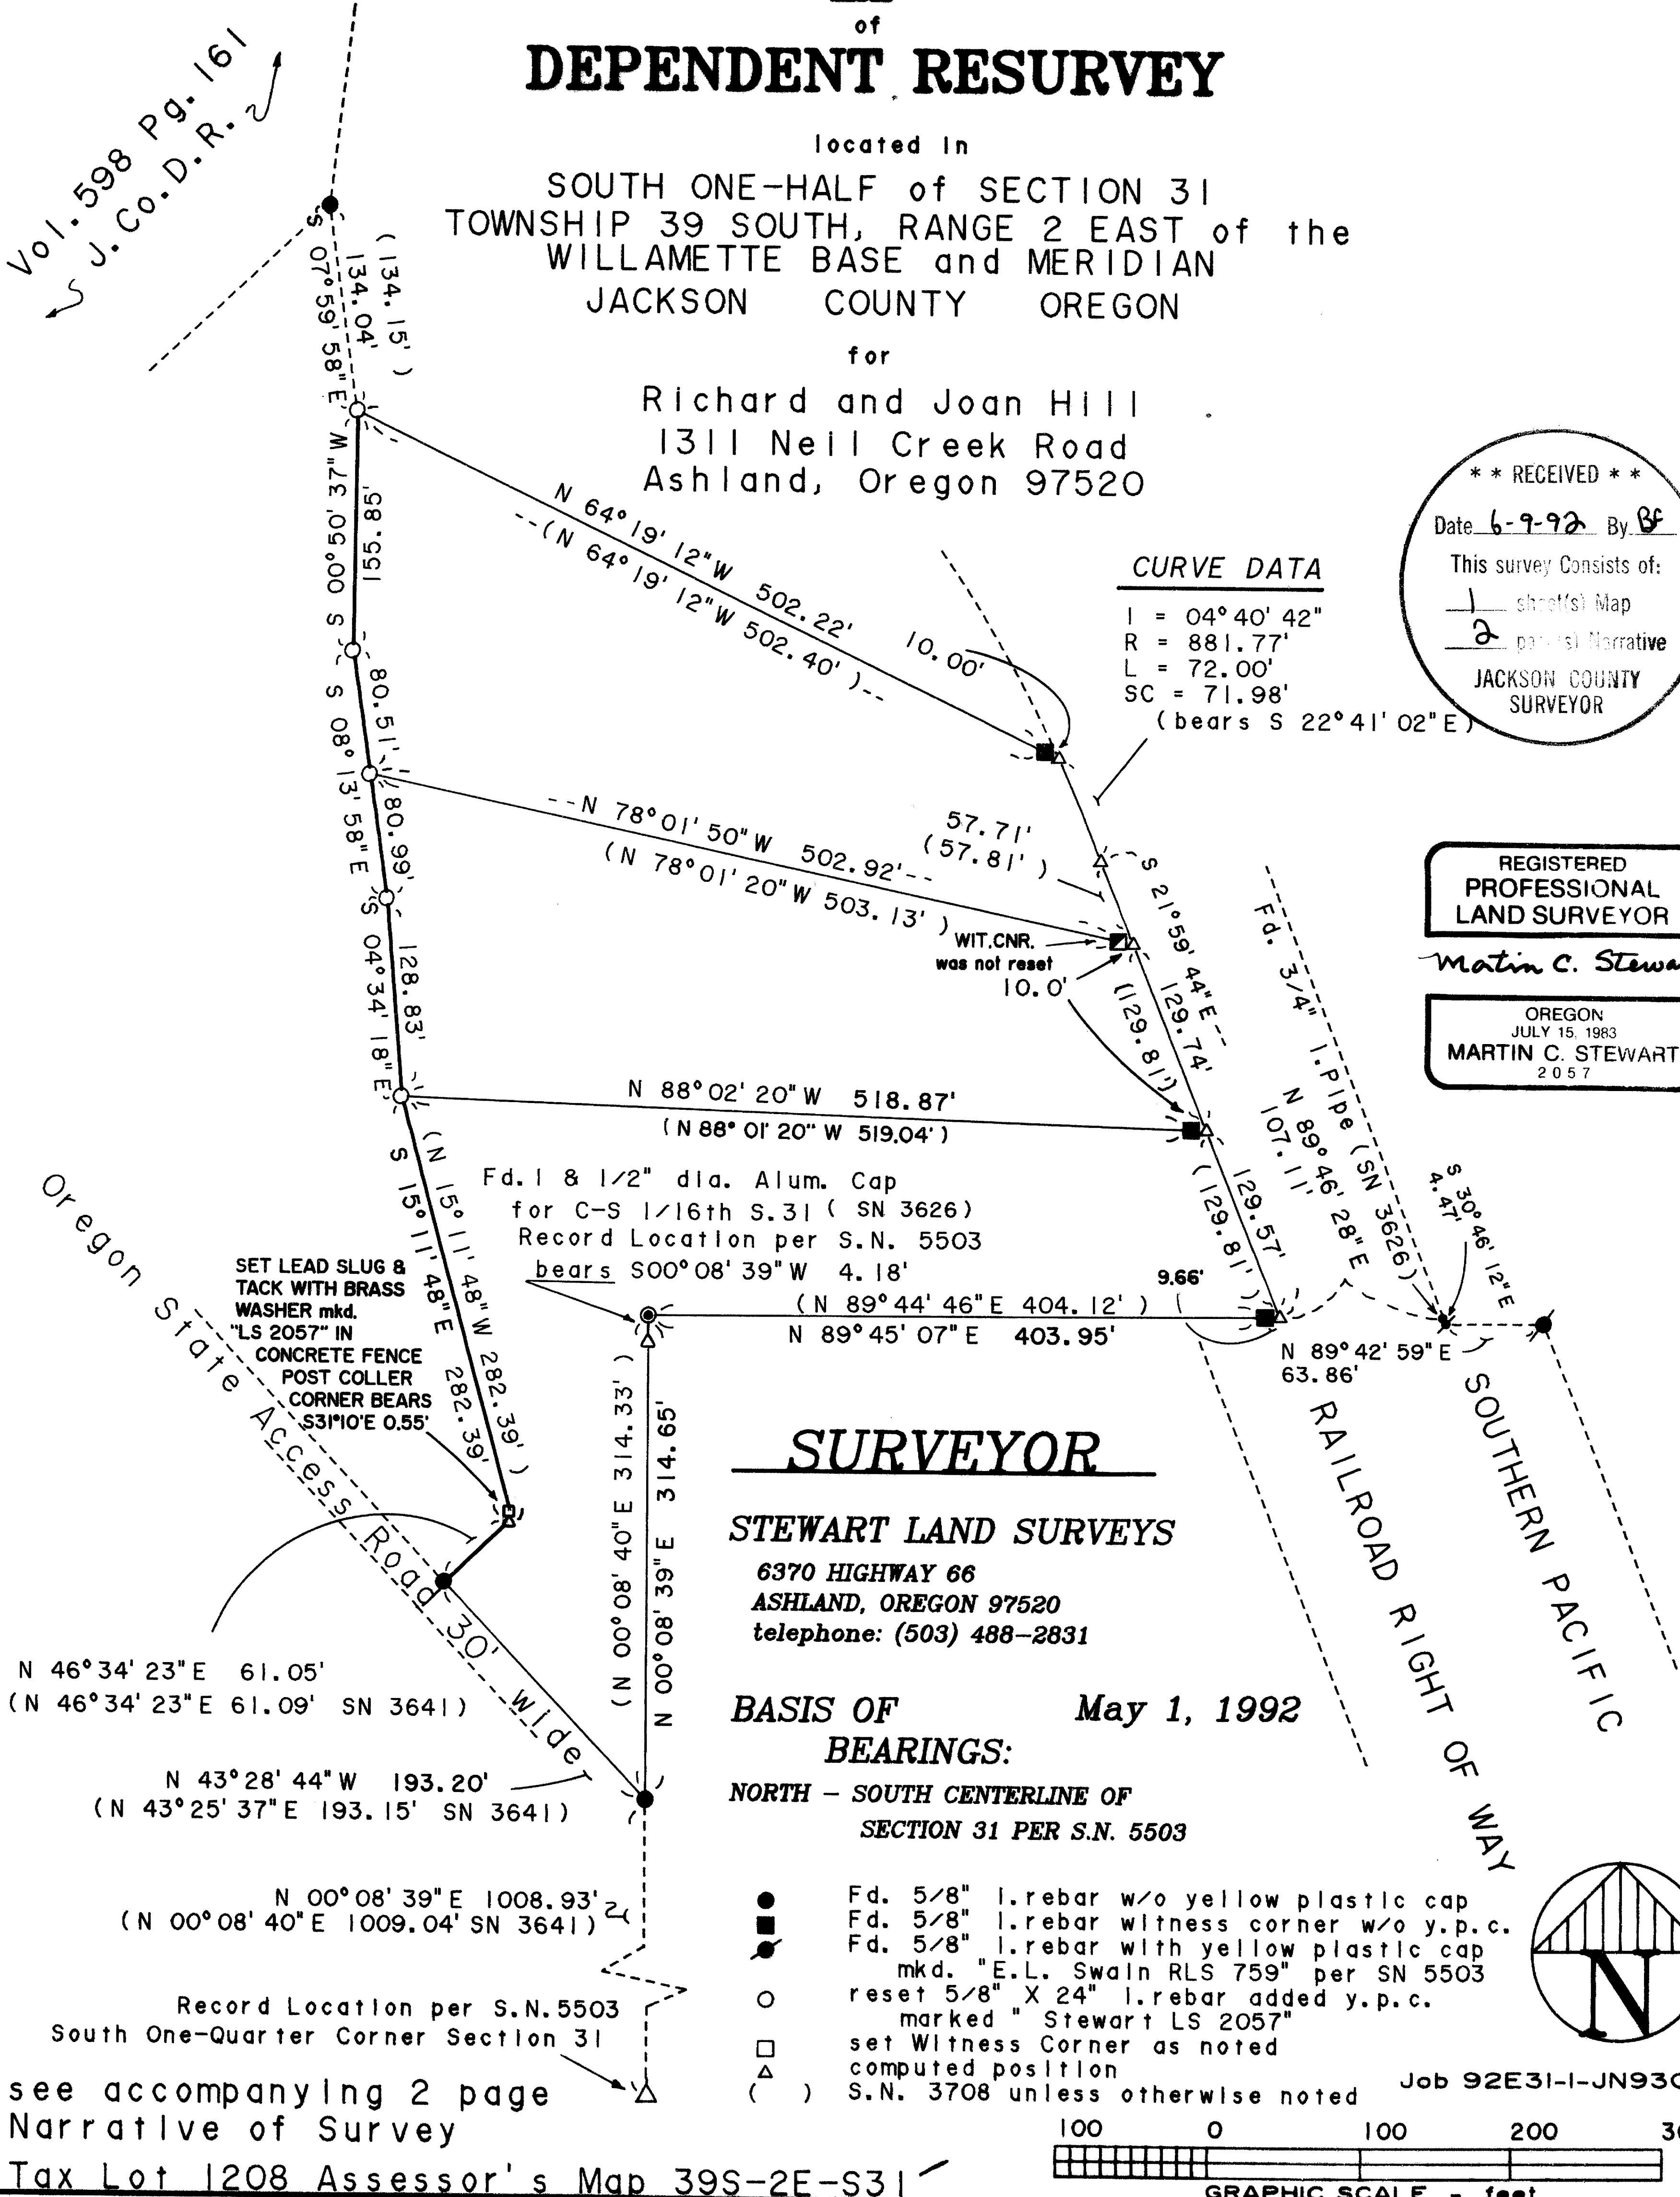
CURVE DATA

I = 04° 40' 42"
R = 881.77'
L = 72.00'
SC = 71.98'
(bears S 22° 41' 02" E)

BASIS OF May 1, 1992
BEARINGS:

NORTH - SOUTH CENTERLINE OF
SECTION 31 PER S.N. 5503

- Fd. 5/8" l.rebar w/o yellow plastic cap
- Fd. 5/8" l.rebar witness corner w/o y.p.c.
- Fd. 5/8" l.rebar with yellow plastic cap
- reset 5/8" X 24" l.rebar added y.p.c.
- marked "Stewart LS 2057"
- set Witness Corner as noted
- △ computed position
- () S.N. 3708 unless otherwise noted

the differences being noted on the Map of Dependent Resurvey. The 1 & 1/2" diameter aluminum cap and the found 3/4" iron pipe (which was intended to be set on the east-west centerline of the southeast quarter of Section 31 in Survey Number 3626) are to far to the north by 4.18' and 4.47' respectively. Unfortunately to re-establish this C-S 1/16th corner is complicated by the destruction of the South 1/4 corner of Section 31 by improvements to Interstate 5 that occurred subsequent to the execution of Survey Number 5503. The correct position for the 3/4" iron pipe was established by a 5/8" iron rebar set in the aforementioned Survey Number 5503, as shown on the Map of Dependent Resurvey.

The property corners were reset between existing found monuments that were verified for record position and all fell within acceptable limits. However, a found 1 & 1/2" diameter aluminum cap set for the Center-South 1/16th of Section 31 in Survey Number 3626, had not been disturbed and was significantly out of position in latitude (this is a southerly property corner of the most southerly tract). Survey Number 3626 subdivided Section 31; subsequently Survey Number 5503 retraced this subdivision and found discrepancies for the locations of the E.1/4 corner as well as the interior subdivision corners of Section 31. As this office has used some of the corners set or accepted in Survey Number 5503 in previous surveys and had found them to be more than acceptable; they were utilized to compute the record location of the C-S 1/16 as well as the pertinent interior subdivision lines. These record locations were compared to the found corners set in Survey Number 3626 with
