**Survey For**

**Salley Rothmeyer**  
4001 Geist Road Suite 7  
Fairbanks, Ak. 99709

SE 1/4 of Section 8  
T.37S., R.3E., W.M.,  
Jackson County, Or.

**Kaiser Surveying**  
19440 Hwy 62  
Eagle Point, Or.  
97524

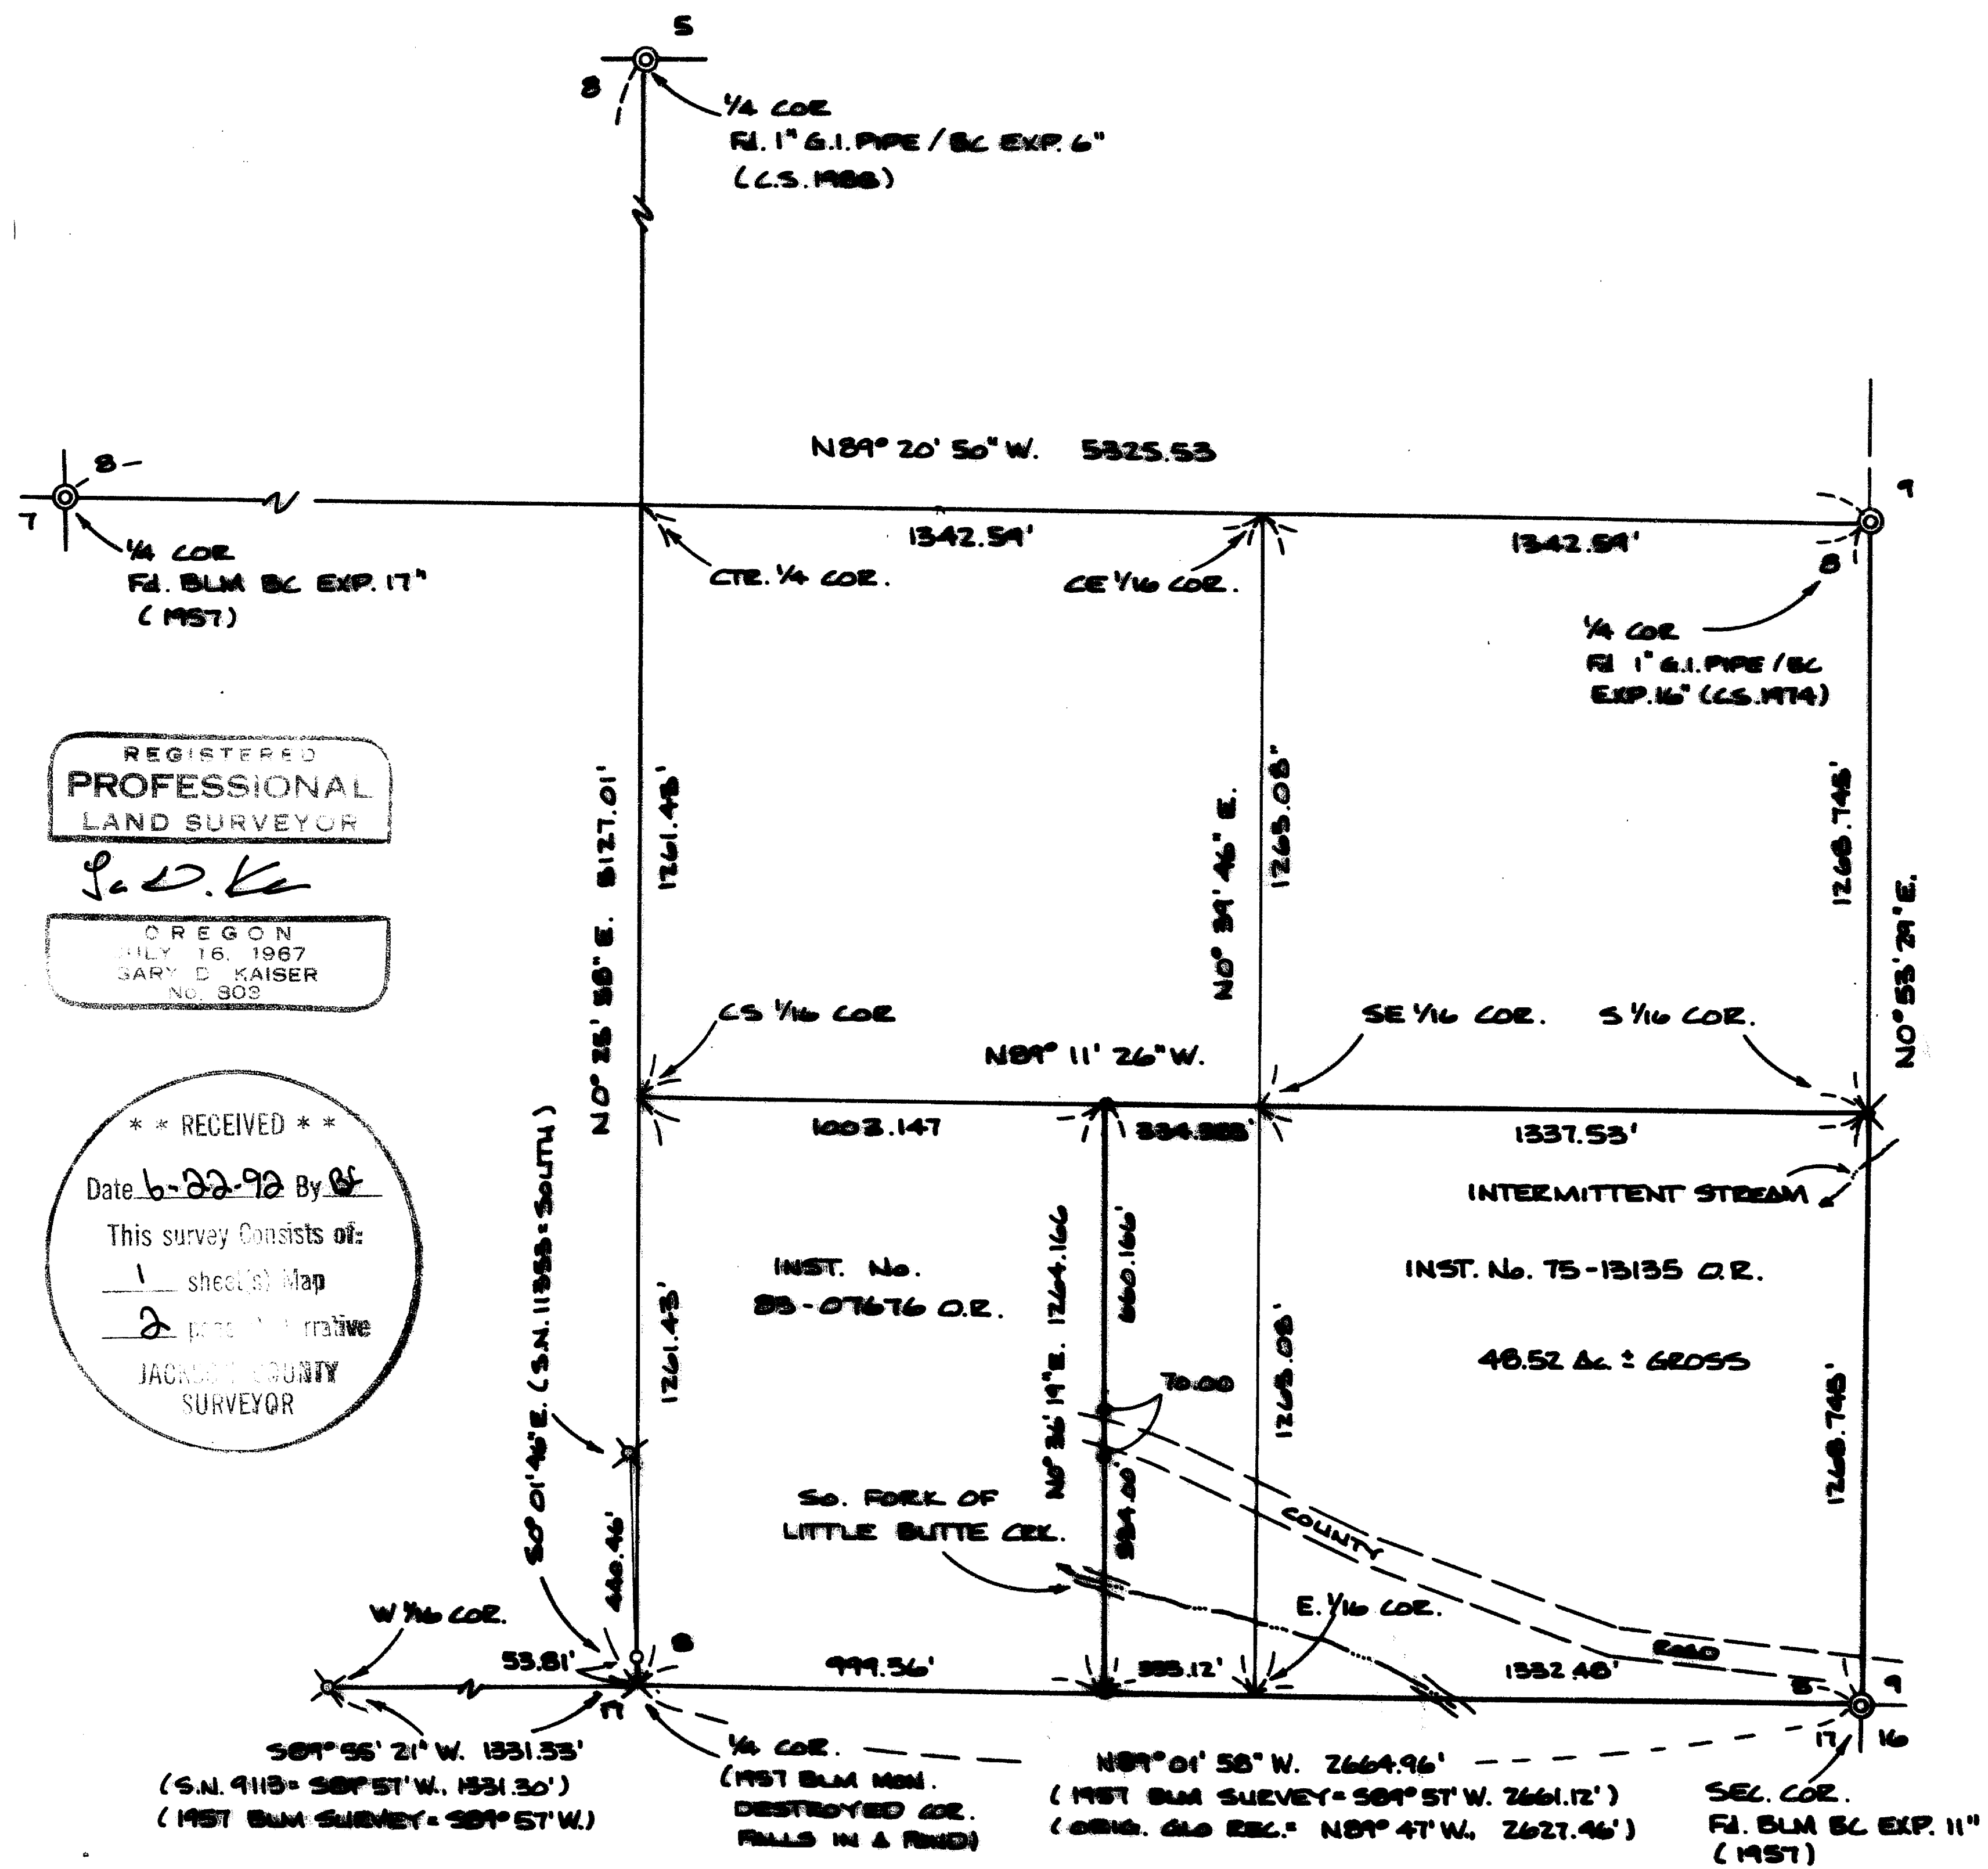
Scale: 1" = 400'

**Basis of Bearings**

Solar Observations

- ⊙ Found Gov't Corner monument as indicated
- ⊗ Found 5/8" Rebar/plastic cap set on S.M. 9N3
- Found 5/8" Rebar/plastic cap set on S.M. 11353
- Set 5/8" x 24" Rebar with plastic cap marked "KAISER RLS 803"
- ⊗ Set 1" x 36" G.I. Pipe with plastic cap marked "KAISER RLS 903" (See Narrative for References)

**PROCEDURE:** Utilizing EDM Equipment, ran a  
series of closed loop traverses tying the found monuments  
shown on the annexed map.

It was found that the  $\frac{1}{4}$  corner set by proportionate measure on the South boundary of Section 8 in 1957 by the BLM was not set according to their field notes. As is shown on the annexed map, there is close to one degree of angle on the section line at the BLM position for said corner and their notes indicate a straight line. The local BLM Cadastral Surveyor, Terrance O. Nickerson, was notified of this problem and he followed up by retracing the South boundary of Section 8. Mr. Nickerson verified the problem with the BLM position for said  $\frac{1}{4}$  corner and sent a report on his findings to the Portland BLM office (see exhibit "A" for a copy of this report and the Portland office reply). The BLM decision was to hold the South boundary of Section 8 as surveyed and monumented in 1957 by the BLM since other surveyors have filed surveys based on the BLM position, see filed survey No.'s 9113 and 11353. A copy of the BLM report and letter from the Portland office was given to the County Surveyor who concurred with the BLM decision.
