# MAP of SURVEY

Donation Land Claim No. 45 in the Northeast Quarter  
and the Southeast Quarter of Section 15, Township 39 South, Range 1 East of the  
Willamette Base and Meridian,  
JACKSON COUNTY OREGON

**SURVEY NARRATIVE TO COMPLY WITH PARAGRAPH 209.250  
OREGON REVISED STATUTES**

**LOCATION:** Situated in Donation Land Claim No. 45 in the Northeast Quarter and the Southeast Quarter of Section 15, Township 39 South, Range 1 East of the Willamette Base and Meridian, Jackson County, Oregon.

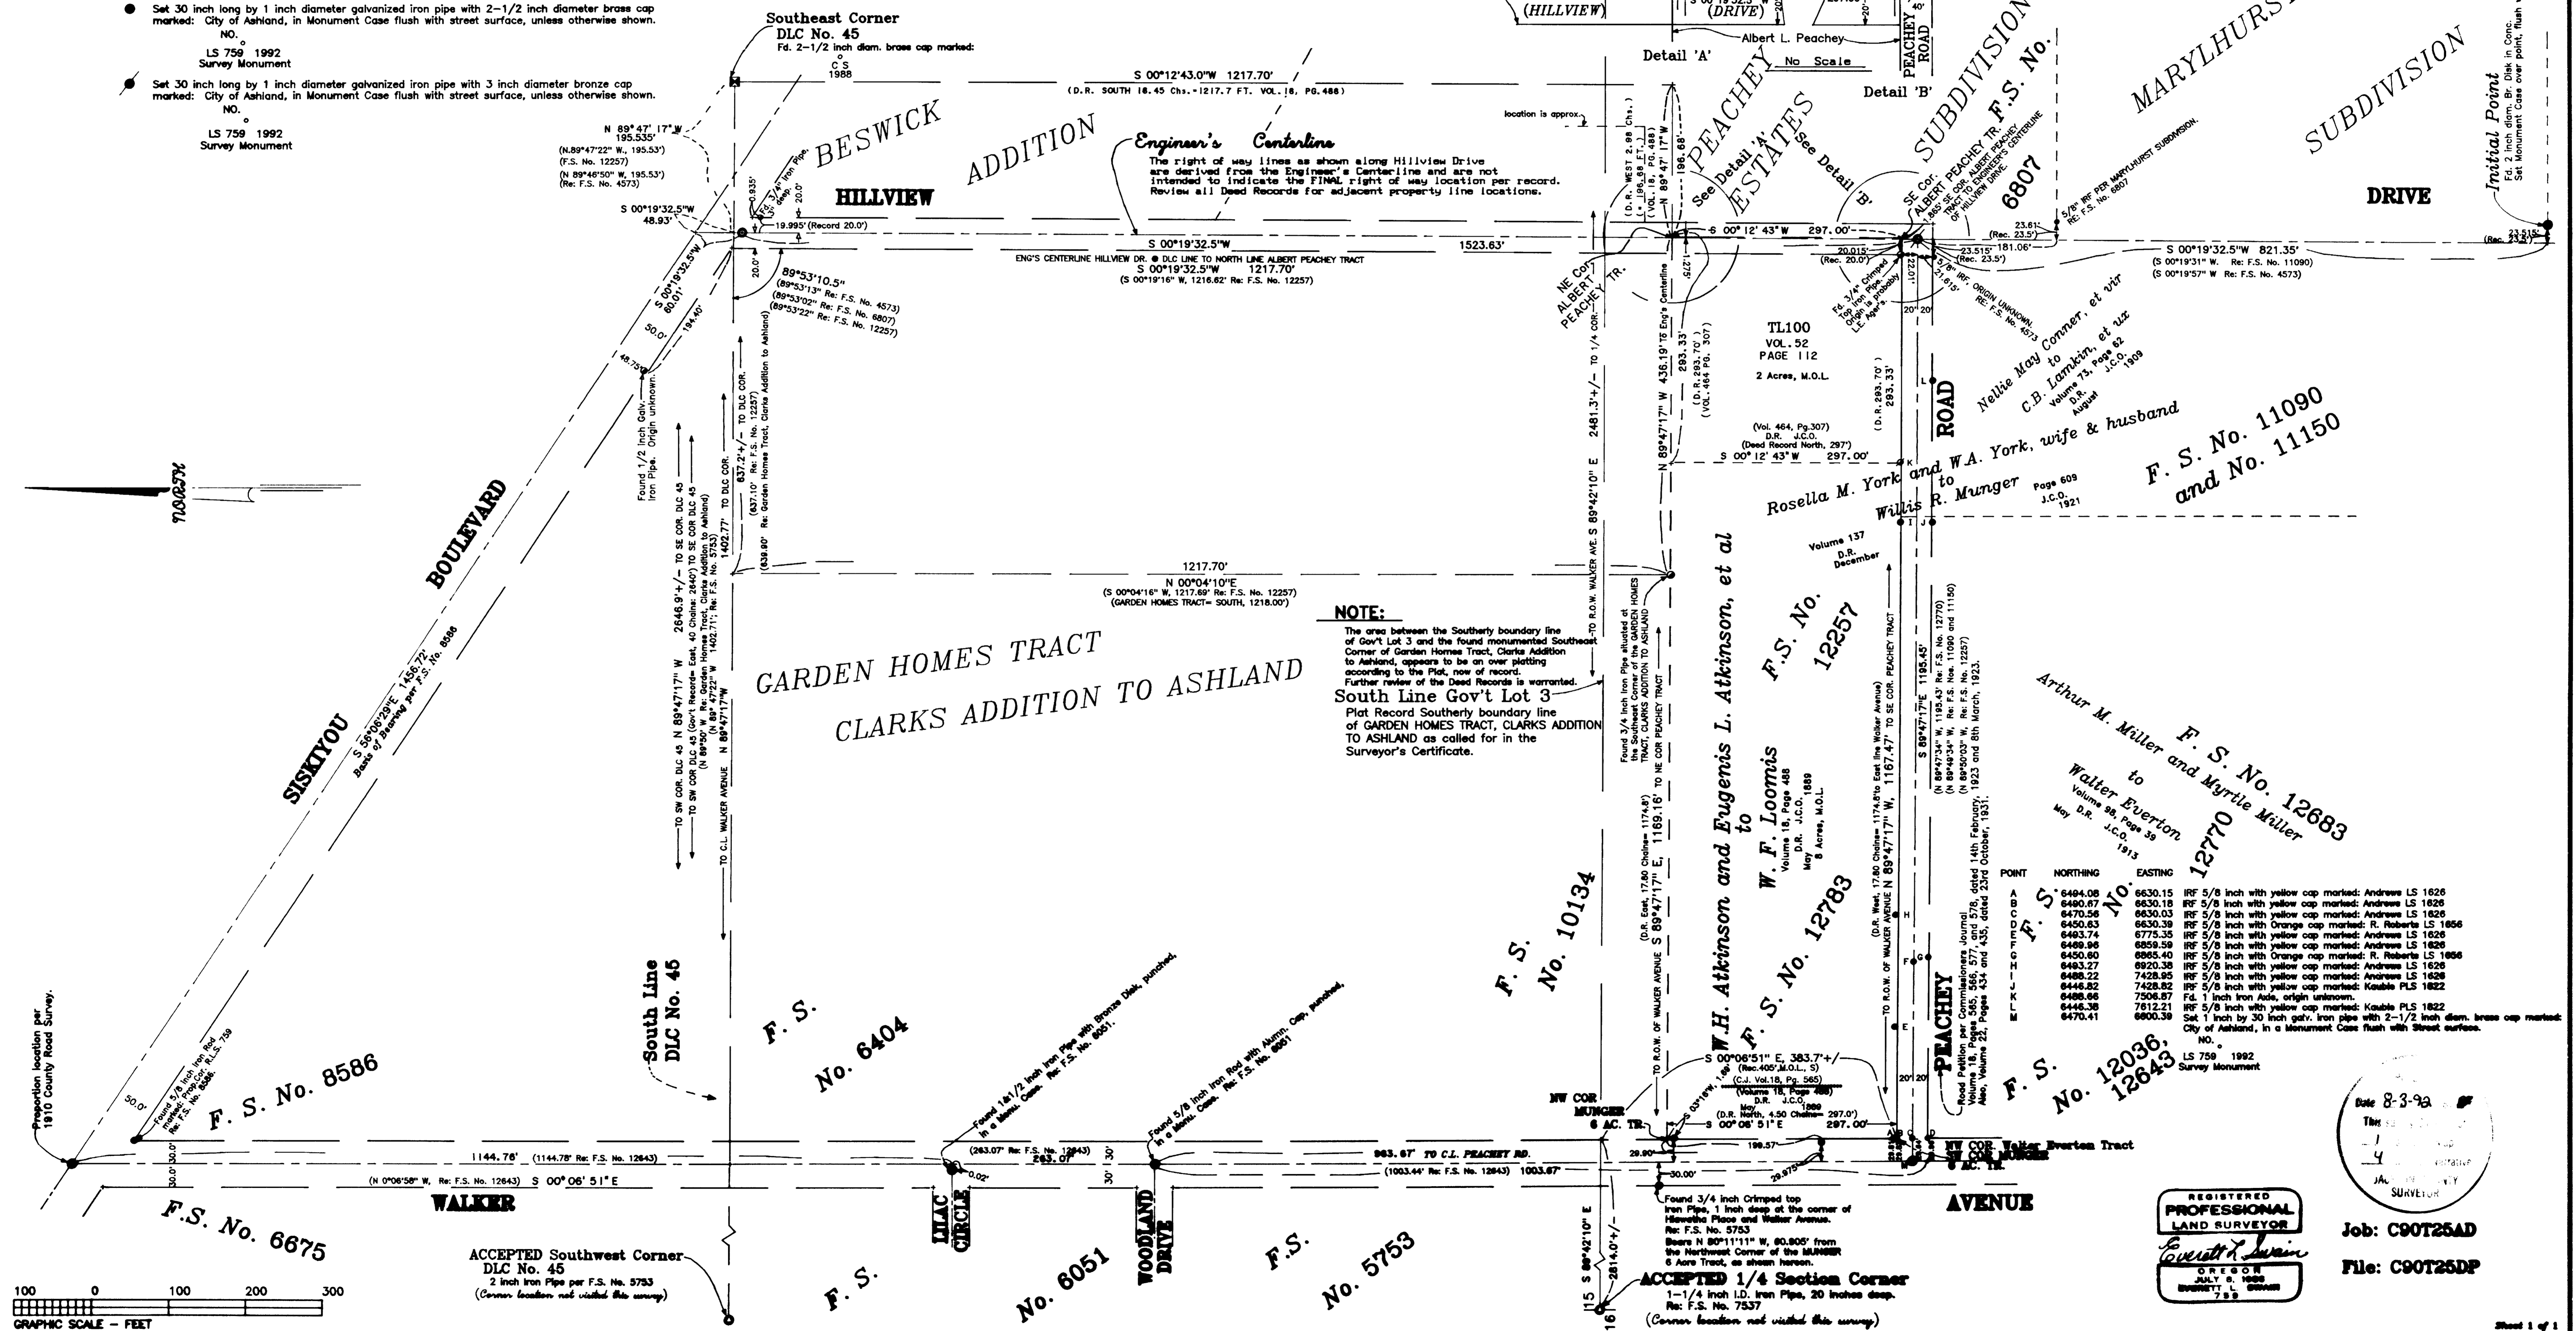
- Found monument as shown
- Found 5/8 inch iron rod with yellow cap marked: Andrews LS 1626, unless otherwise shown.
- Set 30 inch long by 1 inch diameter galvanized iron pipe with 2-1/2 inch diameter brass cap marked: City of Ashland, in Monument Case flush with street surface, unless otherwise shown.
- LS 759 1992 Survey Monument
- Set 30 inch long by 1 inch diameter galvanized iron pipe with 3 inch diameter bronze cap marked: City of Ashland, in Monument Case flush with street surface, unless otherwise shown.
- NO.
- LS 759 1992 Survey Monument

(Corner location not visited this survey) 1/4 Section Corner  
1 inch Iron Pipe with 2.5 inch diam. brass cap, flush with pavement.  
Re: F.S. No. 4847.

**NOTE:**  
The area between the southerly boundary line of Gov't Lot 3 and the found monument Southeast Corner of Garden Homes Tract, Clarke's Addition to Ashland, appears to be an over-plotting according to the Plat, now of record. Further review of the Deed Records is warranted.  
South Line Gov't Lot 3  
Plat Record Southerly boundary line of GARDEN HOMES TRACT, CLARKE'S ADDITION TO ASHLAND as called for in the Surveyor's Certificate.

**PURPOSE:** To survey and monument the centerline intersection of Walker Avenue and Siskiyou Boulevard, Walker Avenue and Peachey Road, Engineer's centerline of Hillview Drive with centerline of Peachey Road and the Engineer's centerline of Hillview Drive with the Southerly right of way line of Siskiyou Boulevard.

**PROCEDURE:** Surveyor, Everett L. Swain while in private practice some years ago, conducted many surveys adjacent to and within Section 15. Utilizing information from this Surveyor's private files, established a new survey control traverse within the area where street centerline monuments were to be set. The Primary Control Traverse closed with an **Adjusted Ratio of Precision of 1 part in 150,000 parts or better.** Three Secondary Control Traverses, which were utilized to tie found monuments by other Surveyors and to establish control for construction staking for the Peachey-Paradise Lane Local Improvement District, were closed with a Ratio of Precision of 1 part in 25,000 parts or better.

All primary traverse angles were observed with a Wild T-2 theodolite with a minimum of 2 sets of observations, that is angles being observed on the right face and the left face twice. Most all of the angles turned were evaluated in terms of a 'Rejection Factor' of 5 seconds from the mean observed angle. Distances were measured both forward and reversed utilizing a Topcon DM-S1 distance meter.

Walker Avenue was established utilizing the proportion location of Walker Avenue along Siskiyou Boulevard as set forth in the 1910 Jackson County Road notes and the 3/4 inch crimped top iron pipe found at the right of way intersection of Walker Avenue and Hiawatha Place. These positions verified the centerline intersection of Walker Avenue with Woodland Drive, as set by this Surveyor and shown on Filed Survey No. 6051. The monument at Walker Avenue and Lilac Circle was determined to be off line by 0.02 of a foot. Rather than re-setting the center point the offset value has been shown. The returned distance from the Southeast Corner of Donation Land Claim No. 45 to the centerline of Walker Avenue is found, by this survey, to be greater in length by 0.06 of a foot than that shown on Filed Survey No. 5753. Filed Survey No. 5753 was a

Land Claim No. 45, as call for on said plat. It should be noted however, that in the Surveyor's Certificate the South boundary of said Subdivision is qualified as being the South line of Government Lot 3, in Section 15. As shown on the accompanying map, there appears to be a vast difference between the distance called for along Harmony Lane and the position of the South boundary line of said Government Lot 3. No further investigation was made of this found condition.
