Survey for

James Merry
506 Wagner Creek Road
Talent, Oregon 97540

Survey by

Boyden Surveyors
108 Mistletoe Street
Medford, Oregon 97501

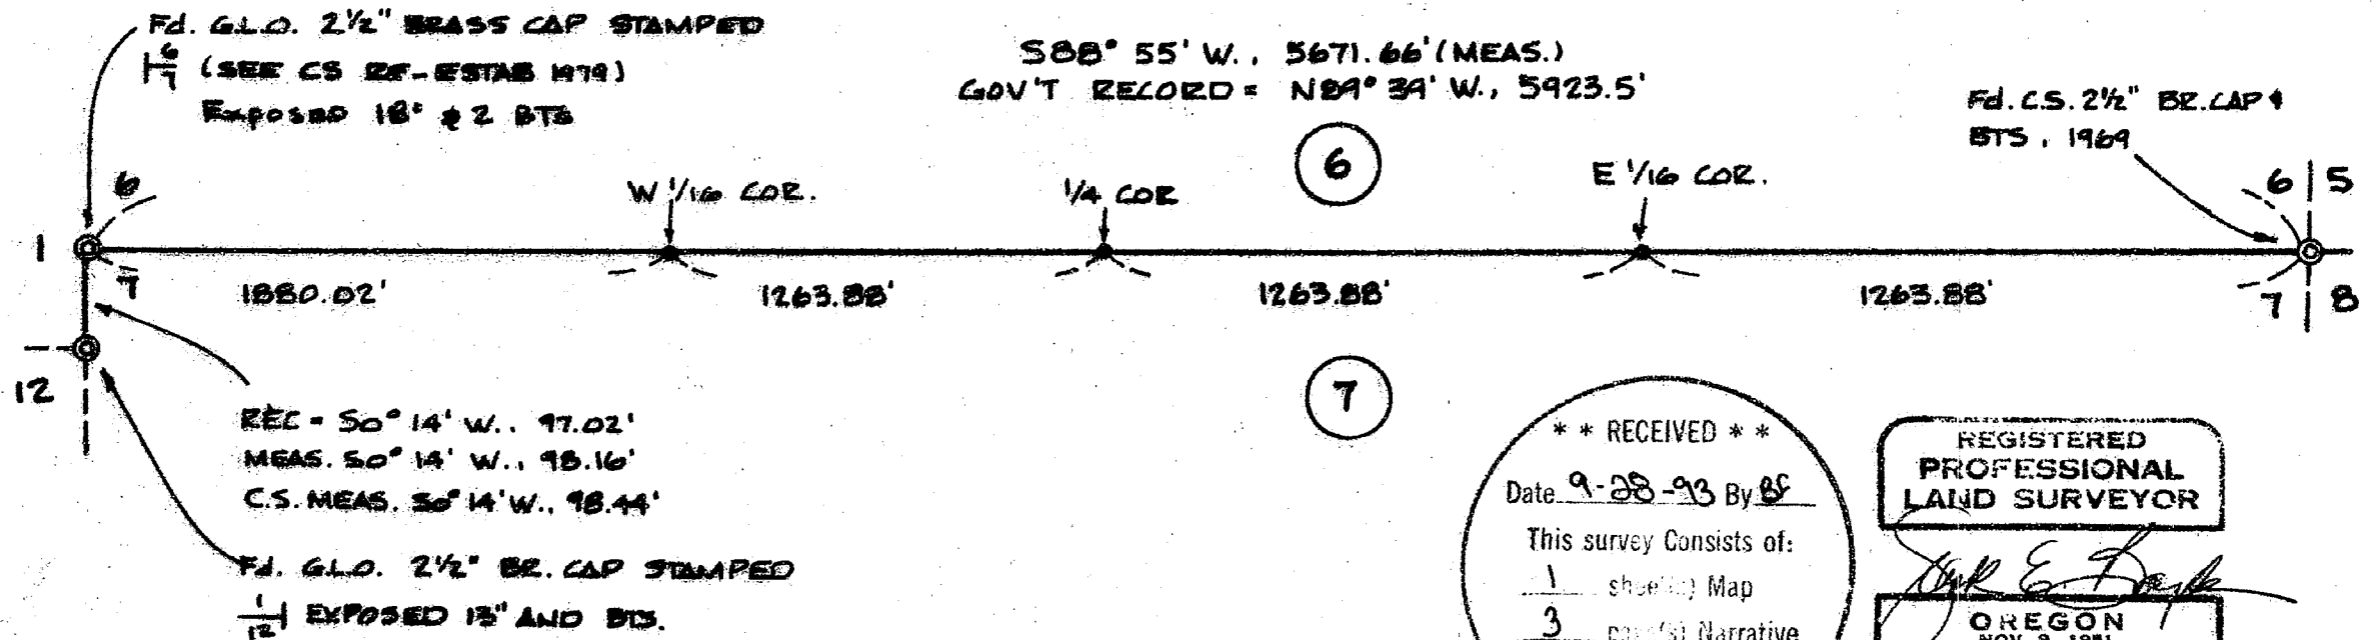
Basis of Bearings

West Boundary of Sec. 7,
GLO Survey 1917

North - Half Section 7,
T.39S., R.1W., W.M.

- ⊙ Found Gov't corner monument as indicated
- Set 5/8" x 30" Rebar with plastic cap marked "BOYDEN RLS 281"

NOT TO SCALE
