PLAT OF RESURVEY FOR
 THE UNITED STATES DEPARTMENT OF AGRICULTURE
UMPQUA NATIONAL FOREST
 CONTRACT NO. 53-0411-146
 JACK CADASTRAL SURVEY
 LOCATED IN GOVT. LOTS 1 THRU 12,
 SECTION 2, T.32S., R.1W., W.M.
 DOUGLAS COUNTY, OREGON
 DATE: JULY, 1991 TO SEPTEMBER, 1993.

SURVEY NARRATIVE to comply with O.R.S. 209.250

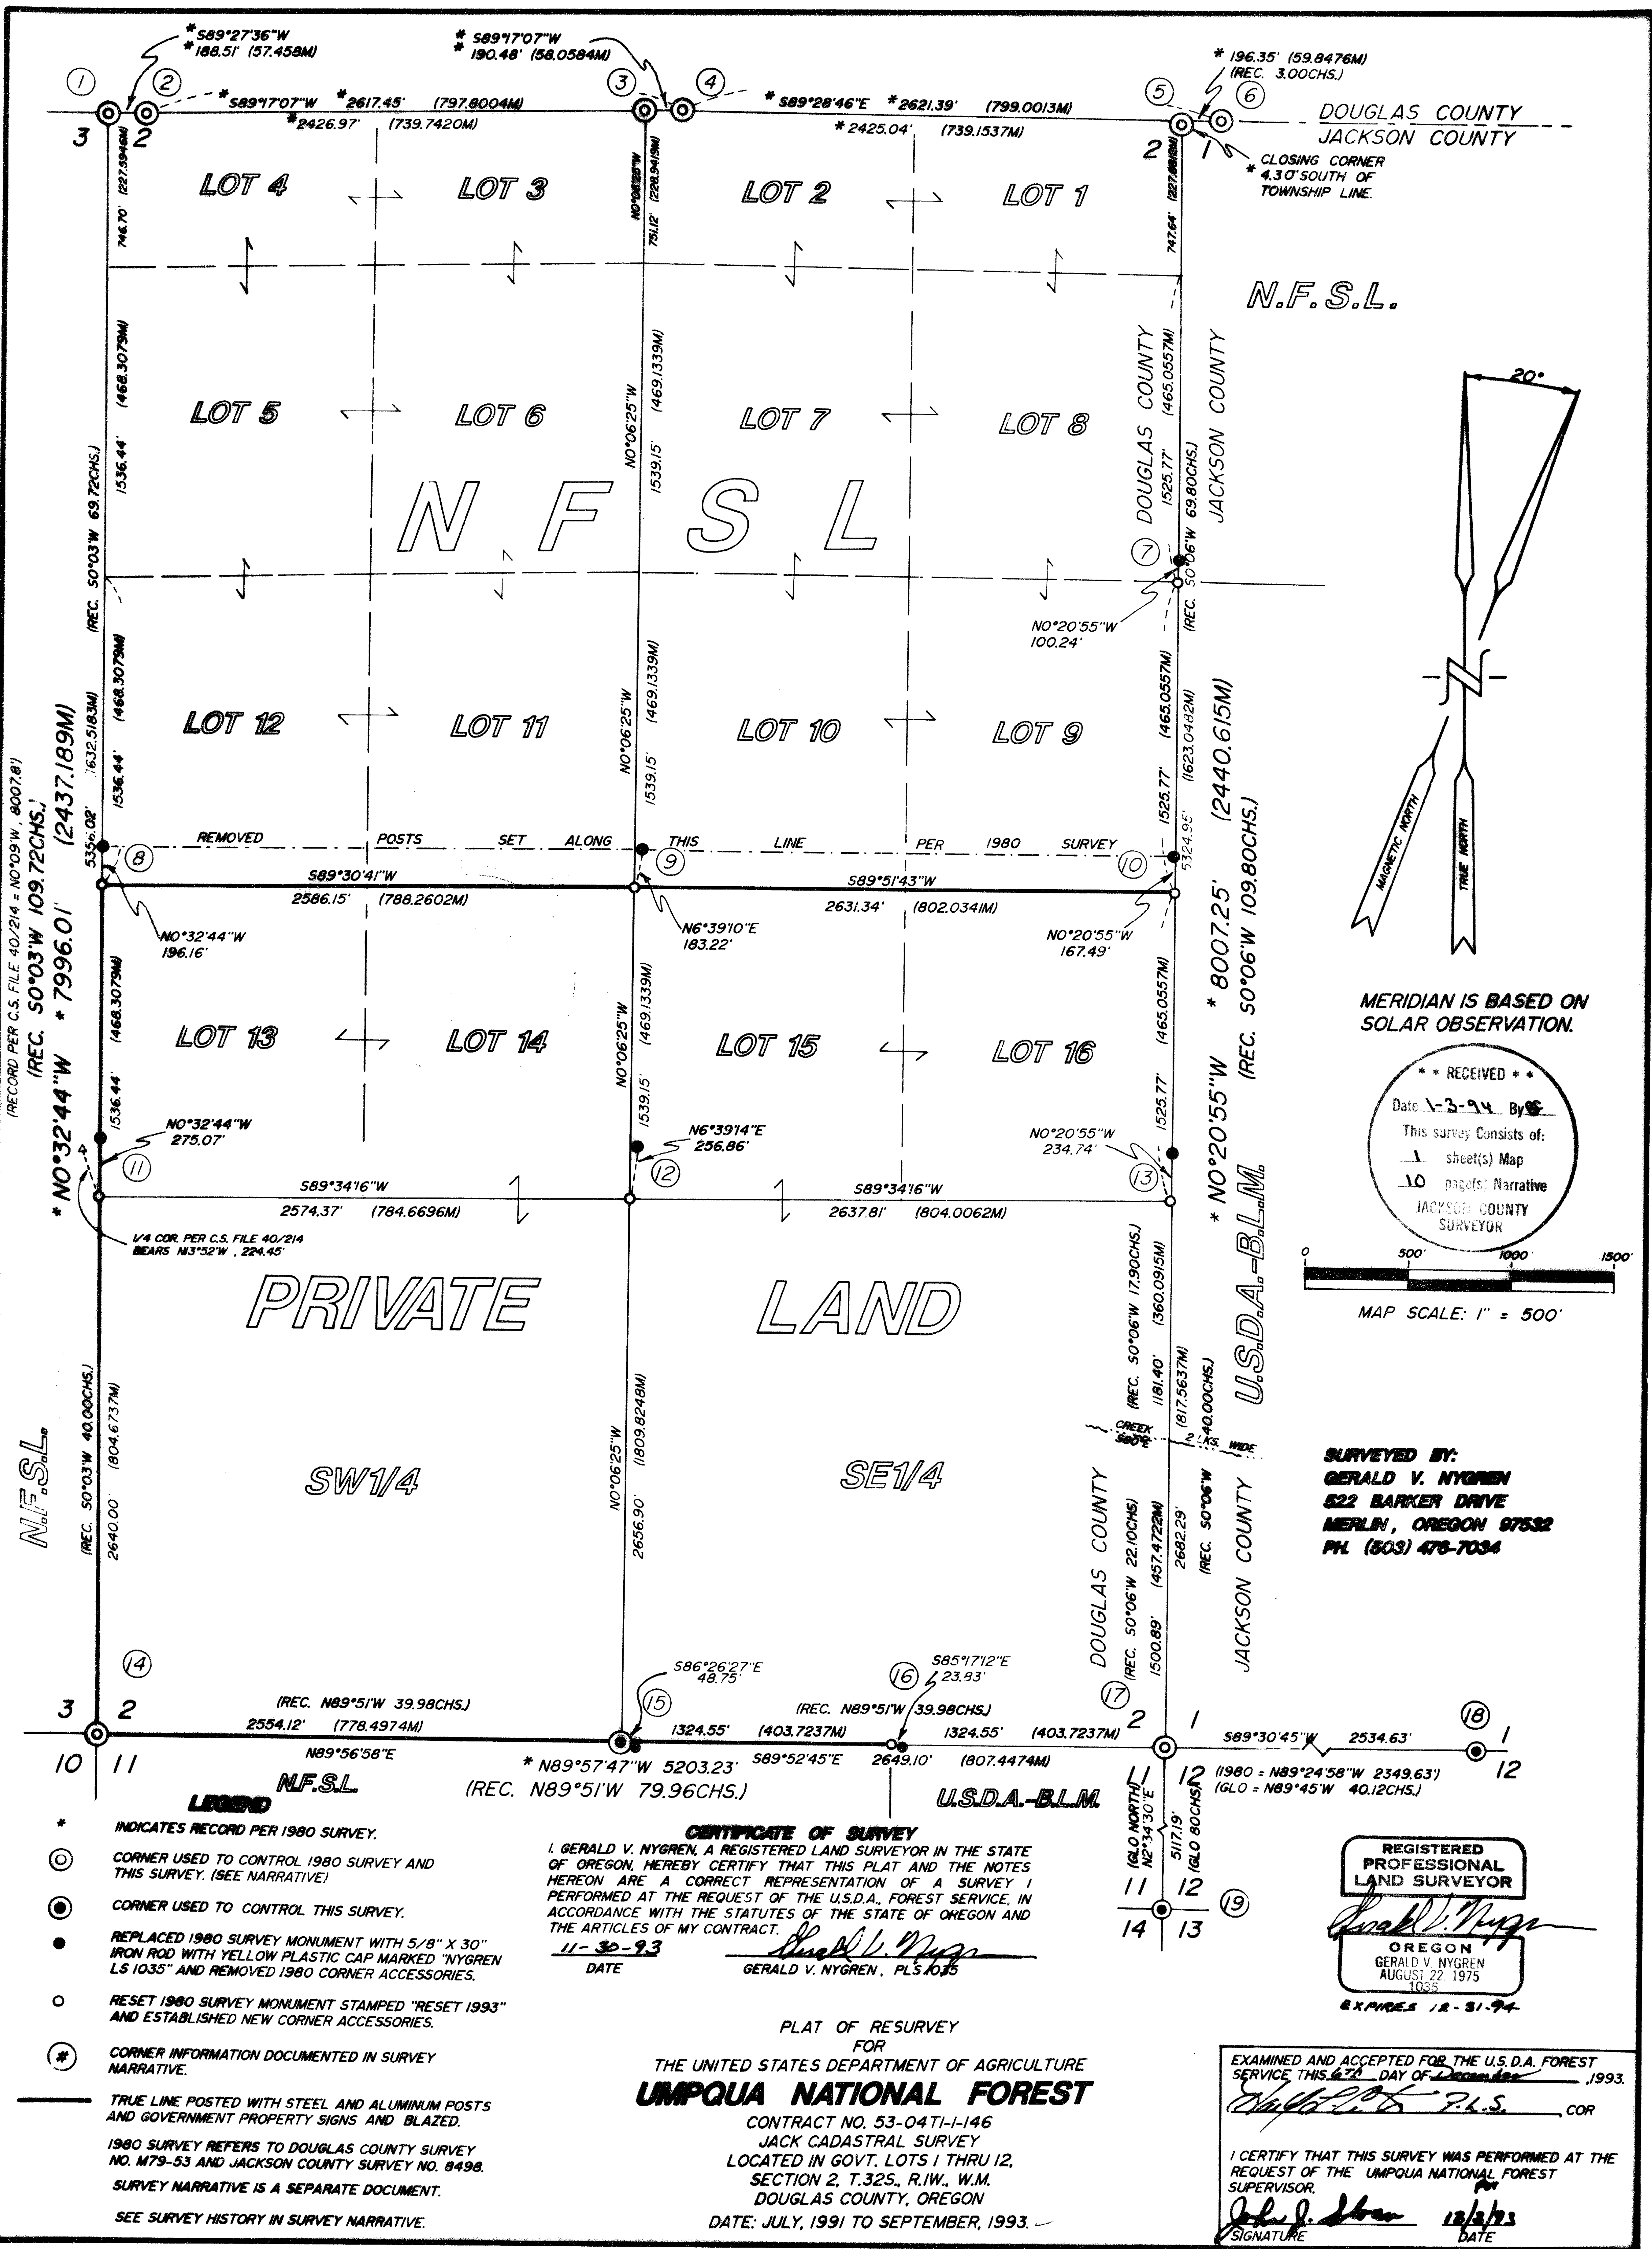
MERIDIAN IS BASED ON SOLAR OBSERVATION.

- LEGEND**
- * INDICATES RECORD PER 1980 SURVEY.
 - CORNER USED TO CONTROL 1980 SURVEY AND THIS SURVEY. (SEE NARRATIVE)
 - CORNER USED TO CONTROL THIS SURVEY.
 - REPLACED 1980 SURVEY MONUMENT WITH 5/8" X 30" IRON ROD WITH YELLOW PLASTIC CAP MARKED "NYGREN LS 1035" AND REMOVED 1980 CORNER ACCESSORIES.
 - RESET 1980 SURVEY MONUMENT STAMPED "RESET 1993" AND ESTABLISHED NEW CORNER ACCESSORIES.
 - CORNER INFORMATION DOCUMENTED IN SURVEY NARRATIVE.
 - TRUE LINE POSTED WITH STEEL AND ALUMINUM POSTS AND GOVERNMENT PROPERTY SIGNS AND BLAZED.
- 1980 SURVEY REFERS TO DOUGLAS COUNTY SURVEY NO. M79-53 AND JACKSON COUNTY SURVEY NO. 8498.
 SURVEY NARRATIVE IS A SEPARATE DOCUMENT.
 SEE SURVEY HISTORY IN SURVEY NARRATIVE.
