Boundary Survey For:

Bear Creek Orchards, Inc.
P.O. Box 9000
Medford, Oregon
97501

Located in the
SE 1/4 of Section 15,
SW 1/4 of Section 14,
NW 1/4 of Section 23,
NE 1/4 of Section 22,
All in T.38S., R.1W., W.M.,
Jackson County, Oregon

SURVEY NO. 15023

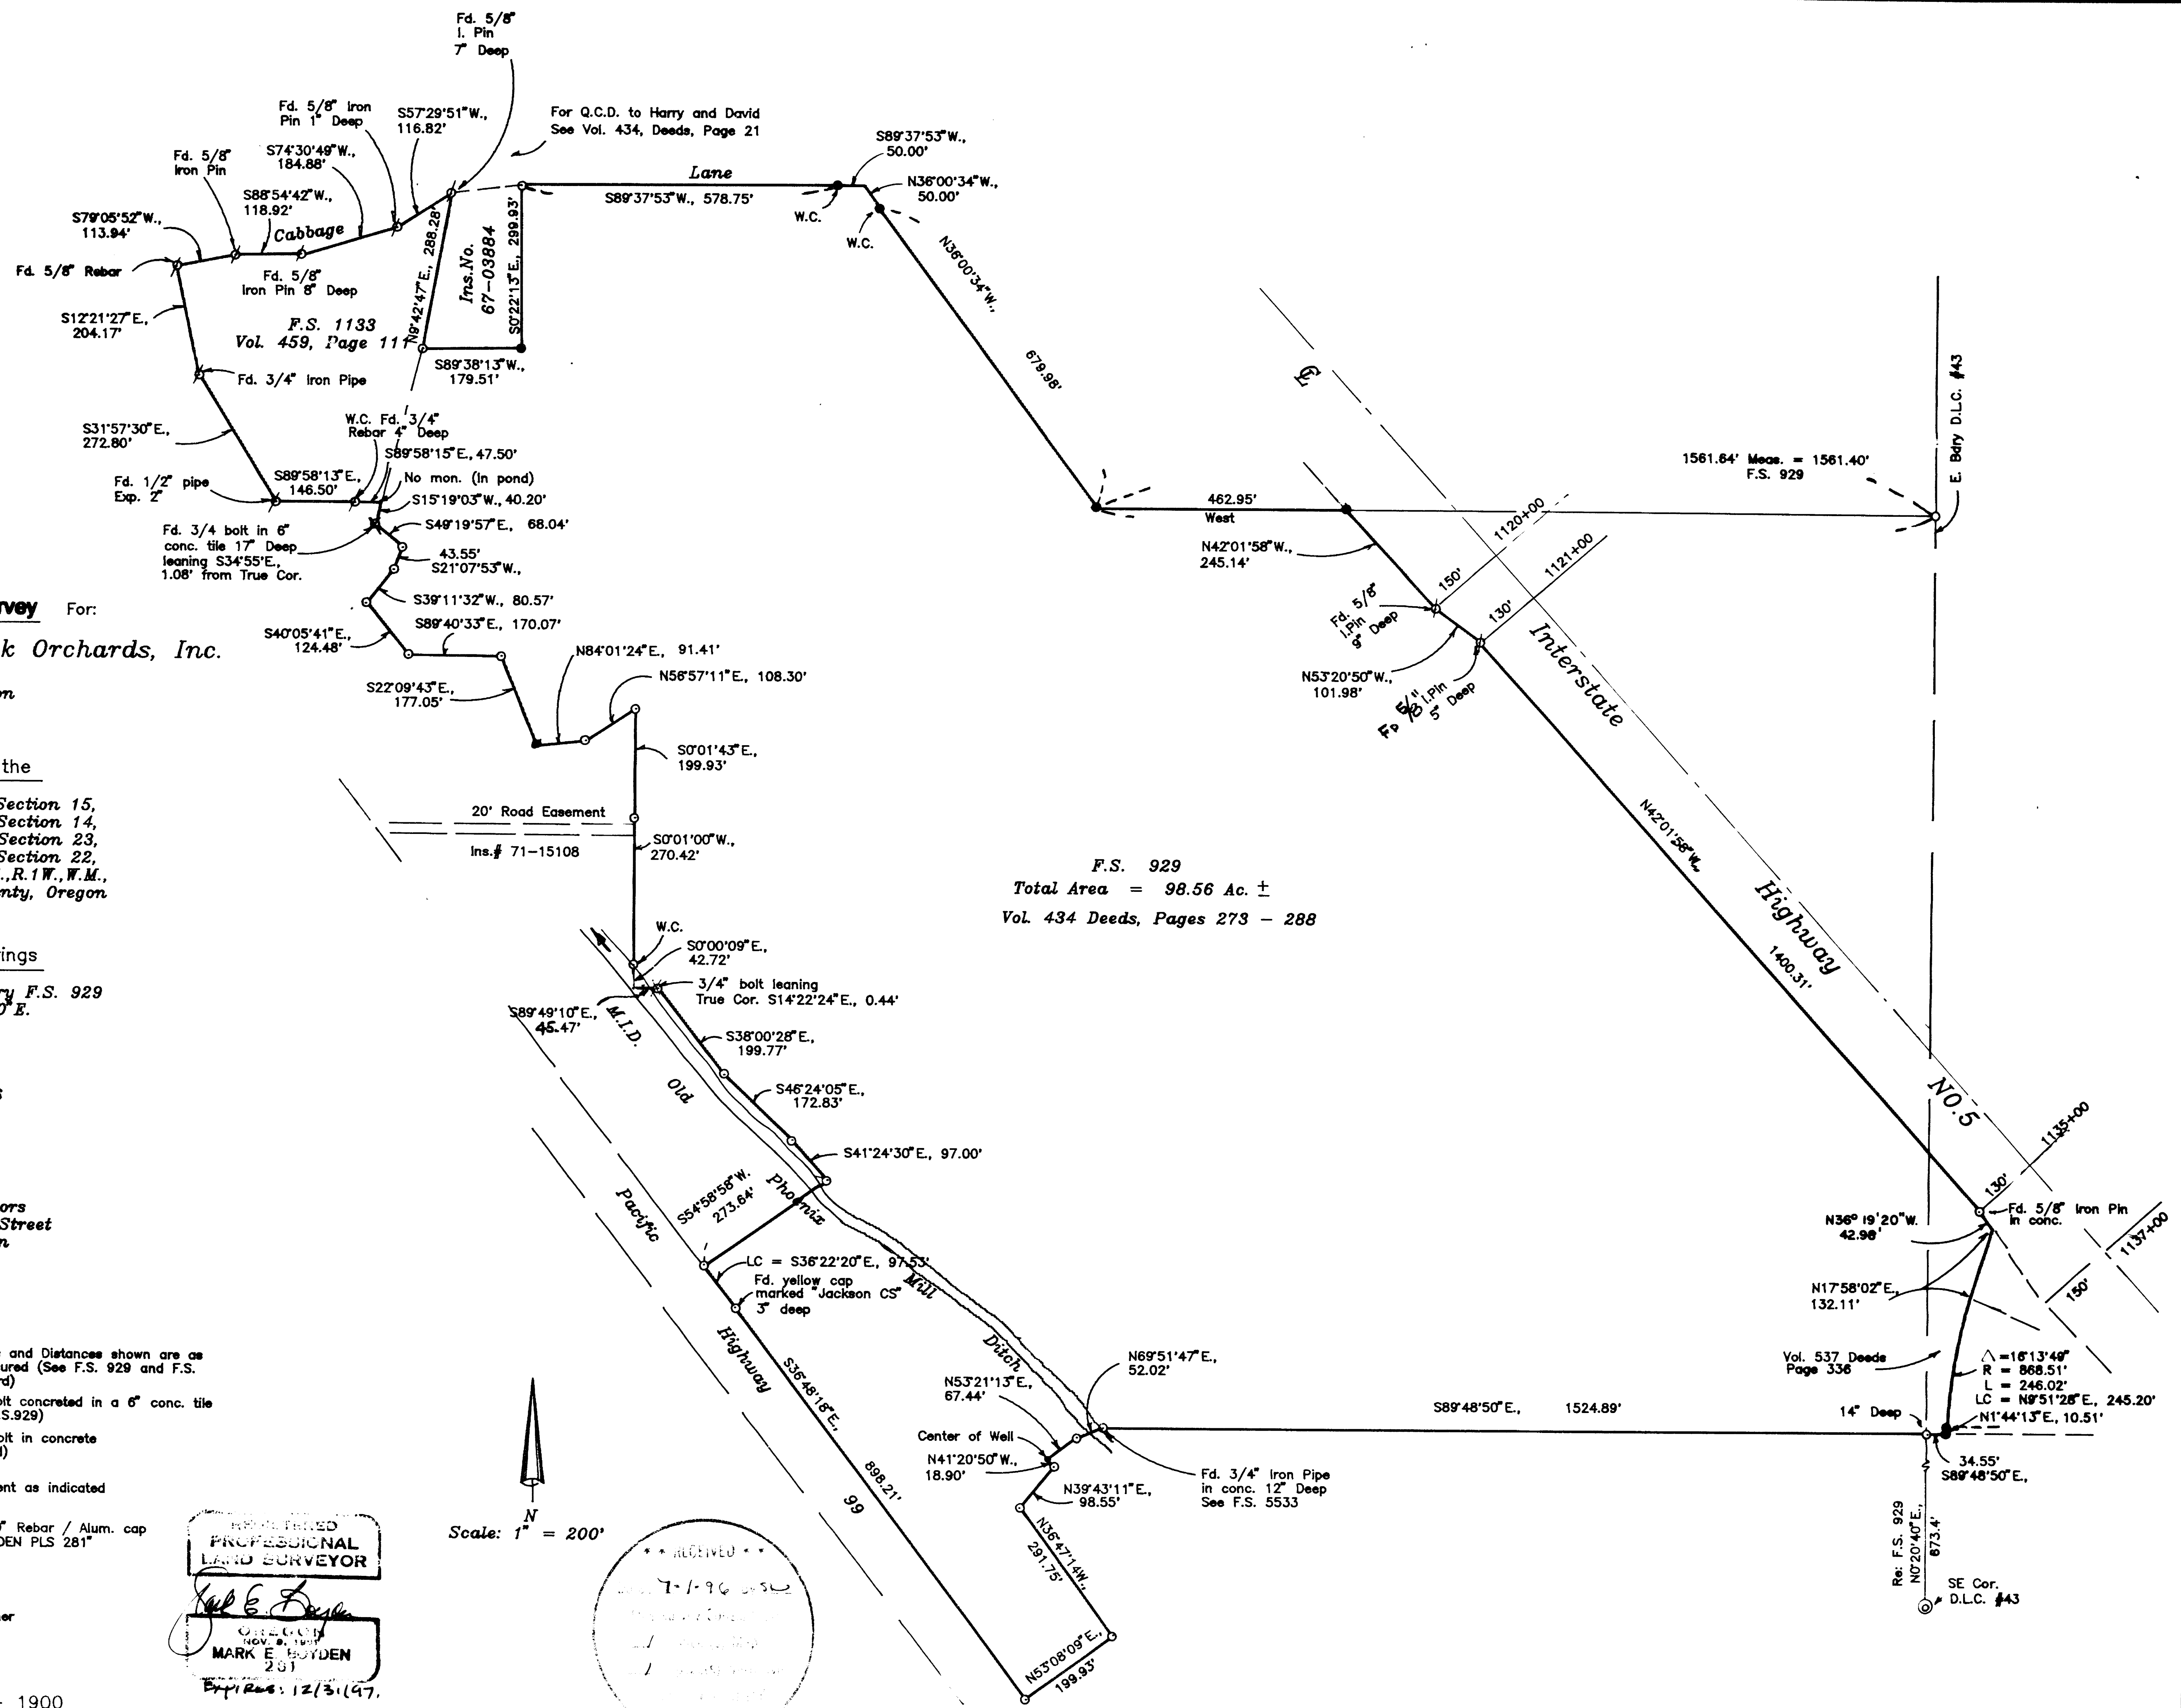
Basis of Bearings
South Boundary F.S. 929
= S89°48'50" E.

- Legend**
- NOTE: Bearings and Distances shown are as currently measured (See F.S. 929 and F.S. 1133 for record)
 - Found 3/4" Bolt concreted in a 6" conc. tile (Bolt set on F.S.929)
 - ⊗ Found 3/4" Bolt in concrete (Post disturbed)
 - ⊕ Found monument as indicated
 - Set 5/8" x 30" Rebar / Alum. cap stamped "BOYDEN PLS 281"

Scale: 1" = 200'

F.S. 929
Total Area = 98.56 Ac. ±
Vol. 434 Deeds, Pages 273 - 288

PURPOSE: To locate the monumented boundaries
of Rainbow Orchard, being set on
Filed Survey No. 929 and No. 1133
lying Southwesterly from Interstate
Highway No. 5 and that additional
parcel described in Volume 537
Deeds, Page 336.

PROCEDURE: Utilizing E.D.M. equipment,
enclosed, the subject tracts, finding monuments at
positions shown.

An effort was made to establish the centerline of Interstate Highway No. 5 from found centerline monuments. Personnel from O.D.O.T. were not able to recover the records as to when and where the monuments were set. In the vicinity of the most Easterly-Northeast property corners, the State centerline monuments were found approximately 58 feet apart on a long tangent and did not fit a reasonable alignment. The Southwesterly right-of-way monuments at Stations 1121+00 and 1135+00 were finally utilized for control.

Some of the original boundary monuments had been dozed out of position, and some instances, others were substantial monuments and shown relative to the true corner position.

Missing boundary monuments were positioned utilizing the "broken boundary" method.

Set monuments at positions shown on the map to accompany this report.
