MAP OF SURVEY
FOR
Mr. Gary Hall
2385 Terri Drive
Medford, Or. 97504

Located in
NORTHEAST QUARTER OF SECTION 6,
TOWNSHIP 39 SOUTH, RANGE 1, EAST
WILLAMETTE MERIDIAN,
JACKSON COUNTY, OREGON

SURVEY NARRATIVE TO COMPLY WITH
PARAGRAPH 209.250 OREGON REVISED STATUTES

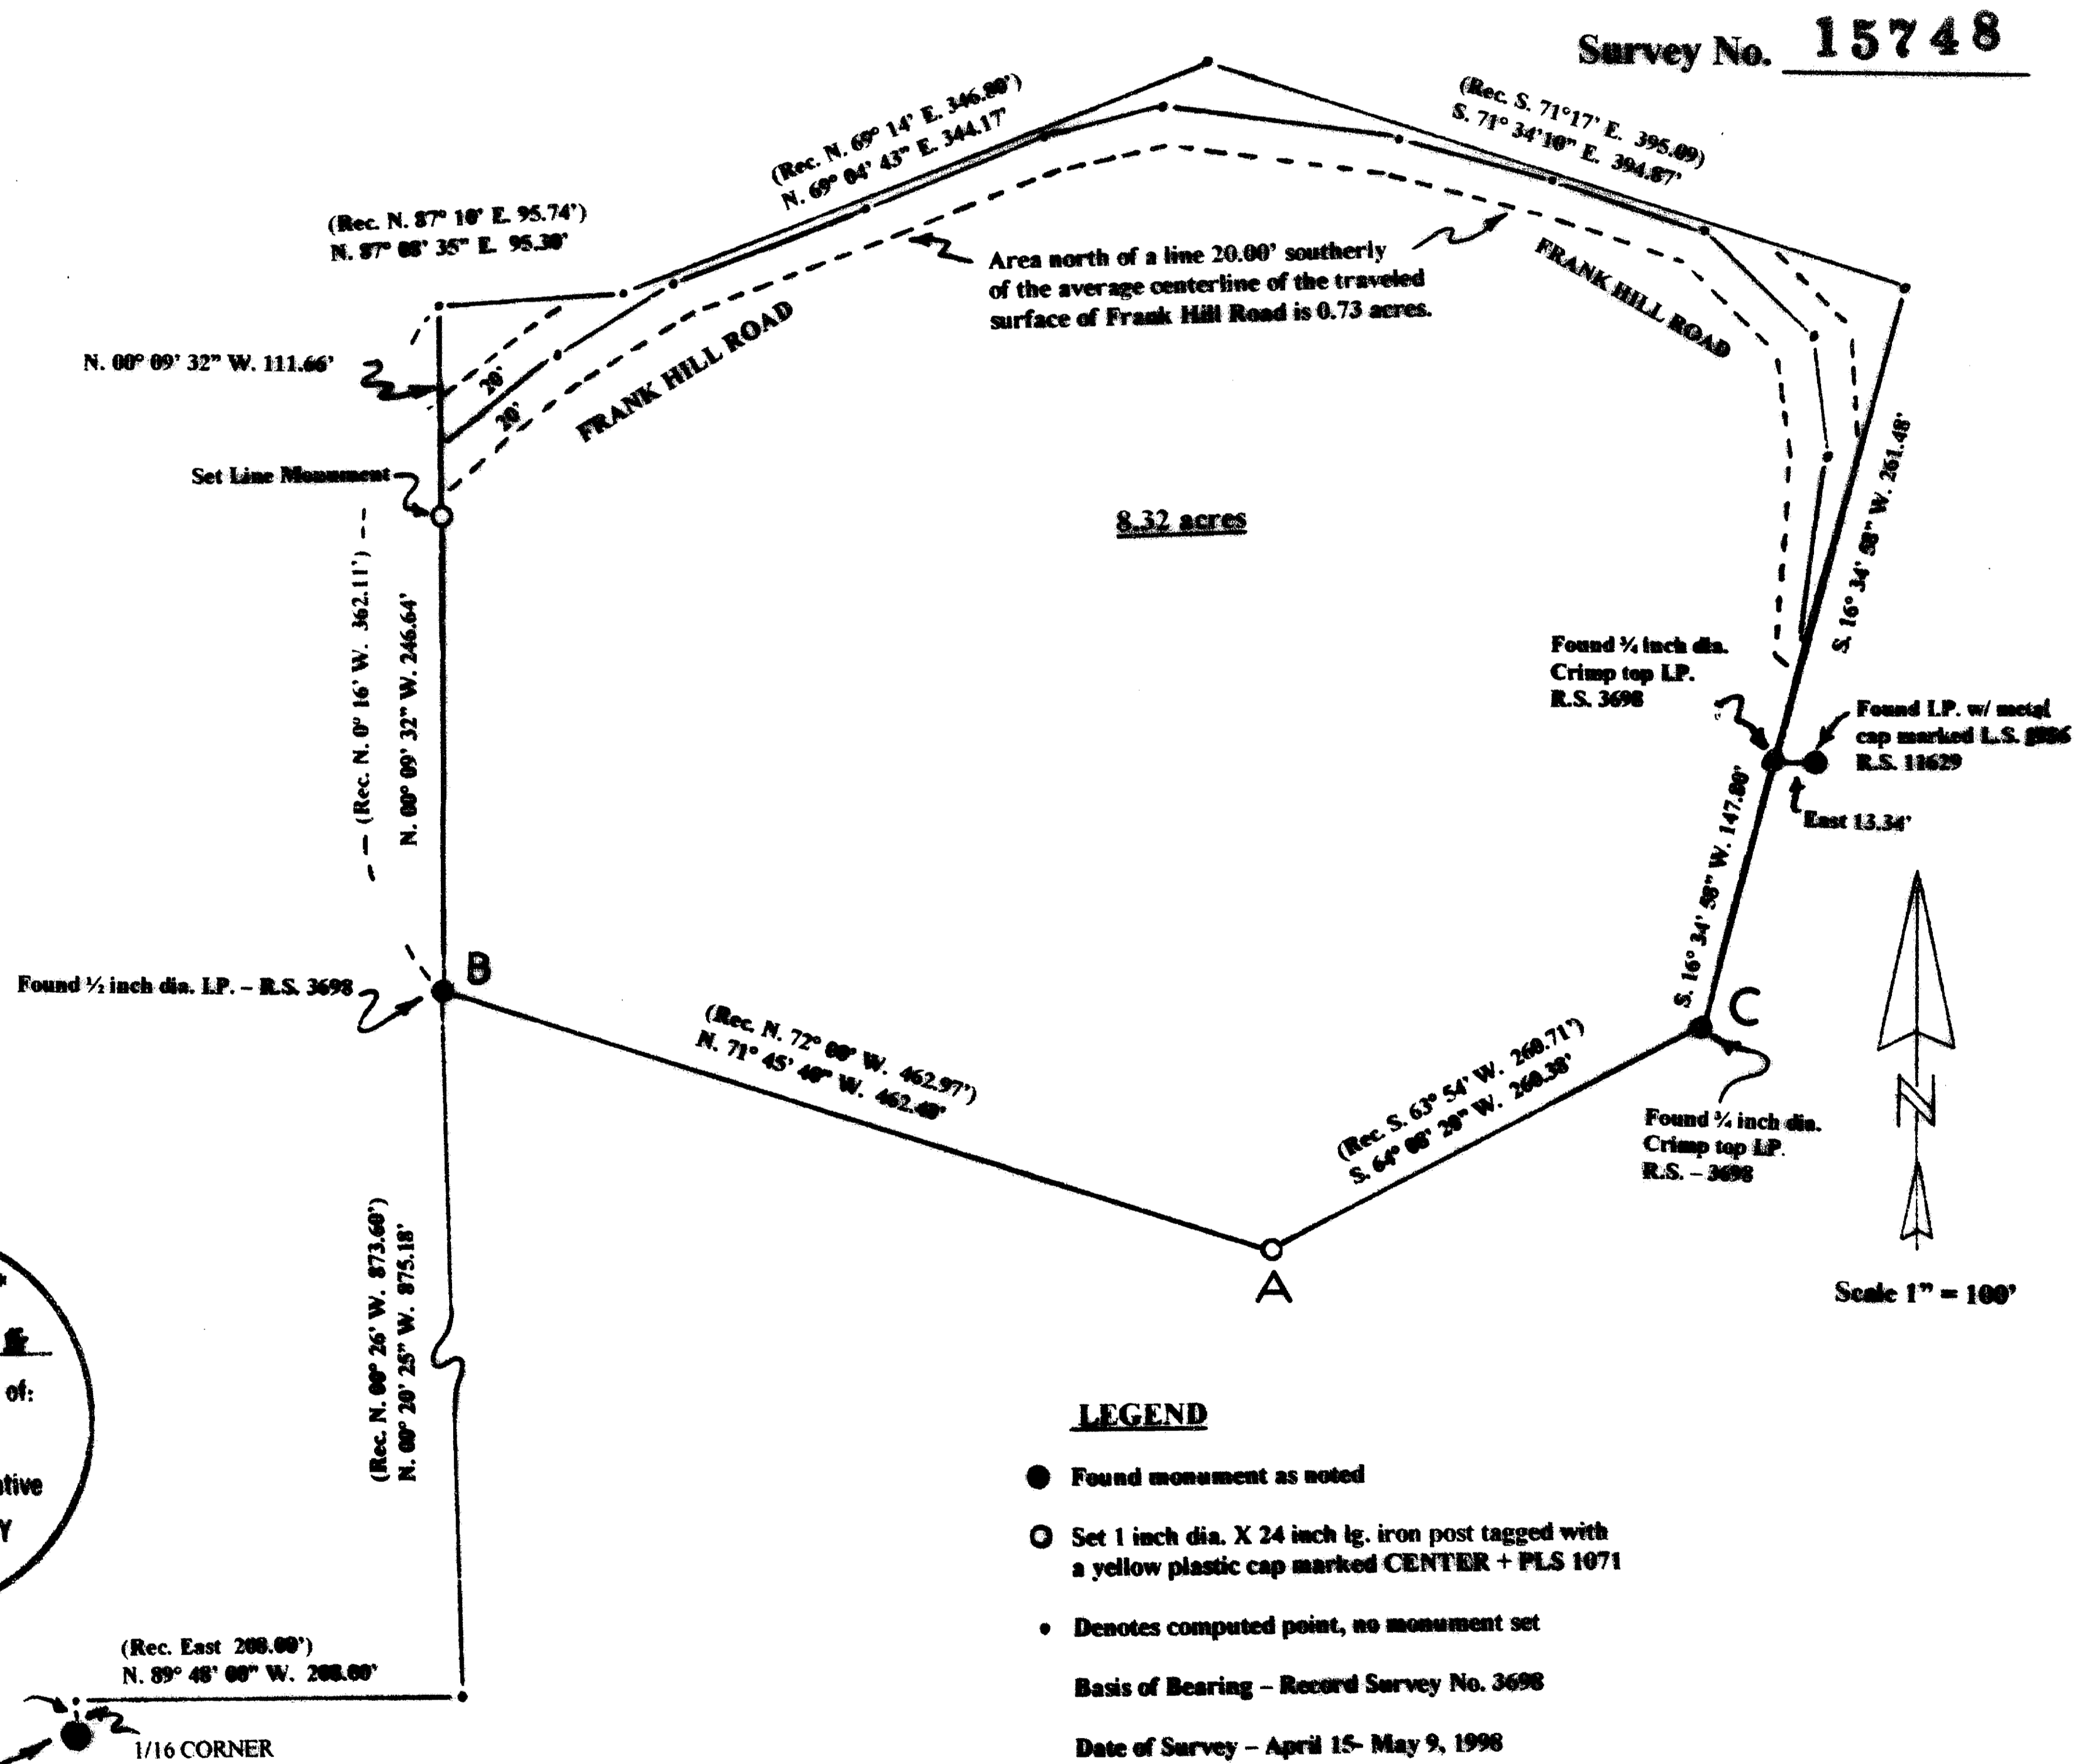
Note - Due to the lack of evidence of the exact monumented
Location of Frank Hill Road, the average centerline of the
traveled surface is shown.

No monuments were set along the north boundary. The
Property line is situated along the north side of Frank Hill
Road and to the south of the TID irrigation canal making
establishment of monuments impracticable.

Refer to narrative for courses along
the centerline of Frank Hill Road.

The following is a listing of the bearings and distances along the average centerline of the existing traveled surface of Frank Hill Road: Beginning at the recovered 3/4 inch diameter iron post situated on the east line; thence along the east line N. 16° 34' 58" E. 65.44 feet to intersect Frank Hill Road; thence along the average centerline the following courses; N. 09° 18' 39" W. 0.86 feet, N. 07° 48' 32" E. 95.98 feet; N. 05° 50' 09" W. 68.52 feet; N. 45° 30' 41" W. 79.69 feet; N. 69° 58' 56" W. 81.97 feet; N. 75° 11' 04" W. 86.92 feet; N. 81° 46' 42" W. 133.07 feet; S. 82° 05' 36" W. 75.00 feet; S. 71° 19' 42" W. 96.73 feet; S. 63° 40' 49" W. 108.98; S. 57° 09' 12" W. 83.17 feet; S. 53° 08' 03" W. 72.46 feet to intersect the west line; thence S. 00° 09' 32" E. 37.65 feet to a 1 inch diameter iron post situated on the west property line.

The east line was established by holding the alignment with the found monuments and projecting record distance to set the northeast corner point. The remaining corner points along the north and east lines were determined using a Crandell method of adjustment of the record courses along those lines.

The corner point situated on the south boundary (denoted as corner point A on the attached map of survey) was reset using the record angles formed by corner points A, B, and C. Record Survey 3137 describes this point to be situated at the "north face of a 12" dead oak". During the process of reestablishing the corner point, I recovered the remains of a broken oak stump. The remains of the oak tree with the remains of a fence attached, were recovered to the northwest of the corner point.
