## Page 3 of 3

## Page 2 of 3

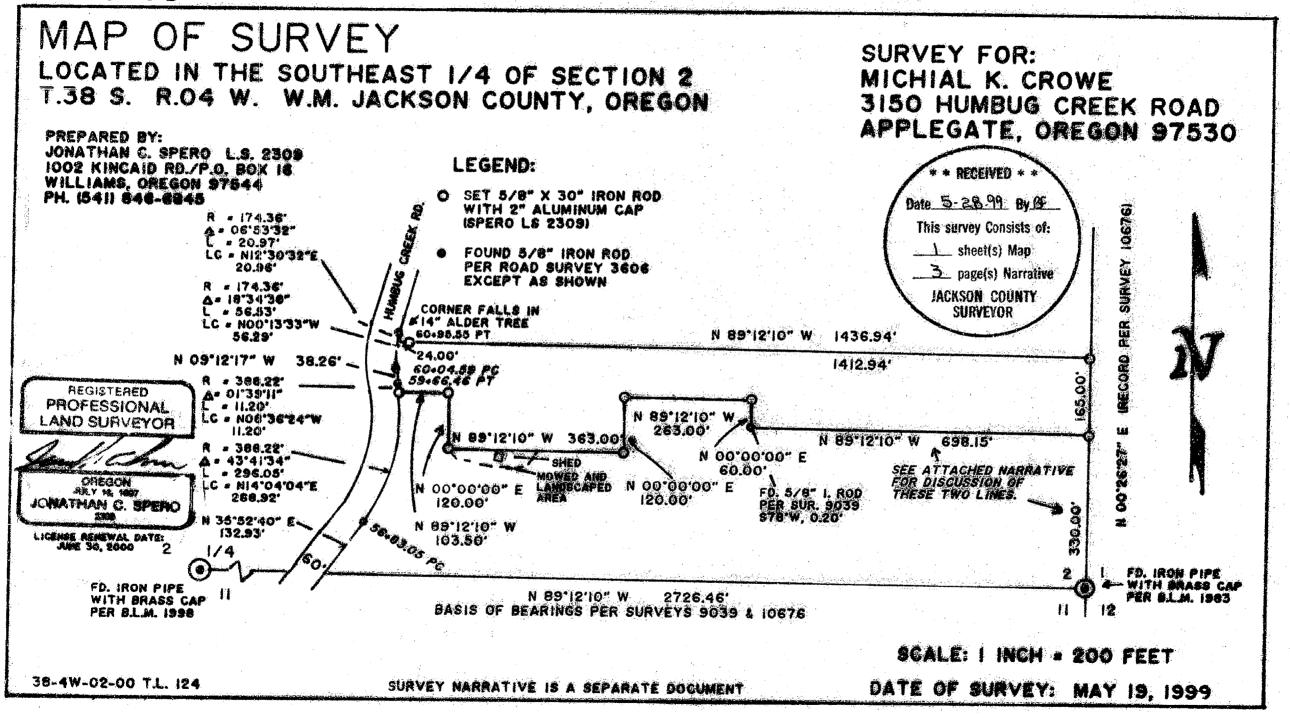
Basis of bearings is the South line of Section 2 from the Southeast corner to the South 1/4 corner thereof, which bears North 89°12'10" West per surveys 9039, and 10676.

This survey was accomplished using a Nikon DTM-430 electronic survey station.

Survey monumentation was completed on: May 19, 1999

Holding the 263 foot call results in a nearly equal exchange of property. Holding the 815 foot call does not. It should also be noted that the 815 feet was to be measured from the East line of the Section, which was not monumented at the time of the exchange, whereas the 263 foot call was from the road right-of-way, which had been surveyed and monumented. A strong preponderance of evidence points to the conclusion that the 263.00 feet was intended to control this line.

The West line is the Easterly right-of-way line of Humbug Creek Road. This road rightof-way was monumented in 1967 in Survey No. 3606. Monuments per that survey were found in good condition (although some were buried by more than a foot, presumably by flooding of nearby Kane Creek) and accepted for this survey.
