Survey For
GLEN ALLEN
Located in Sec. 1, T. 38 S., R. 2 W., W.M.
By: Mark E. Boyden
March, 1961

SURVEY NARRATIVE TO COMPLY WITH O.R.S. 209.250

PURPOSE: To monument and describe a parcel lying between the East boundary of Lot No. 3 of VAWTER SUBDIVISION, the Southerly boundary of Stage Road South, the West boundary of Recorded Survey No. 1174 and the Northerly right-of-way line of the Medford Irrigation District canal.

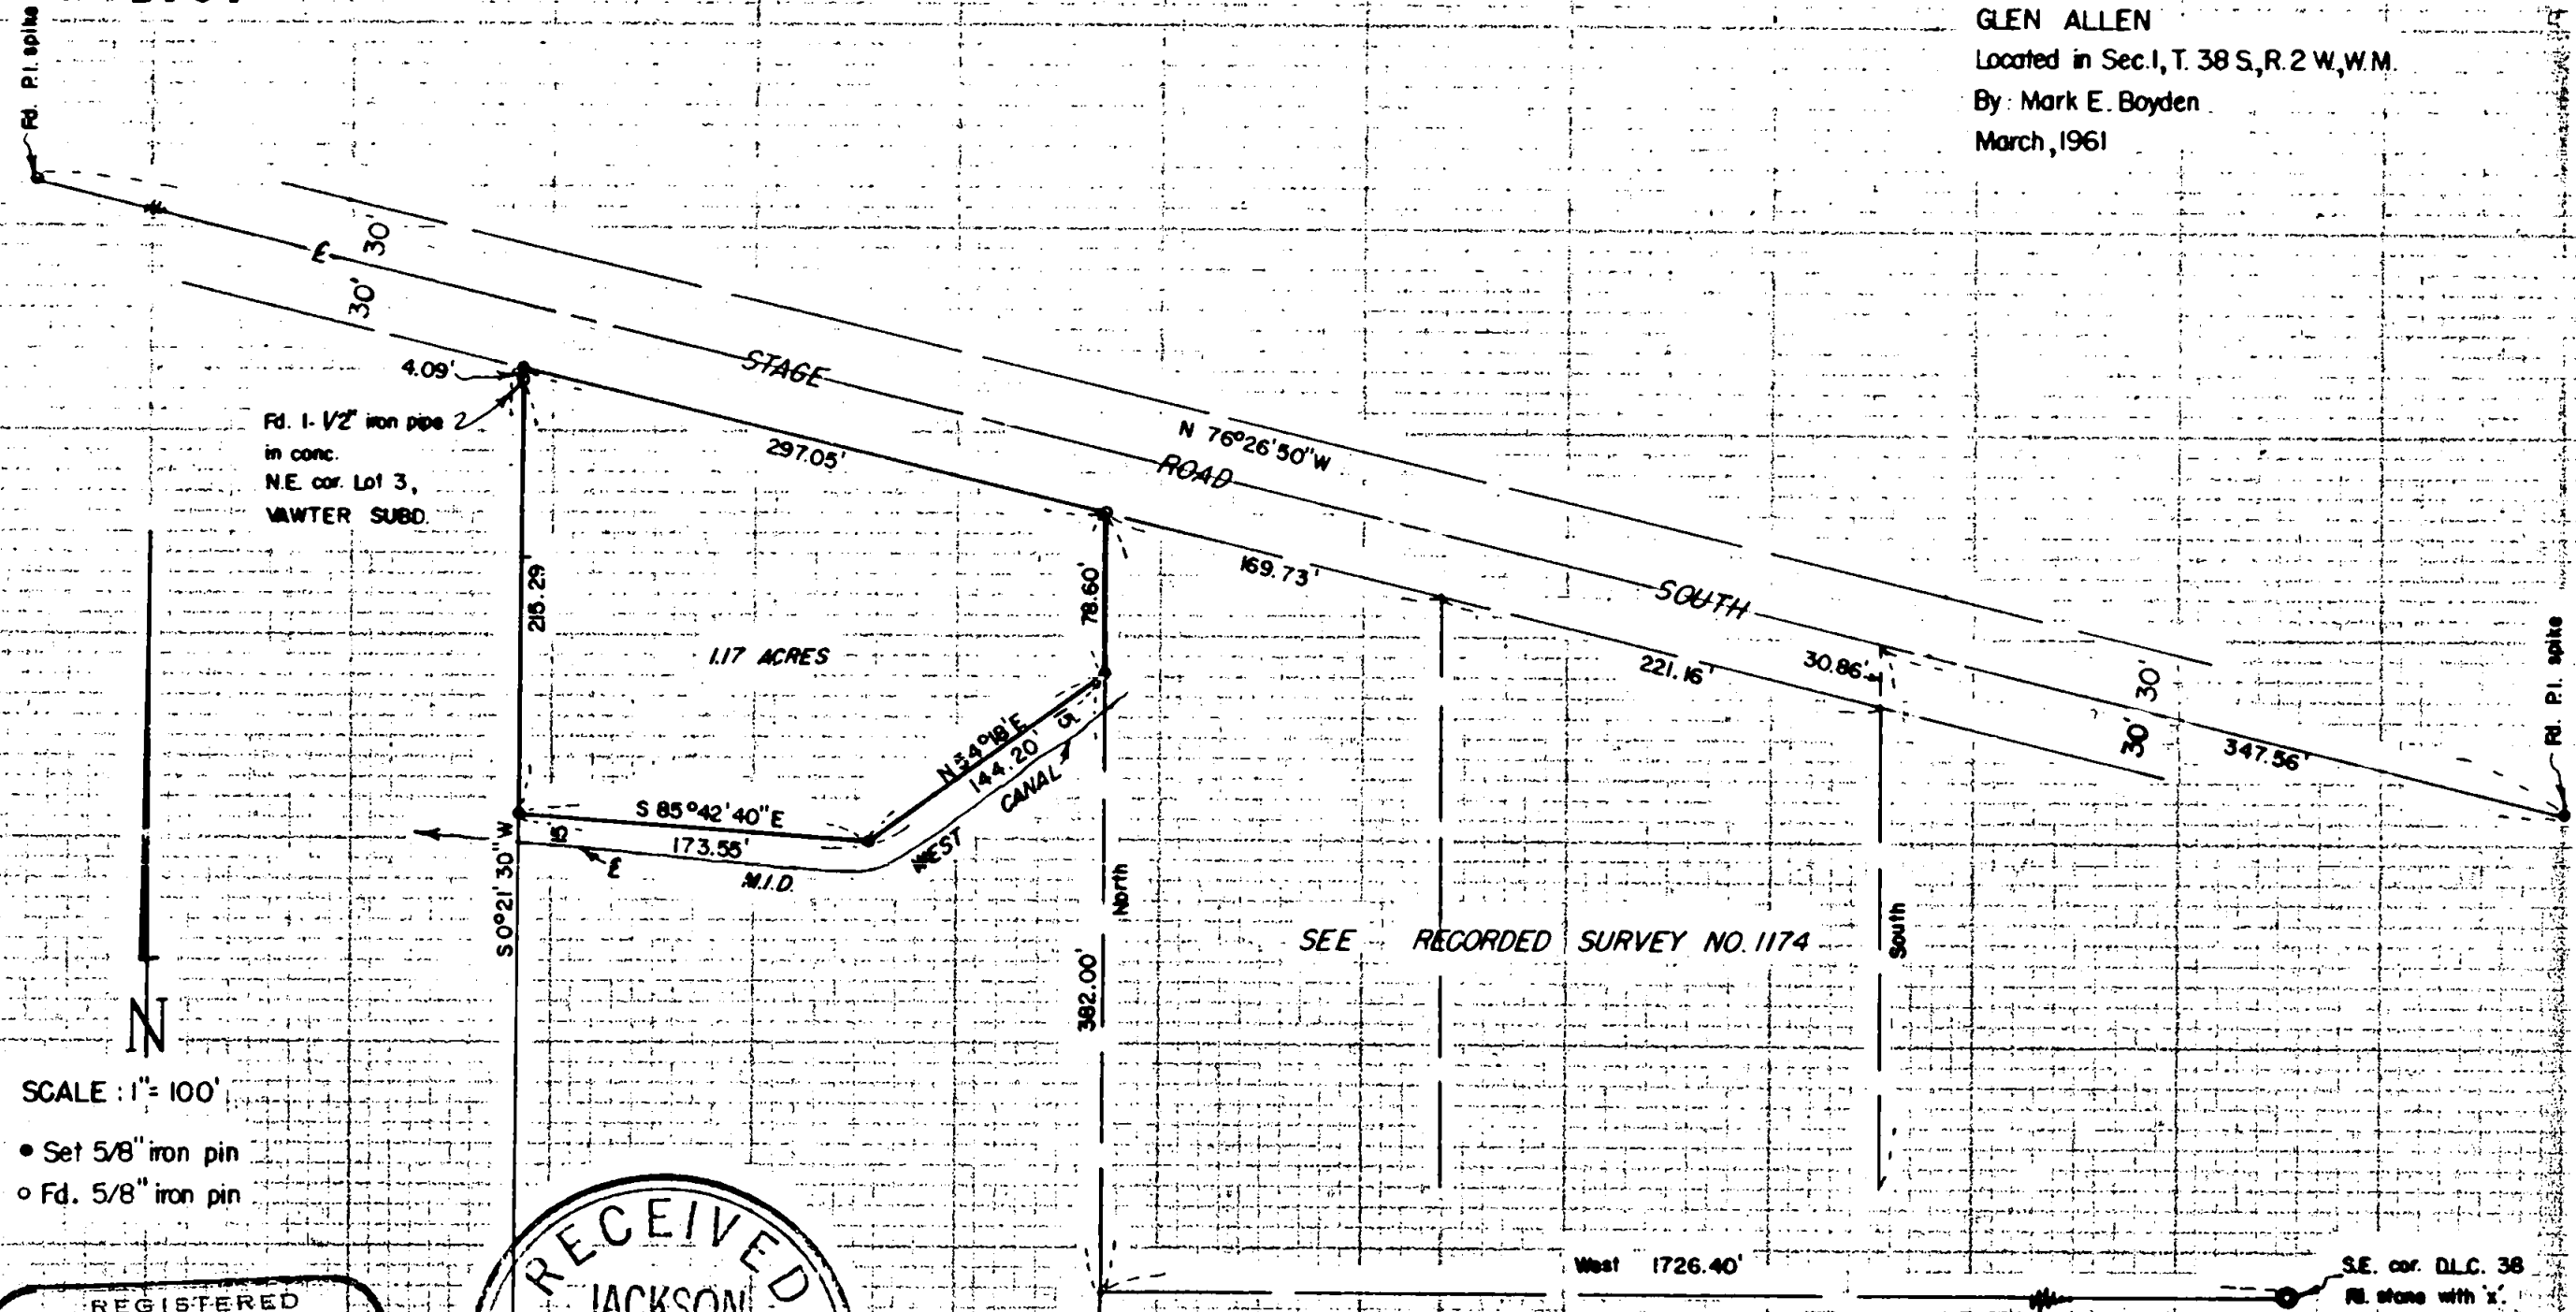
Fd. 1- 1/2" iron pipe 2
in conc.
N.E. cor. Lot 3,
WATER SUBD.

1.17 ACRES

SEE RECORDED SURVEY NO. 1174

- Set 5/8" iron pin
- Fd. 5/8" iron pin

S.E. cor. D.L.C. 38
Pd. stone with 'x'

Monumented the parcel as shown, using the solar bearing control previously used on Recorded Survey No. 1174.

PROCEDURE: Found the iron pin monuments to control the East boundary of the subject property and the road P.I. spikes to the East and West to control the located centerline of Stage Road South.

Loop-traversed around said tract, tying in also the canal centerline and the Northeast corner of Lot No. 3 of VAWTER SUBDIVISION. Also ran Southerly near the East line of said lot No. 3 tying in the remains of the old fence post near the Southeast corner of said lot 3 which is immediately East of the present cedar post and continued Southerly to the $\frac{1}{4}$ corner common to Sections 1 and 12. At the $\frac{1}{4}$ corner, found scribe marks for both original bearing trees and a 2" iron pipe said to have been set by an old-time resident to replace a hub with tack.

No evidence could be found of the $1\frac{1}{4}$ " iron pipe set in concrete reported as the initial point of VAWTER SUBDIVISION. In that the 2" pipe does not agree with the original witness trees, the true corner was set Southwesterly 2.0 feet from said 2" pipe (see official re-establishment).
