SURVEY NARRATIVE TO COMPLY WITH PARAGRAPH 209.250 OREGON REVISED STATUTES

LOCATION: in the Northeast and the Southeast one-quarter's of Section 16, Township 39 South,

PURPOSE: To survey and monument those tracts of land described in Instruments No. 71-02513

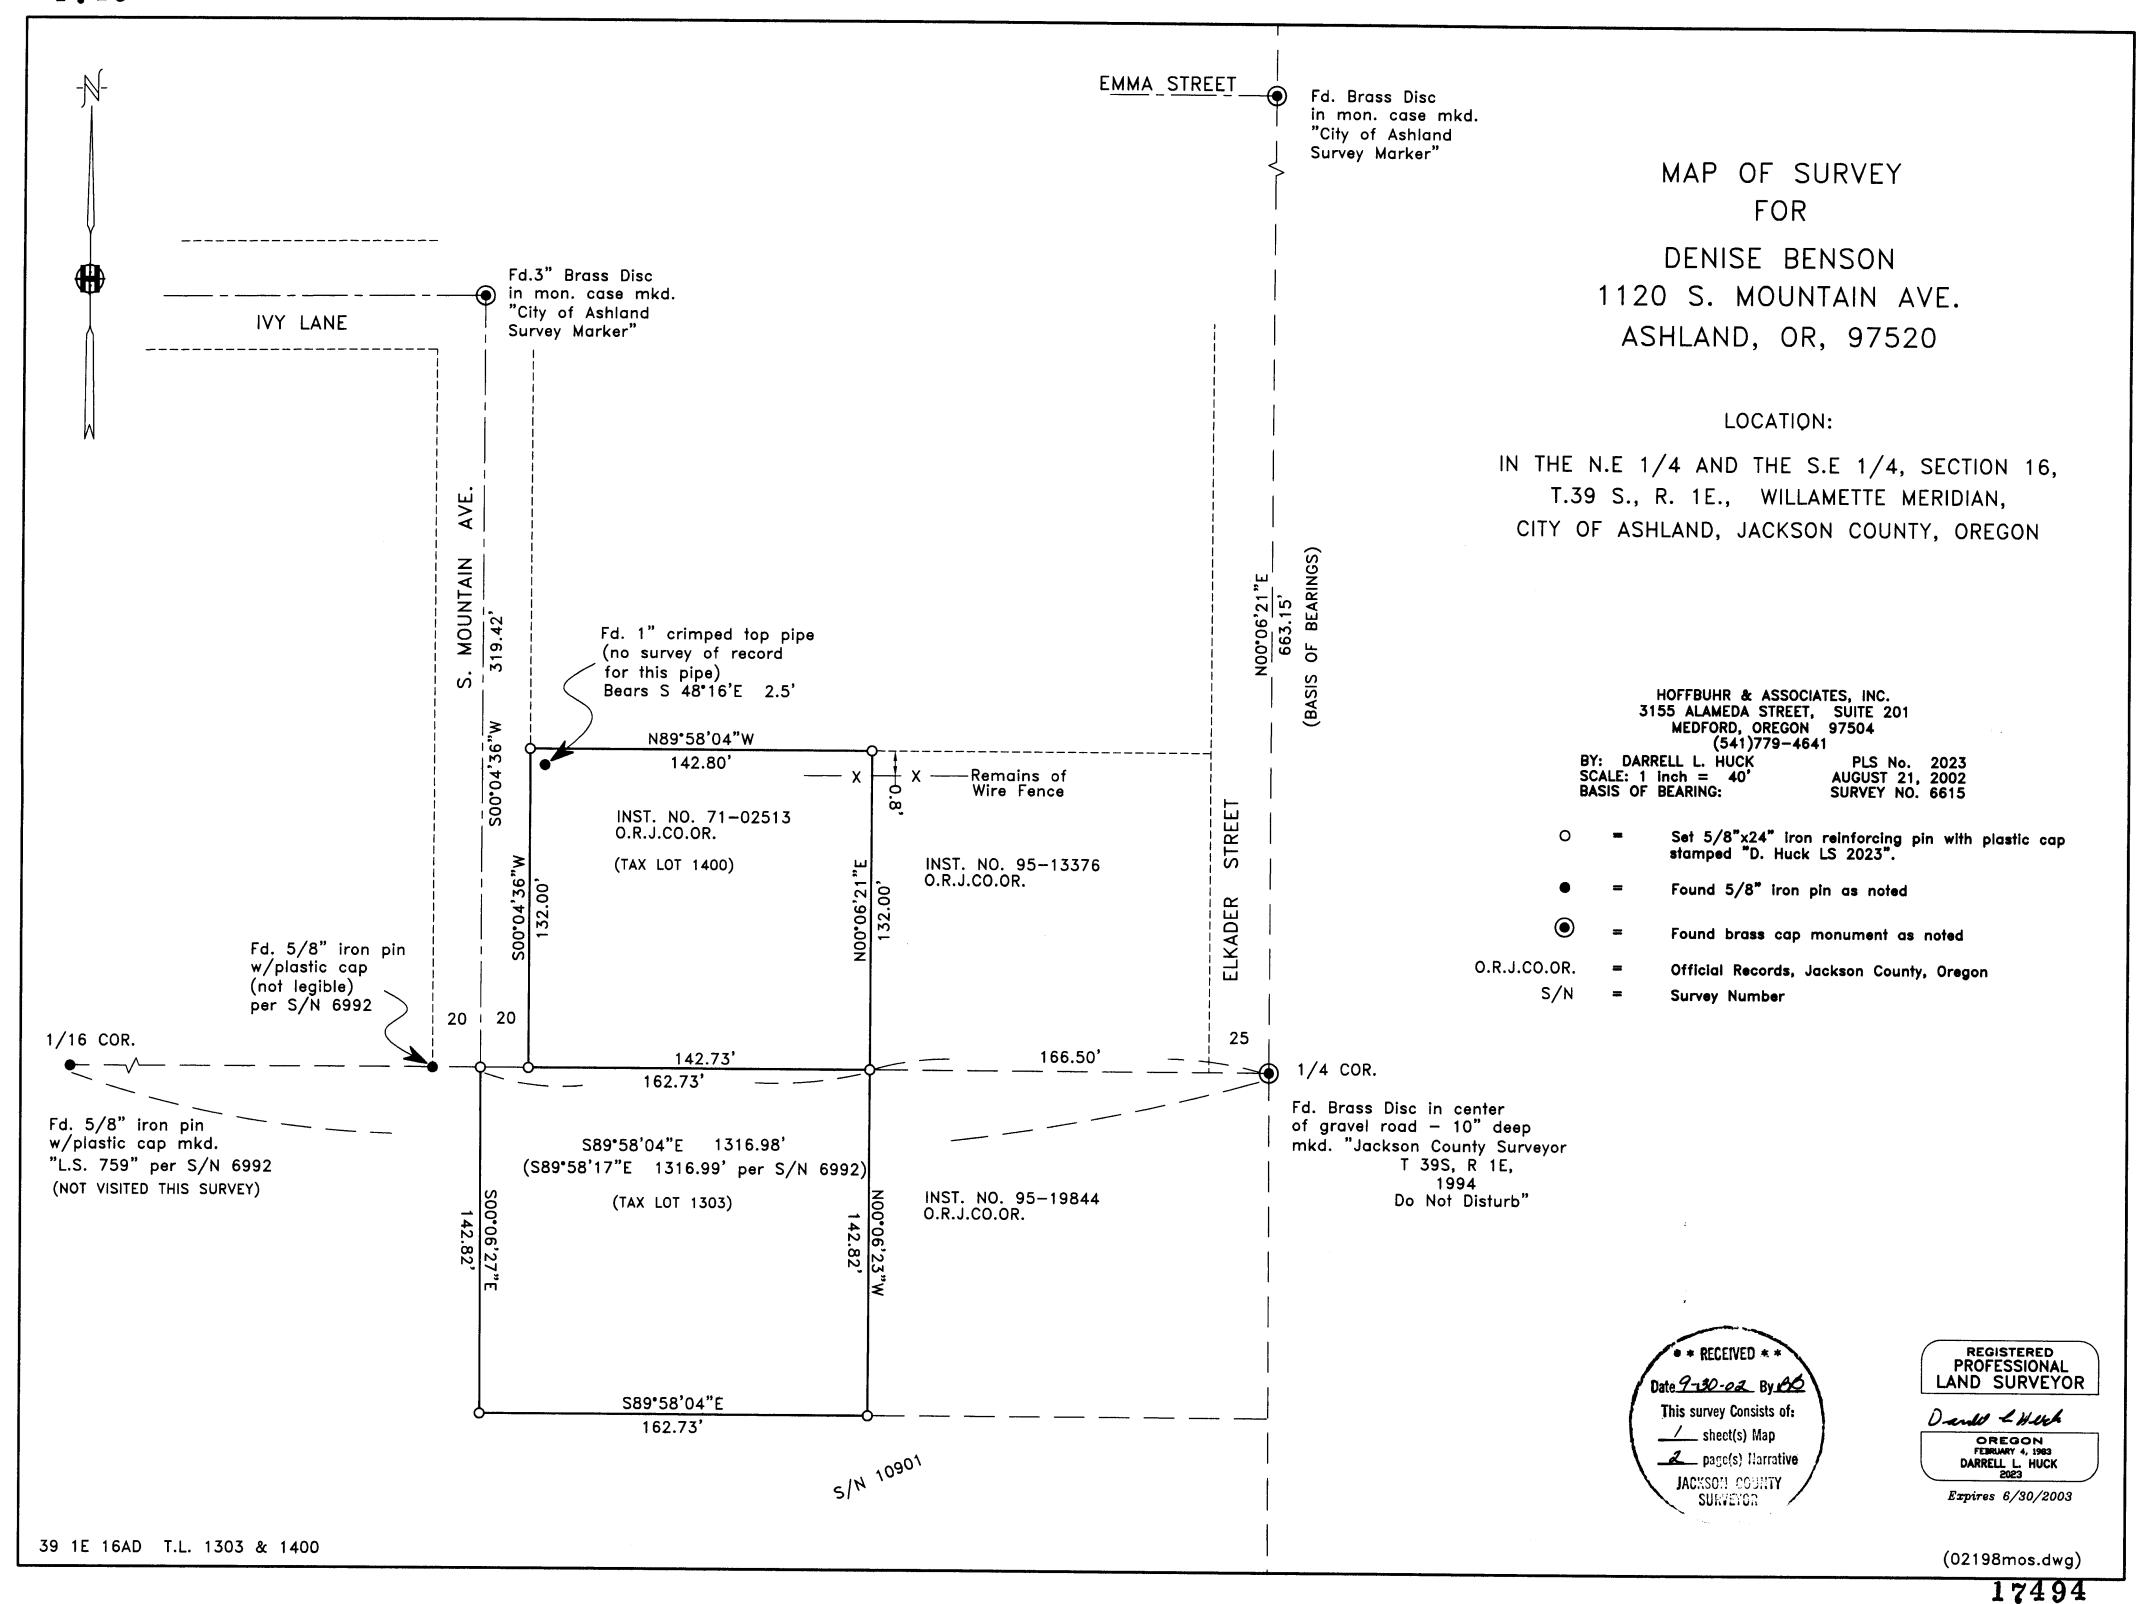
Now then, regarding the location of tax lot 1303 as described in Instrument No. 76-04005.

Now then, regarding the location of tax lot 1303 as described in Instrument No. 76-04005. The point of beginning of this tax lot is "the Southeast corner" of tract conveyed pursuant to Instrument No. 76-03760, which Instrument has been determined to be erroneous as cited above. If this point of beginning is held a 1.00' deed gap would be created between tax lot 1303 and the adjoining tax lot 1302 to the east.

After reviewing deeds of record it is apparent that there is an intent for the Northeast corner of tax lot 1303 to be common with the Southeast corner of tax lot 1400. I therefore held the west line of the property adjoining to the east and described in Instrument No. 95-19844 to control the east boundary of tax lot 1303.

PROCEDURE: Utilizing a Leica TCA 1800 total station, a control traverse was run tying found monuments as shown and also tied into survey control previously established by this office for Pine View Estates Subdivision.

Client owns 2 tax lots, currently designated as Tax Lot 1400 and Tax Lot 1303 by the County Assessor's Office. In 1971 ownership of Tax Lot 1404 was conveyed to James & Denise Benson from Richard & Virginia Westerfield by warranty deed Instrument No. 71-02513. The point of beginning of the property conveyed is 166.5' west of the East 1/4 corner of Section 16. In 1976 another deed was filed for record, (Instrument No. 76-03760) titled a "Corrected Warranty Deed and Easements" whereby Richard and Virginia convey to James and Denise Benson. The point of beginning of the second deed is 167,5' feet West of the East 1/4 corner of Section 16. The revised point of beginning moves the East line of the Benson property 1.00 foot west, creating a 1.00 foot deed gap between the Benson property and the adjoining property to the east. I spoke to Mrs. Benson regarding the second deed and she was surprised that it existed. She could not remember ever having seen a second deed. According to Mrs. Benson the property was paid for, free and clear before 1976. Mrs. Benson contacted Mrs. Westerfield, who couldn't remember the particulars regarding the second deed, but she seemed to feel that a real estate person had been instrumental in having the deed corrected. The validity of the correction deed is questionable since the Benson's were, at the date of the correction deed, the fee owners of the property and were not a party to the new deed. I therefore held the original 1971 deed to control the location of Tax Lot 1400.
