MAP OF SURVEY
 FOR
 MR. AND MRS. GARY AND LINDA HALL
 2391 TERRI DRIVE
 MEDFORD, OR 97504
 SITUATED IN
 SECTION 36, T.37S., R.1W., W.M.
 JACKSON COUNTY, OREGON
 JUNE 20, 2006

SURVEY NARRATIVE TO COMPLY WITH PARAGRAPH 209.250
OREGON REVISED STATUTES

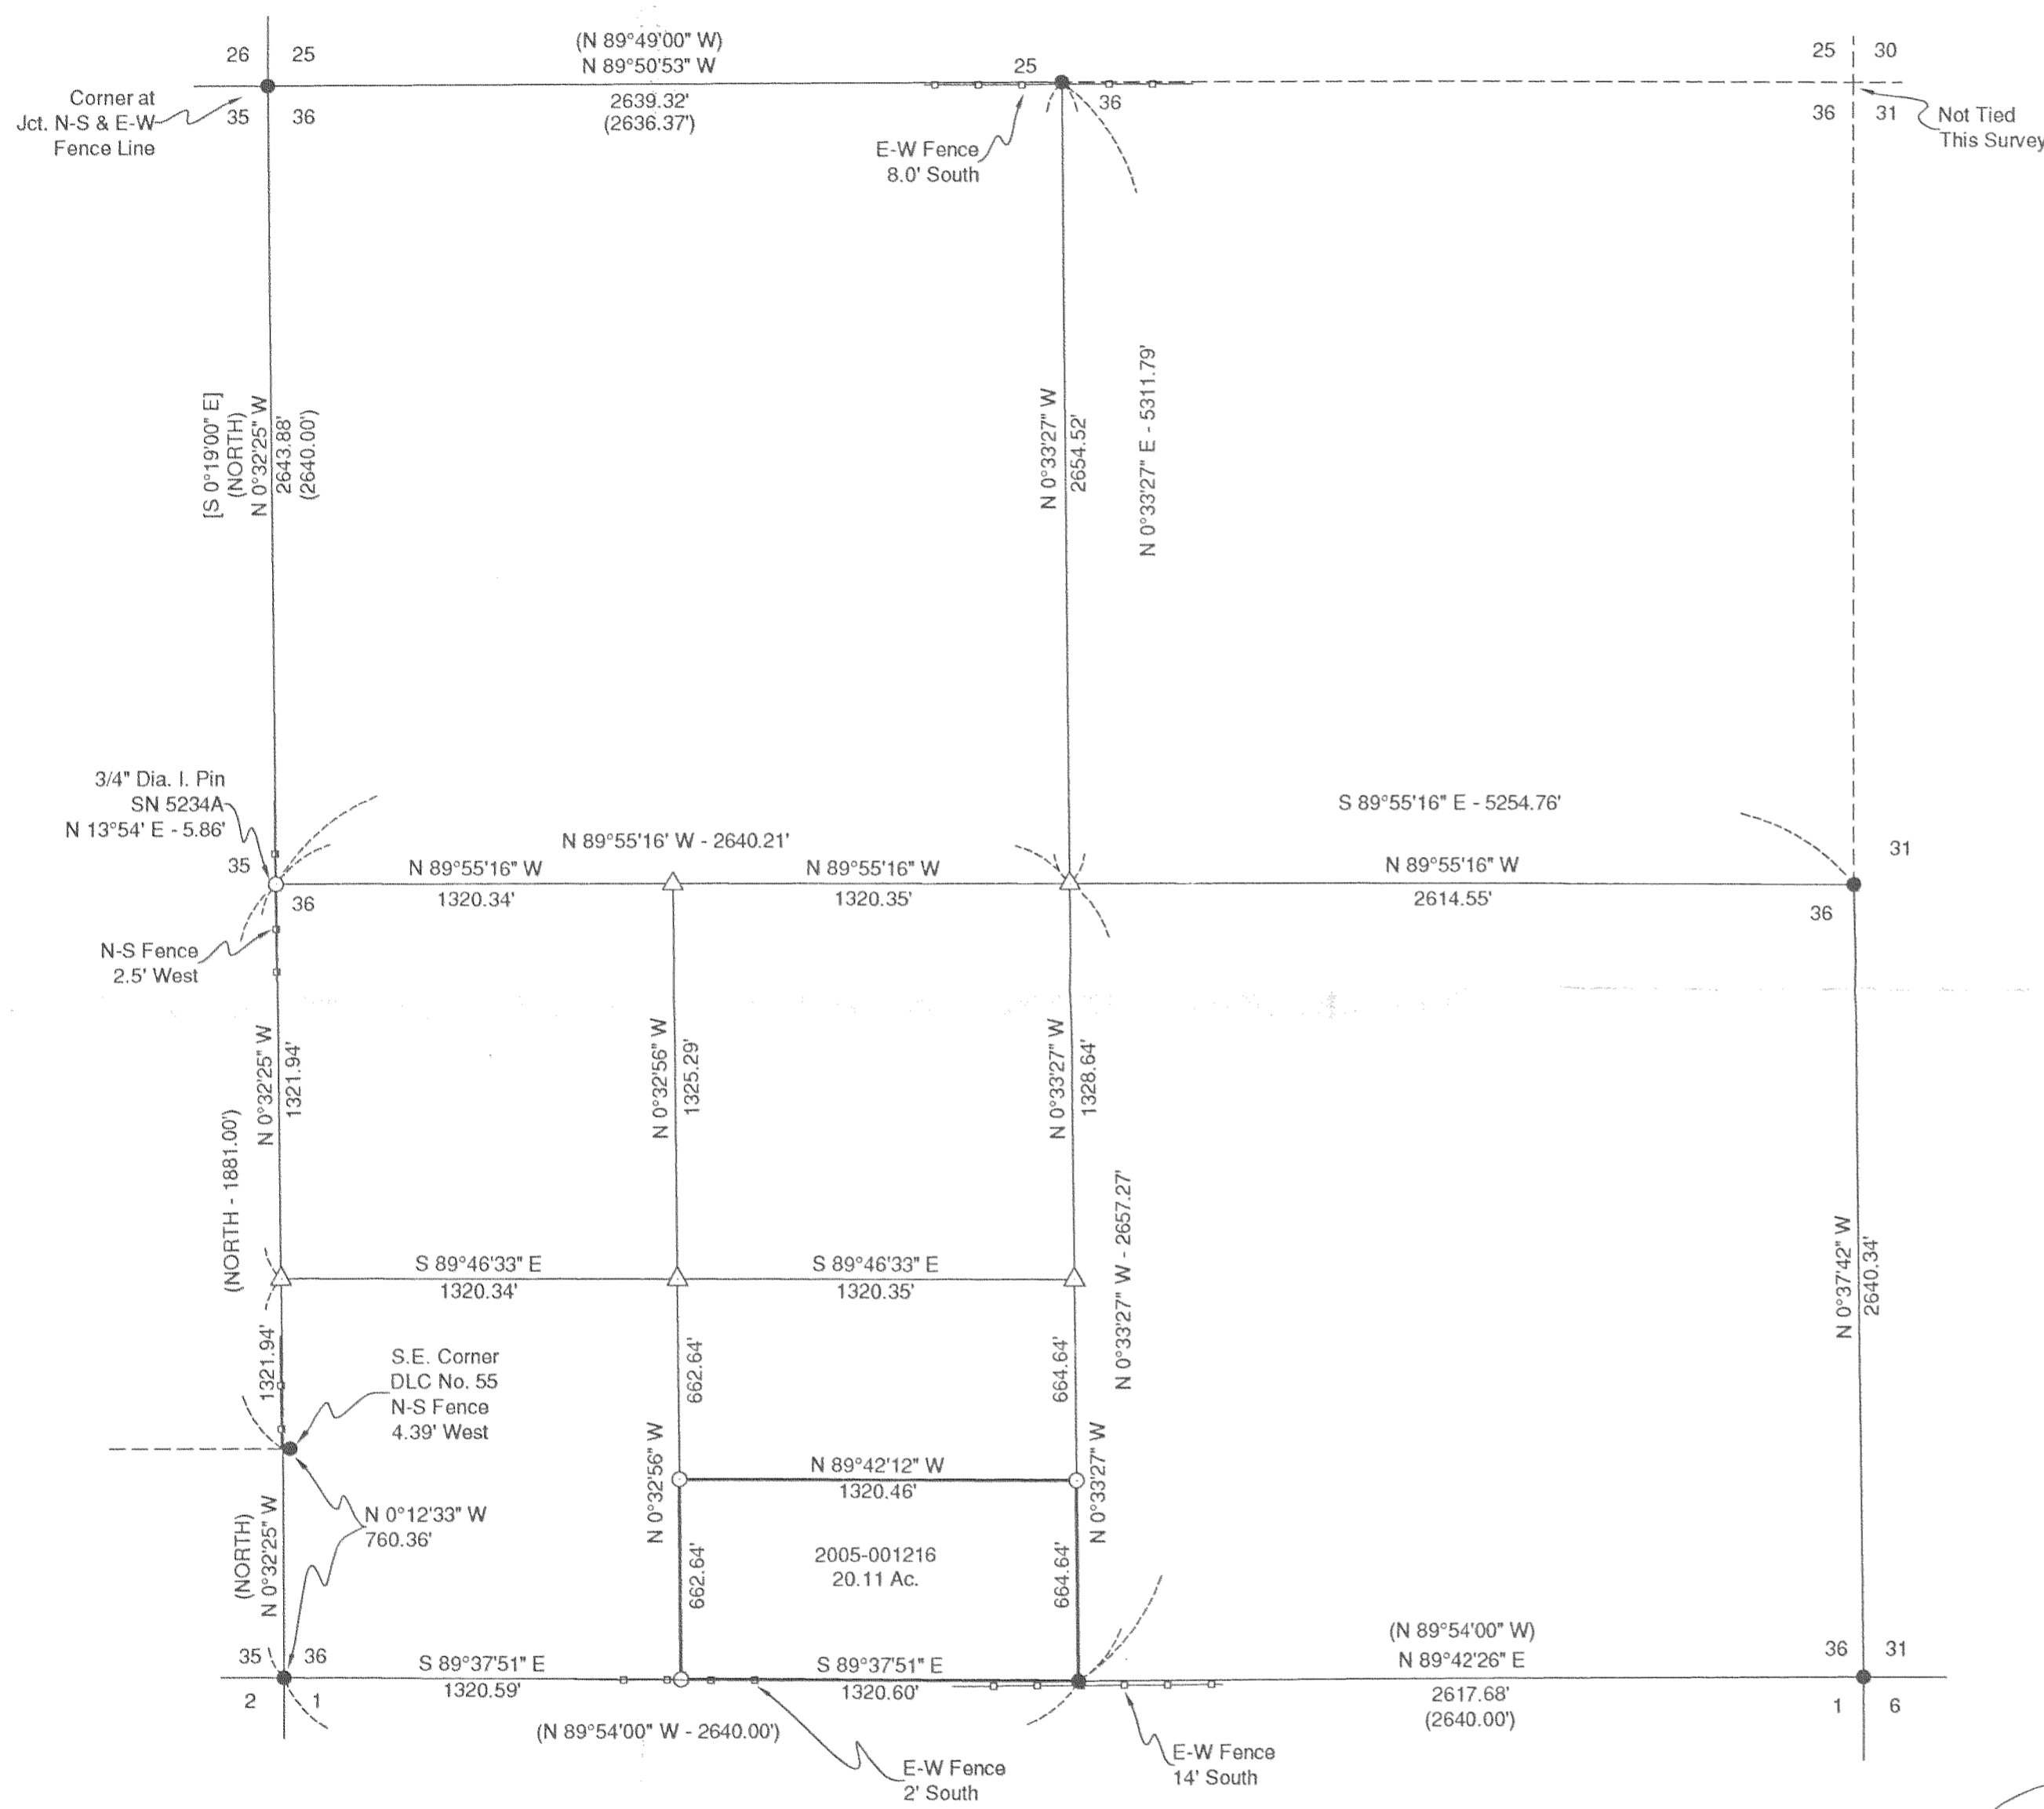
- LEGEND**
- Found Jackson County Surveyor Monument and Accessories
 - Set 1" Diameter, 30" Long Galvanized Iron Post With 1-1/2" Diameter Metal Cap Marked: "CENTER + LS 1071"
 - △ Computed Point, No Monument Set
 - SN Filed Survey Reference Number
 - () Denotes GLO/DLC Survey Record
 - [] SN 5243, SN 5461 Record
 - Denotes Fence Line

Purpose: To monument the corner points and post the boundary of the South half of the Southeast one-quarter of the Southwest one-quarter of Section 36, Township 37 South, Range 1 West, Willamette Meridian as directed by my client. The controlling document for this property is 2005-001216.

Procedure: I began this survey with the recovery of monuments required for the subdivision of Section 36. All original corners had been recovered and perpetuated by the Jackson County Surveyor with the exception of the one quarter common to Sections 35 and 36 (west one-quarter corner of Section 36).

Unable to positively identify original scribing or suitable evidence to corroborate the evidence recovered by Hurst I established the corner point by proportional measurement.
