MAP OF SURVEY FOR PROPERTY LINE ADJUSTMENT, HORIZONTAL CONTROL, AND MONUMENT RECOVERY SITUATED IN S.W. 1/4 SECTION 36, T37S, R2W, W.M. JACKSON COUNTY, OREGON MAY 2010

FOR: Medford School District 549C
Attn: Mark Button
500 Monroe Street
Medford, OR. 97501

BY: Hardey Engineering and Associates, Inc.
Richard L. Bath, LS 1069
P.O. Box 1625
Medford, OR. 97501

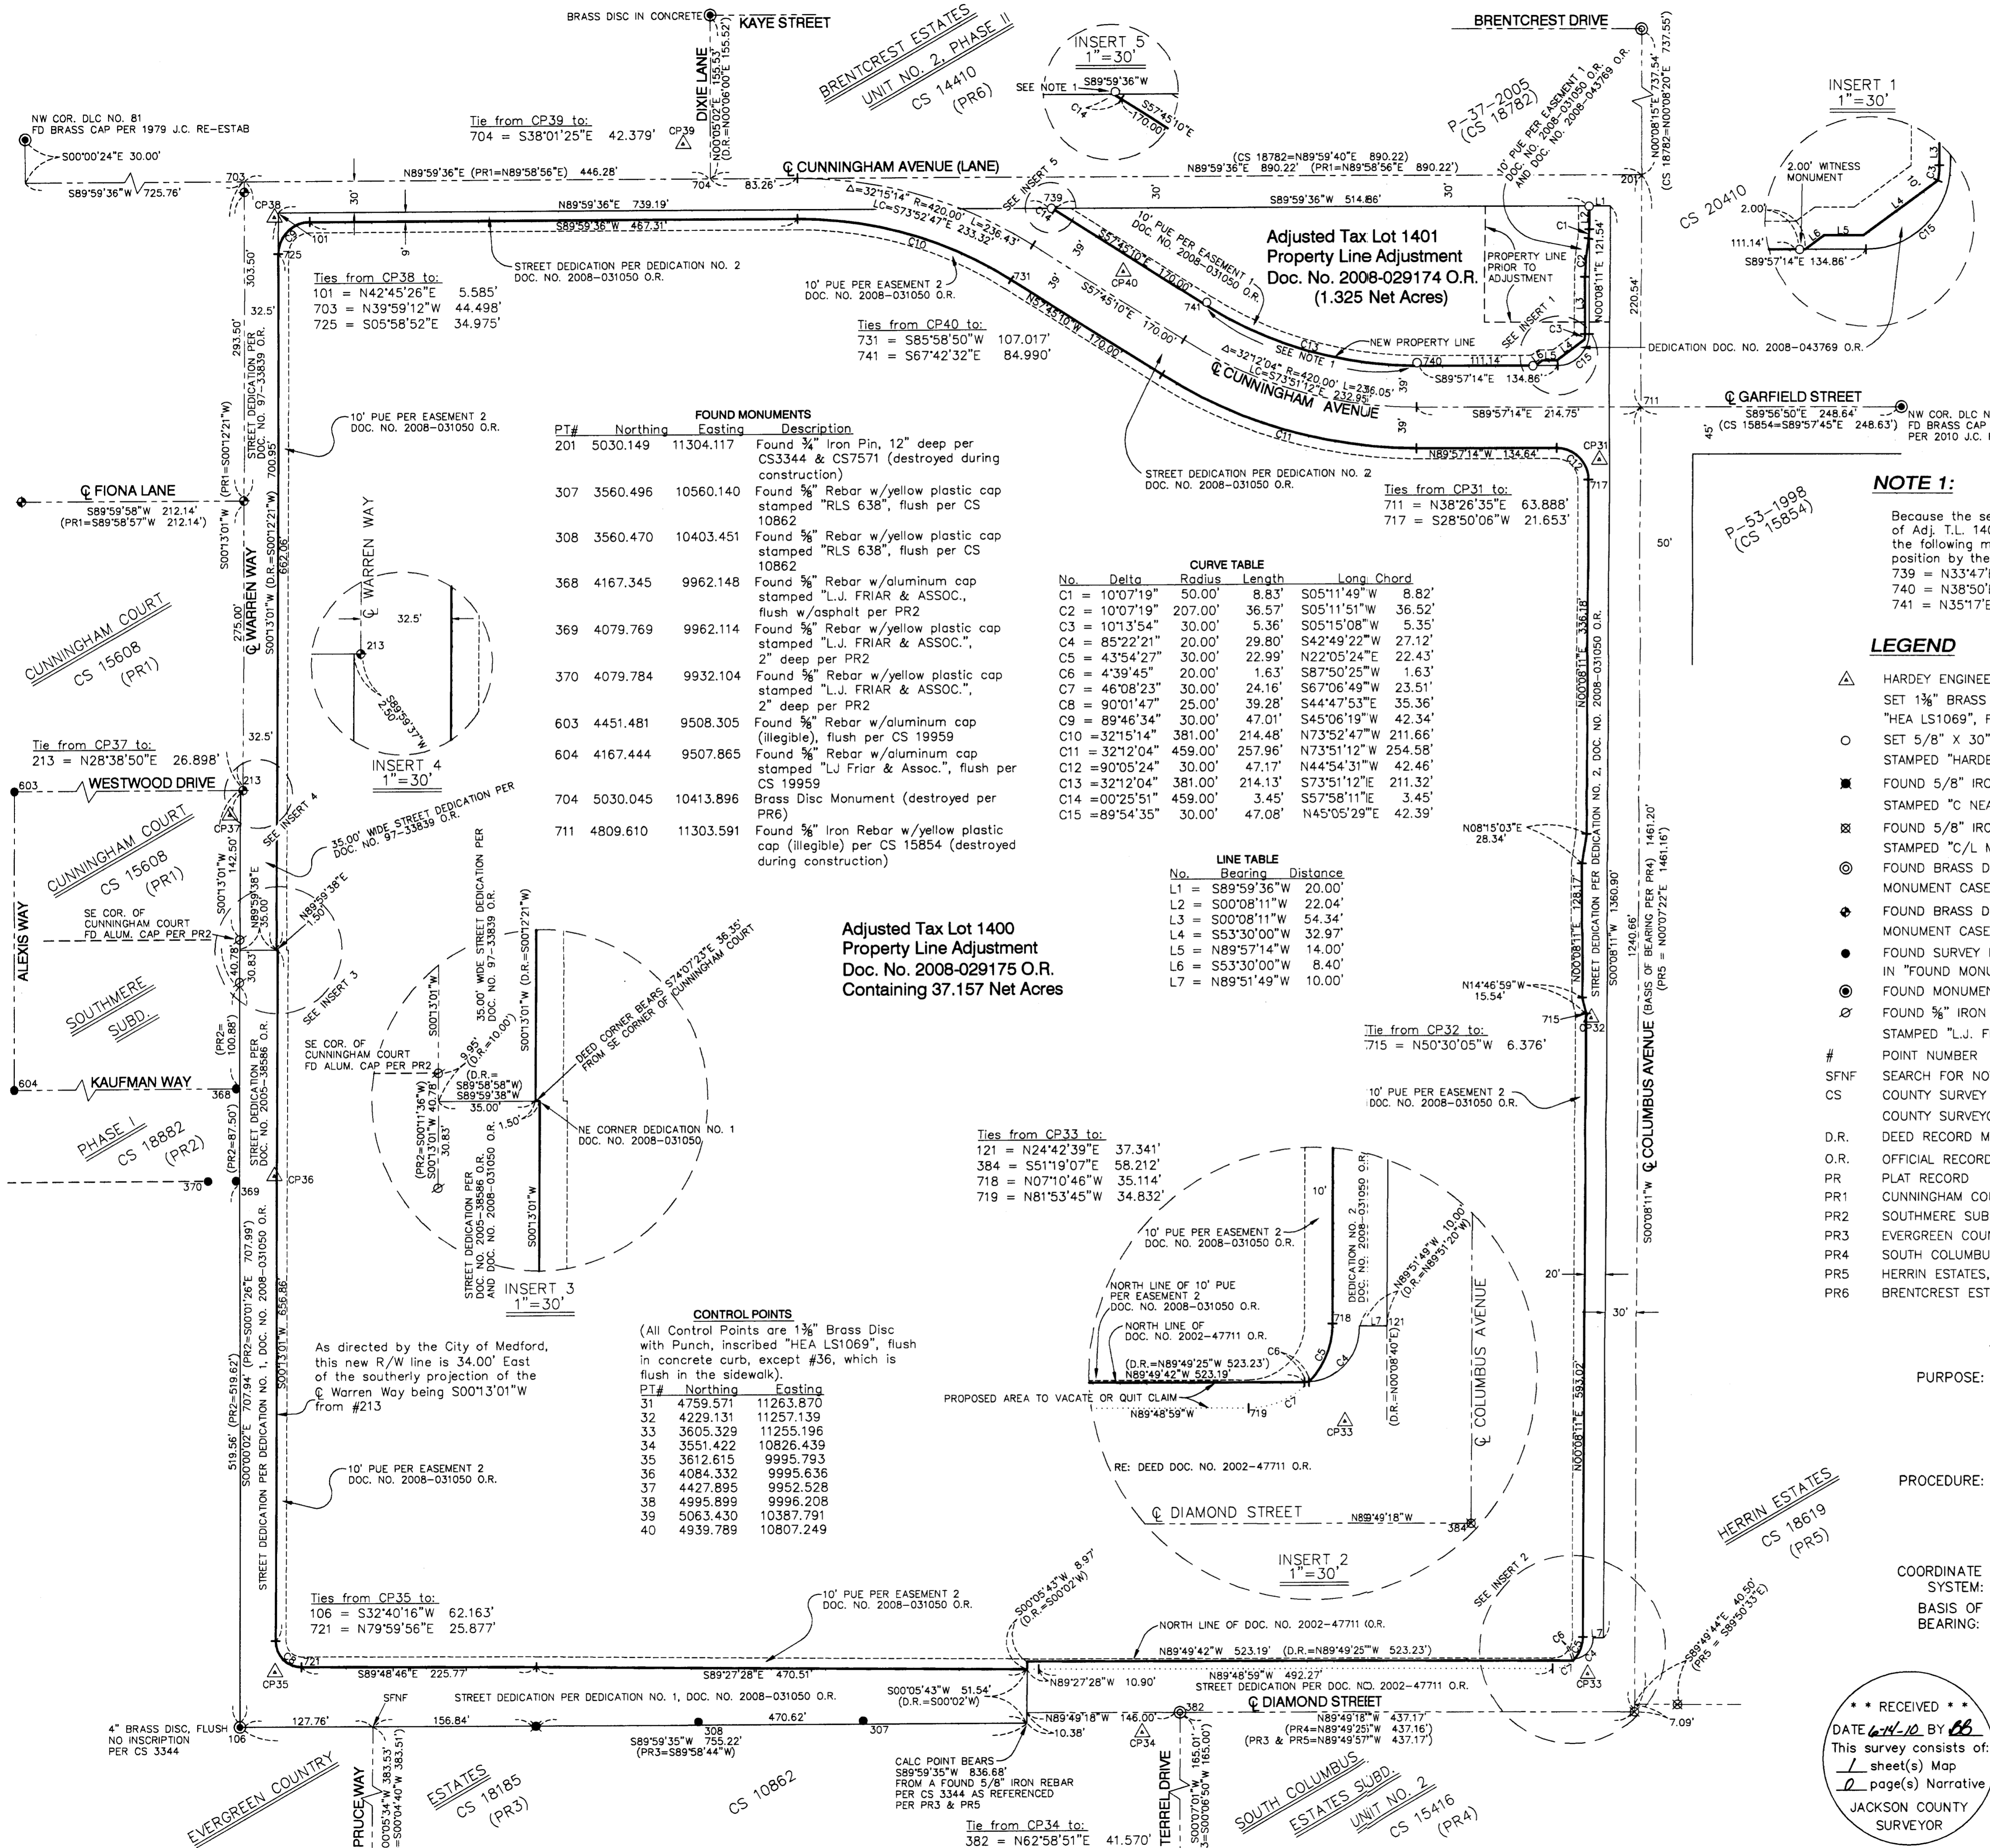
PURPOSE: To survey and monument the property line adjustments described in Doc. Nos. 2008-029174 and 2008-029175 of the Official Records and to mathematically locate right of way lines described in Doc. Nos. 2008-031050 and 2008-043769 of said Official Records relative to set control monuments and other found monuments shown hereon. The purpose of the property line adjustment was to initially separate the two adjusted tax lots along the northerly right of way line of the re-aligned Cunningham Avenue.

PROCEDURE: A closed control traverse was surveyed around the exterior boundary of the subject property tying in all found survey monuments of record for monument preservation as well as being used to analyze the existing locations of street centerlines, right of way lines, and deed lines. The deed record locations of all new right of way lines and preserved locations of survey monuments relative to this survey are plainly set forth on this map.
