LITTLE BUTTE CREEK PARK NO. 2

FAYDREX, INC.

SEC. 36, T. 35 S., R. 1 W., W.M.

Survey Number-----

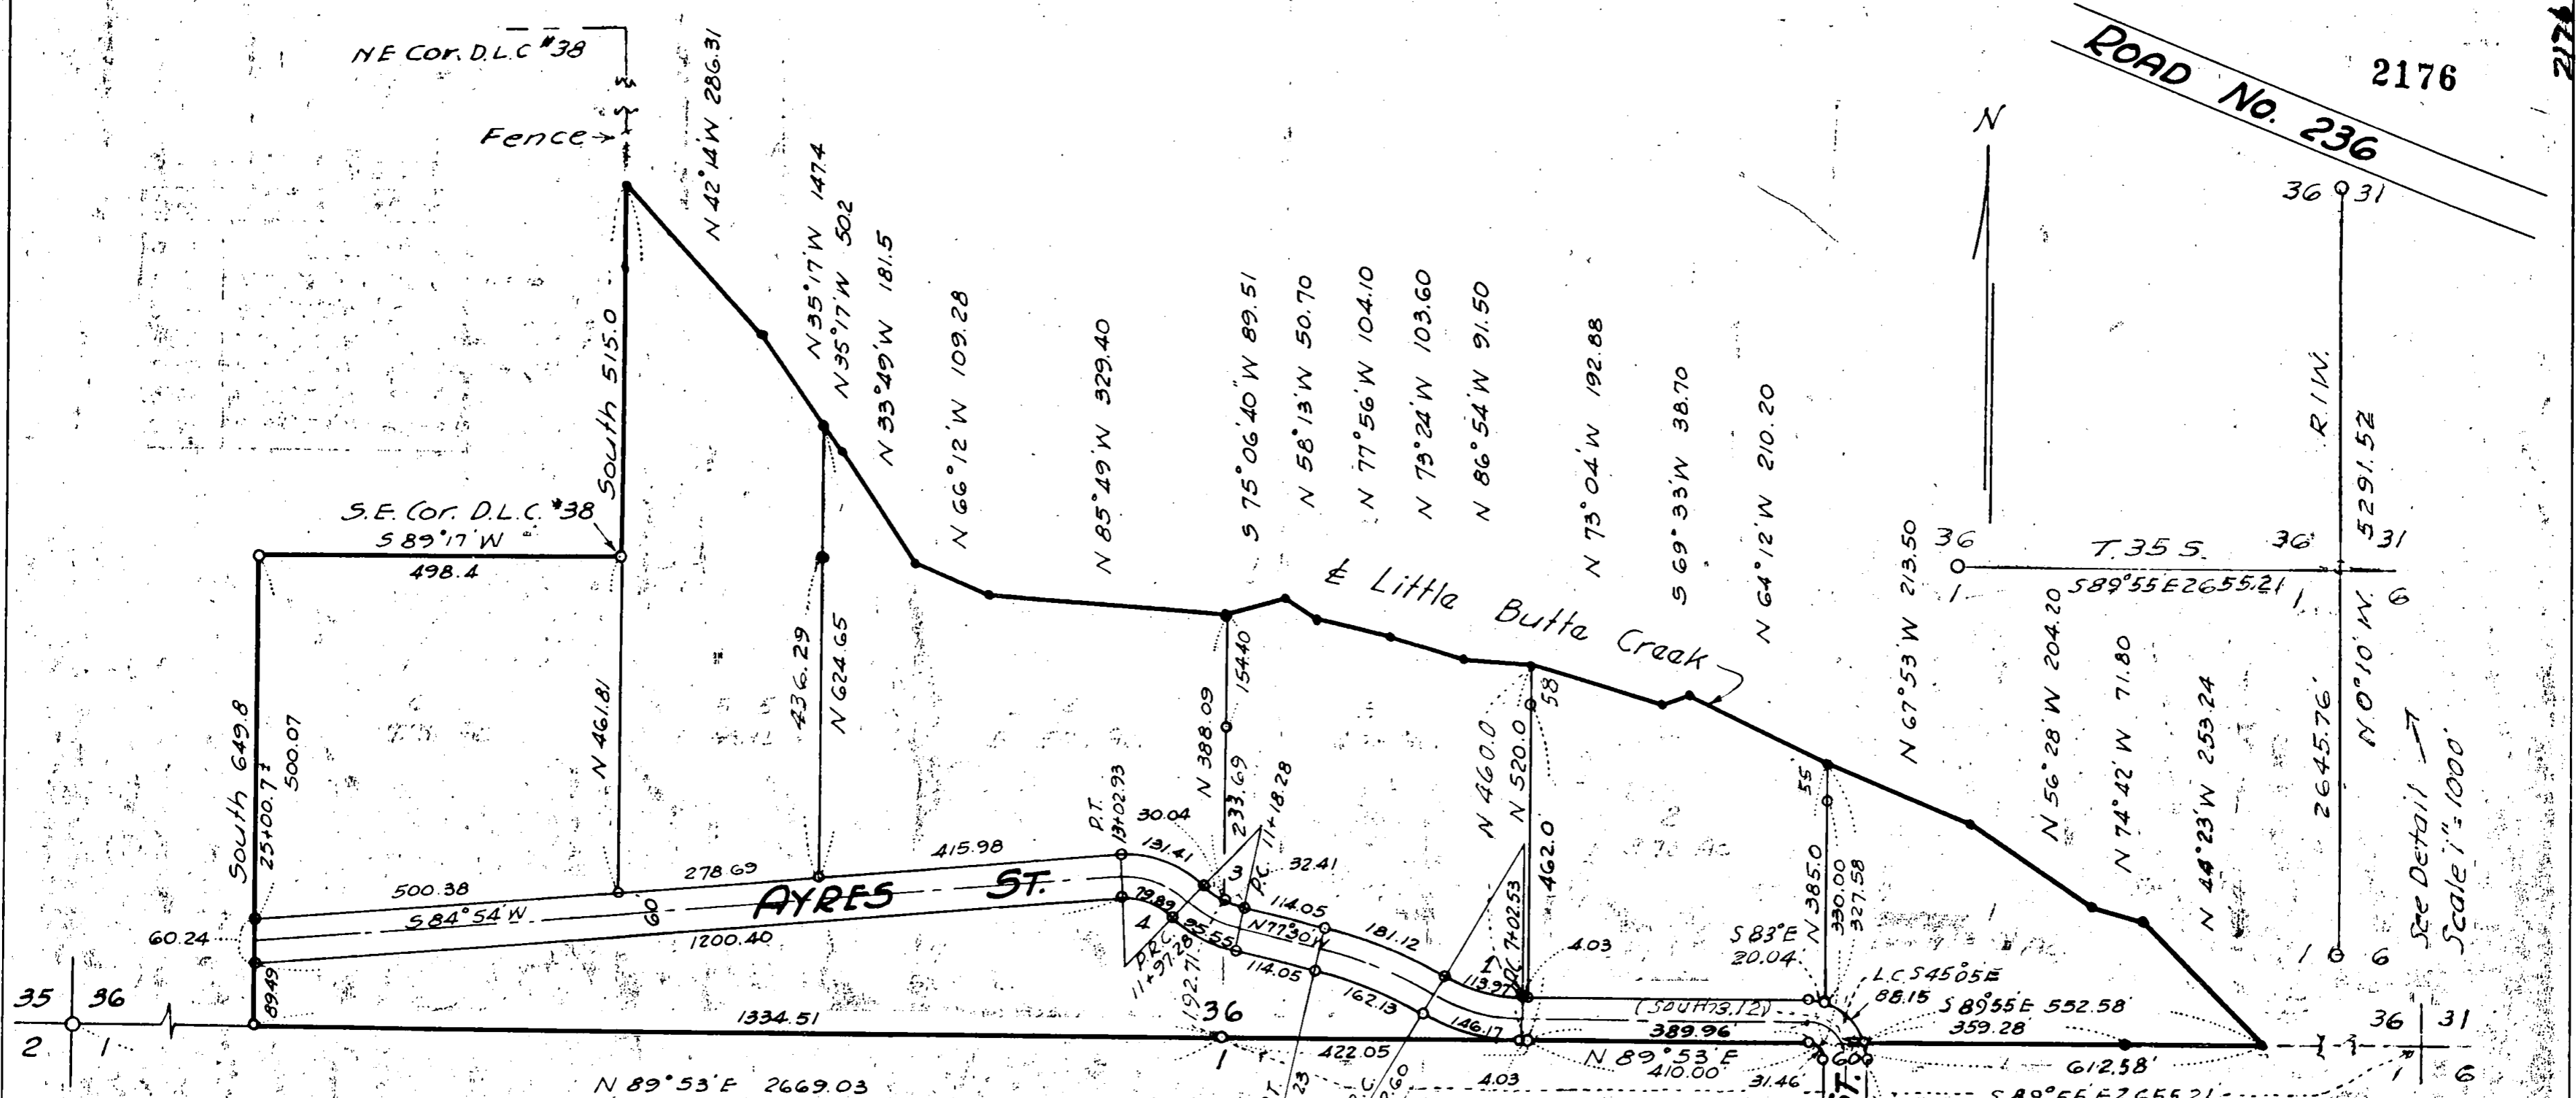
Curve No. 4 Δ = 49°12' D = 46°34' R = 123.03 T = 56.33 L = 105.65	Curve No. 3 Δ = 31°36' D = 40° R = 143.24 T = 40.53 L = 79.00	Curve No. 2 Δ = 18°08' D = 10°34' R = 542.29 T = 86.55 L = 171.63	Curve No. 1 Δ = 30°45' D = 23°38½' R = 242.35 T = 66.64 L = 130.07
--	--	--	---

o Set 1/2" Iron pipe

Δ = 90°07'  
R = 50  
T = 50.1  
L = 78.64  
P.C. 2+29.1  
P.T. 3+08.5

Scale: 1"=200'

From the center line of Little Butte Creek, above mentioned, I moved the point South 4.95 feet and meandered downstream; thence along said center line, on courses and distances shown on the accompanying map to a point on the East line of D.L.C. No. 38; from the Southeast corner of D.L.C. 38 I ran North falling in a fence line, running North from Little Butte Creek between Kunkel and Daly properties I continued North, following distances and searching for reference points as listed in County Surveyor records. The P.I. at curve on Lake Creek Road was not found. This road shows evidence of extensive remodeling since 1936 which is the date of notes. The recorded position of Northeast corner of the D.L.C. 38, is now an open pasture, the orchard having been grubbed out about 1936 or 1937, according to Dr. Dixon owner, and Mr. Daily. A diligent search was made for the recorded 1 in. I.P. with Dip Needle. Nothing was found. Also searched for Iron Rod recorded as in North and South fence line which pin bears S.89°E. 360 feet. All evidence of fence line has disappeared. Pin could not be located.
