MAP OF SURVEY

Located in
 Township 35 South, Range 1 West
 Southeast Quarter of Section 6
 Jackson County, Oregon

T35S. R1W. Sec 6, Tax Lot 300

SURVEY NARRATIVE TO COMPLY WITH PARAGRAPH 209.250
OREGON REVISED STATUTES

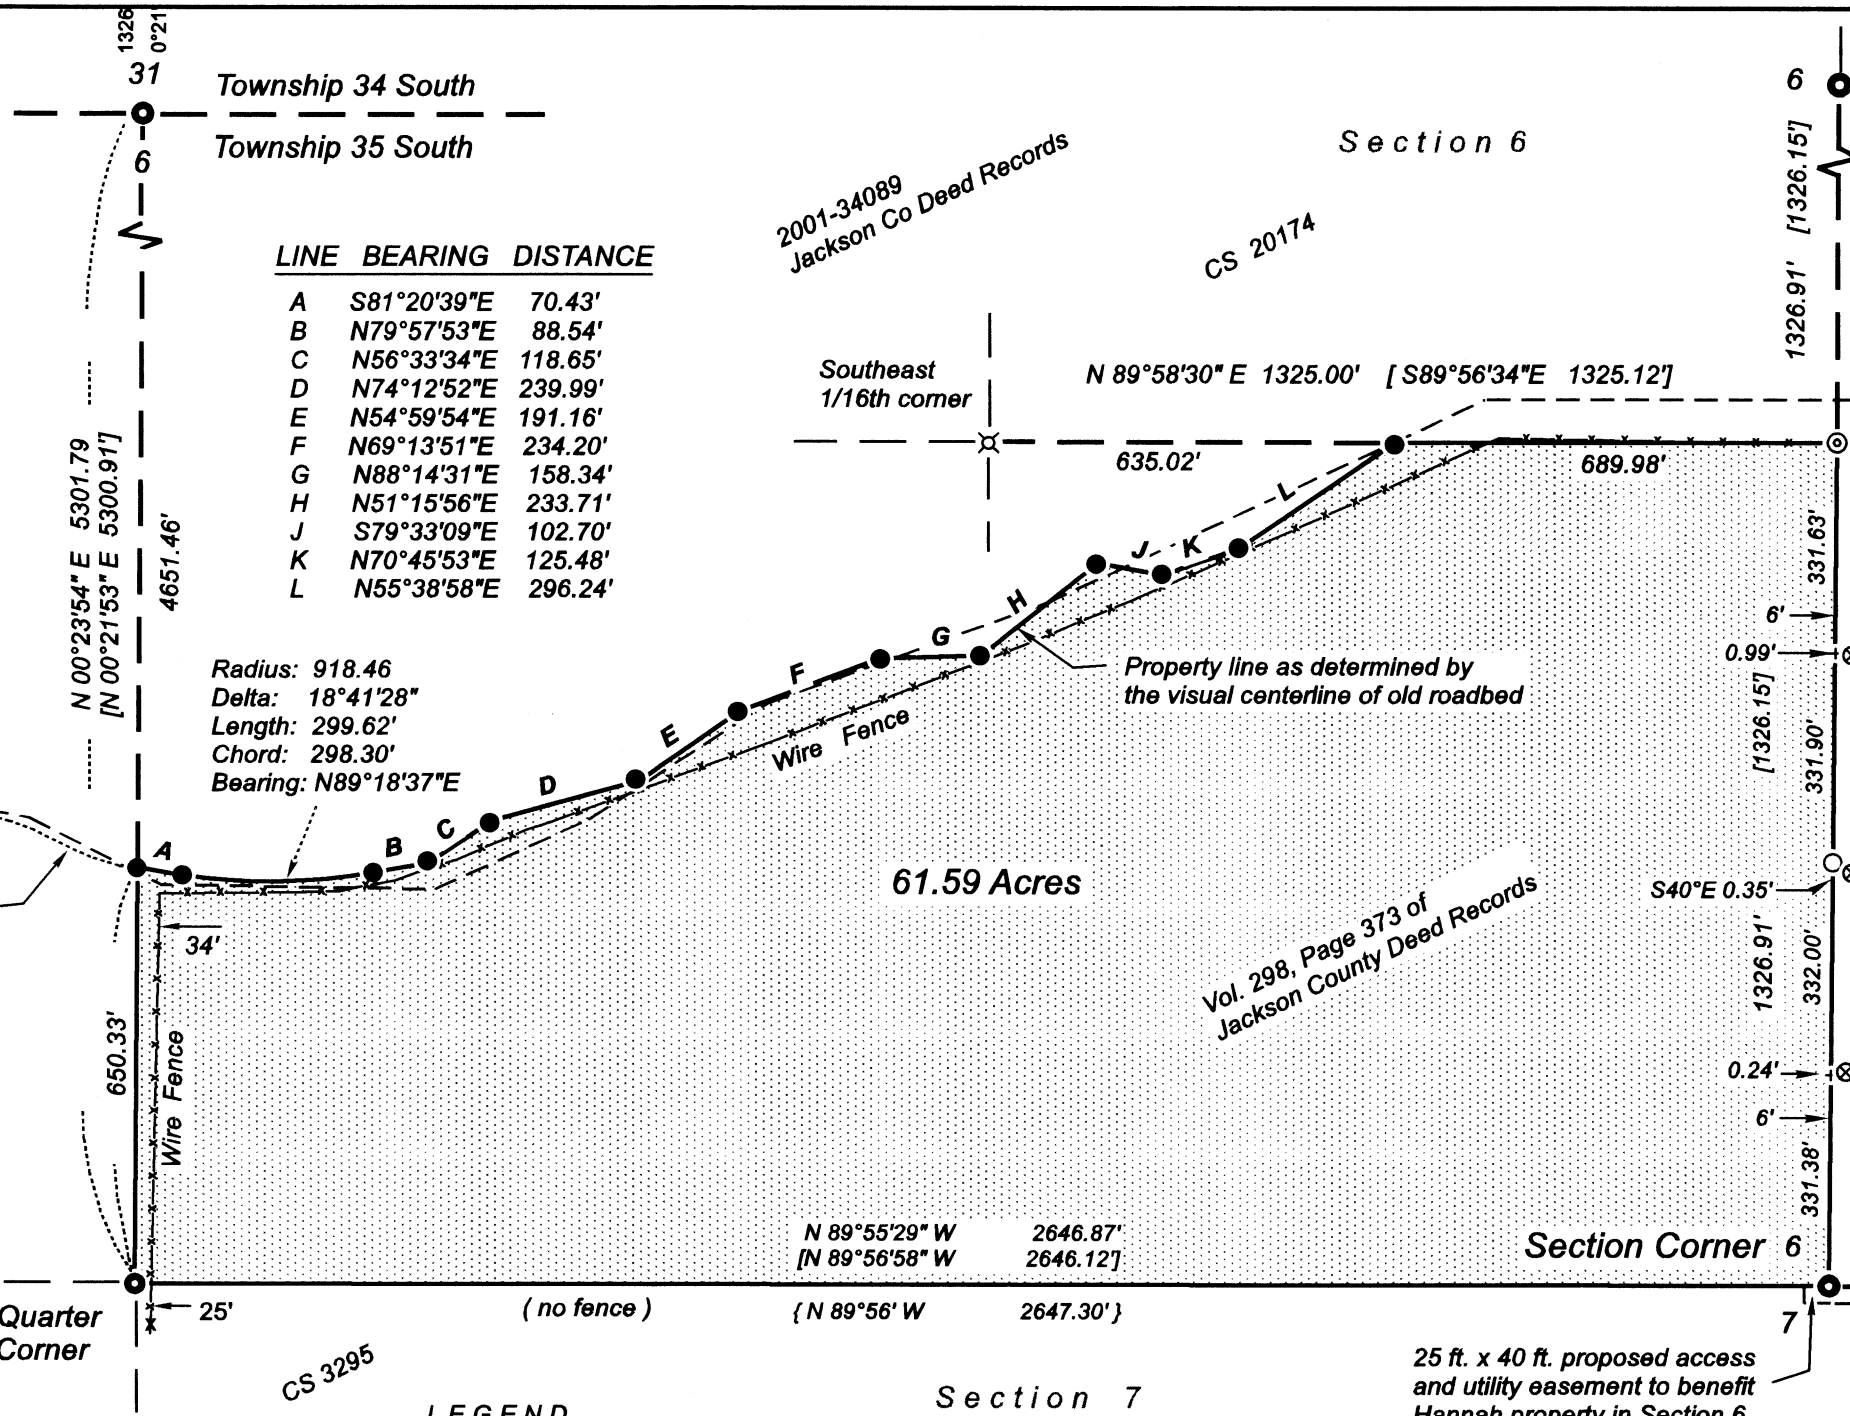
LINE	BEARING	DISTANCE
A	S81°20'39"E	70.43'
B	N79°57'53"E	88.54'
C	N56°33'34"E	118.65'
D	N74°12'52"E	239.99'
E	N54°59'54"E	191.16'
F	N69°13'51"E	234.20'
G	N88°14'31"E	158.34'
H	N51°15'56"E	233.71'
J	S79°33'09"E	102.70'
K	N70°45'53"E	125.48'
L	N55°38'58"E	296.24'

Radius: 918.46
 Delta: 18°41'28"
 Length: 299.62'
 Chord: 298.30'
 Bearing: N89°18'37"E

Debeneger Gap Road survey as described in Road Petition, Jackson Co. Road Records Vol 3 Page 324, dated 1906

Current road centerline

61.59 Acres

Basis of Bearing: CS 3295.
 along the north line of Section 8

The brass cap on a pipe monument at the One Quarter corner between Section 6 and Section 7 is possibly not in it's original location. The pipe was found exposed 18 inches, with the cap facing south rather than the customary cap facing north. A "T" steel fence post was driven along the west side of the cap, and a wire wrapped around both the post and the pipe to stabilize the pipe. The monument is at the top of the slope on the west side of a 2 ft. deep drainage ditch, course north to south. It's possible that the monument was dislodged during the digging of the drainage ditch.

Using the monument as found, the northeast bearing tree, a 31 inch diameter ponderosa pine, bears N 49°44'E 307.3 ft to face of upper healed blaze (original 1965 record = 22 inch dia., N 49°48' E 307.7 ft. to face of upper blaze). The southeast bearing tree, a 12 inch diameter white oak, bears S 68°14' East 458.2 ft. to the face of the healed upper blaze (original 1965 record = 9 inch diameter, S 68°11' E 458.8 ft. to the face of the upper blaze).

The measured angle between the two bearing trees was 62°02', compared with the record of 62°01'. Due to the new measurements comparing very well with the record, I accepted the found location of the monument. I then lowered the pipe so that the cap is now exposed 8 inches above ground level. Both bearing trees are in good condition.

At the quarter corner between Section 5 and Section 6, the brass cap and 1 inch diameter galvanized iron pipe monument was found to have been disturbed from it's original position. The cap was found still fastened firmly to the pipe, but cap and pipe were leaning southeasterly out of plumb. Digging down alongside the pipe, I determined that the pipe was not bent. It became obvious after exposing the entire 36 inch length of the pipe that it was leaning 52° to the south-southeast as if it was pushed over. I stood the pipe and cap upright, set the instrument over it, and checked the measurements to the two bearing trees. After making adjustments in the pipe and cap position, I felt that I finally had a good position for

The west boundary of the subject property was determined by the north-south centerline of Section 6. The brass cap and pipe at the north 1/4 corner of Section 6 was located and measured to. The monument is in a mound of stone, about 6 ft. north of an east-west all terrain vehicle roadway. The two bearing trees in the southeast quadrant were found in good condition. The stump remains of the original white oak northeast bearing tree was located. A northeast bearing tree, a 10 inch cedar with scribing visible, is dead and down. No measurements were taken to the bearing trees.
