SURVEY NARRATIVE TO COMPLY WITH O.R.S. 209.250 REVISED BY CHAPTER 555, O.L. 1963

To monument and describe by metes and bounds, 13 tracts located in the Southeast quarter of the Southwest quarter and Government Lot 4 in Section 30, and Government Lot 1 in Section 31, Township 36 South, Range 2 West, Willamette Meridian.

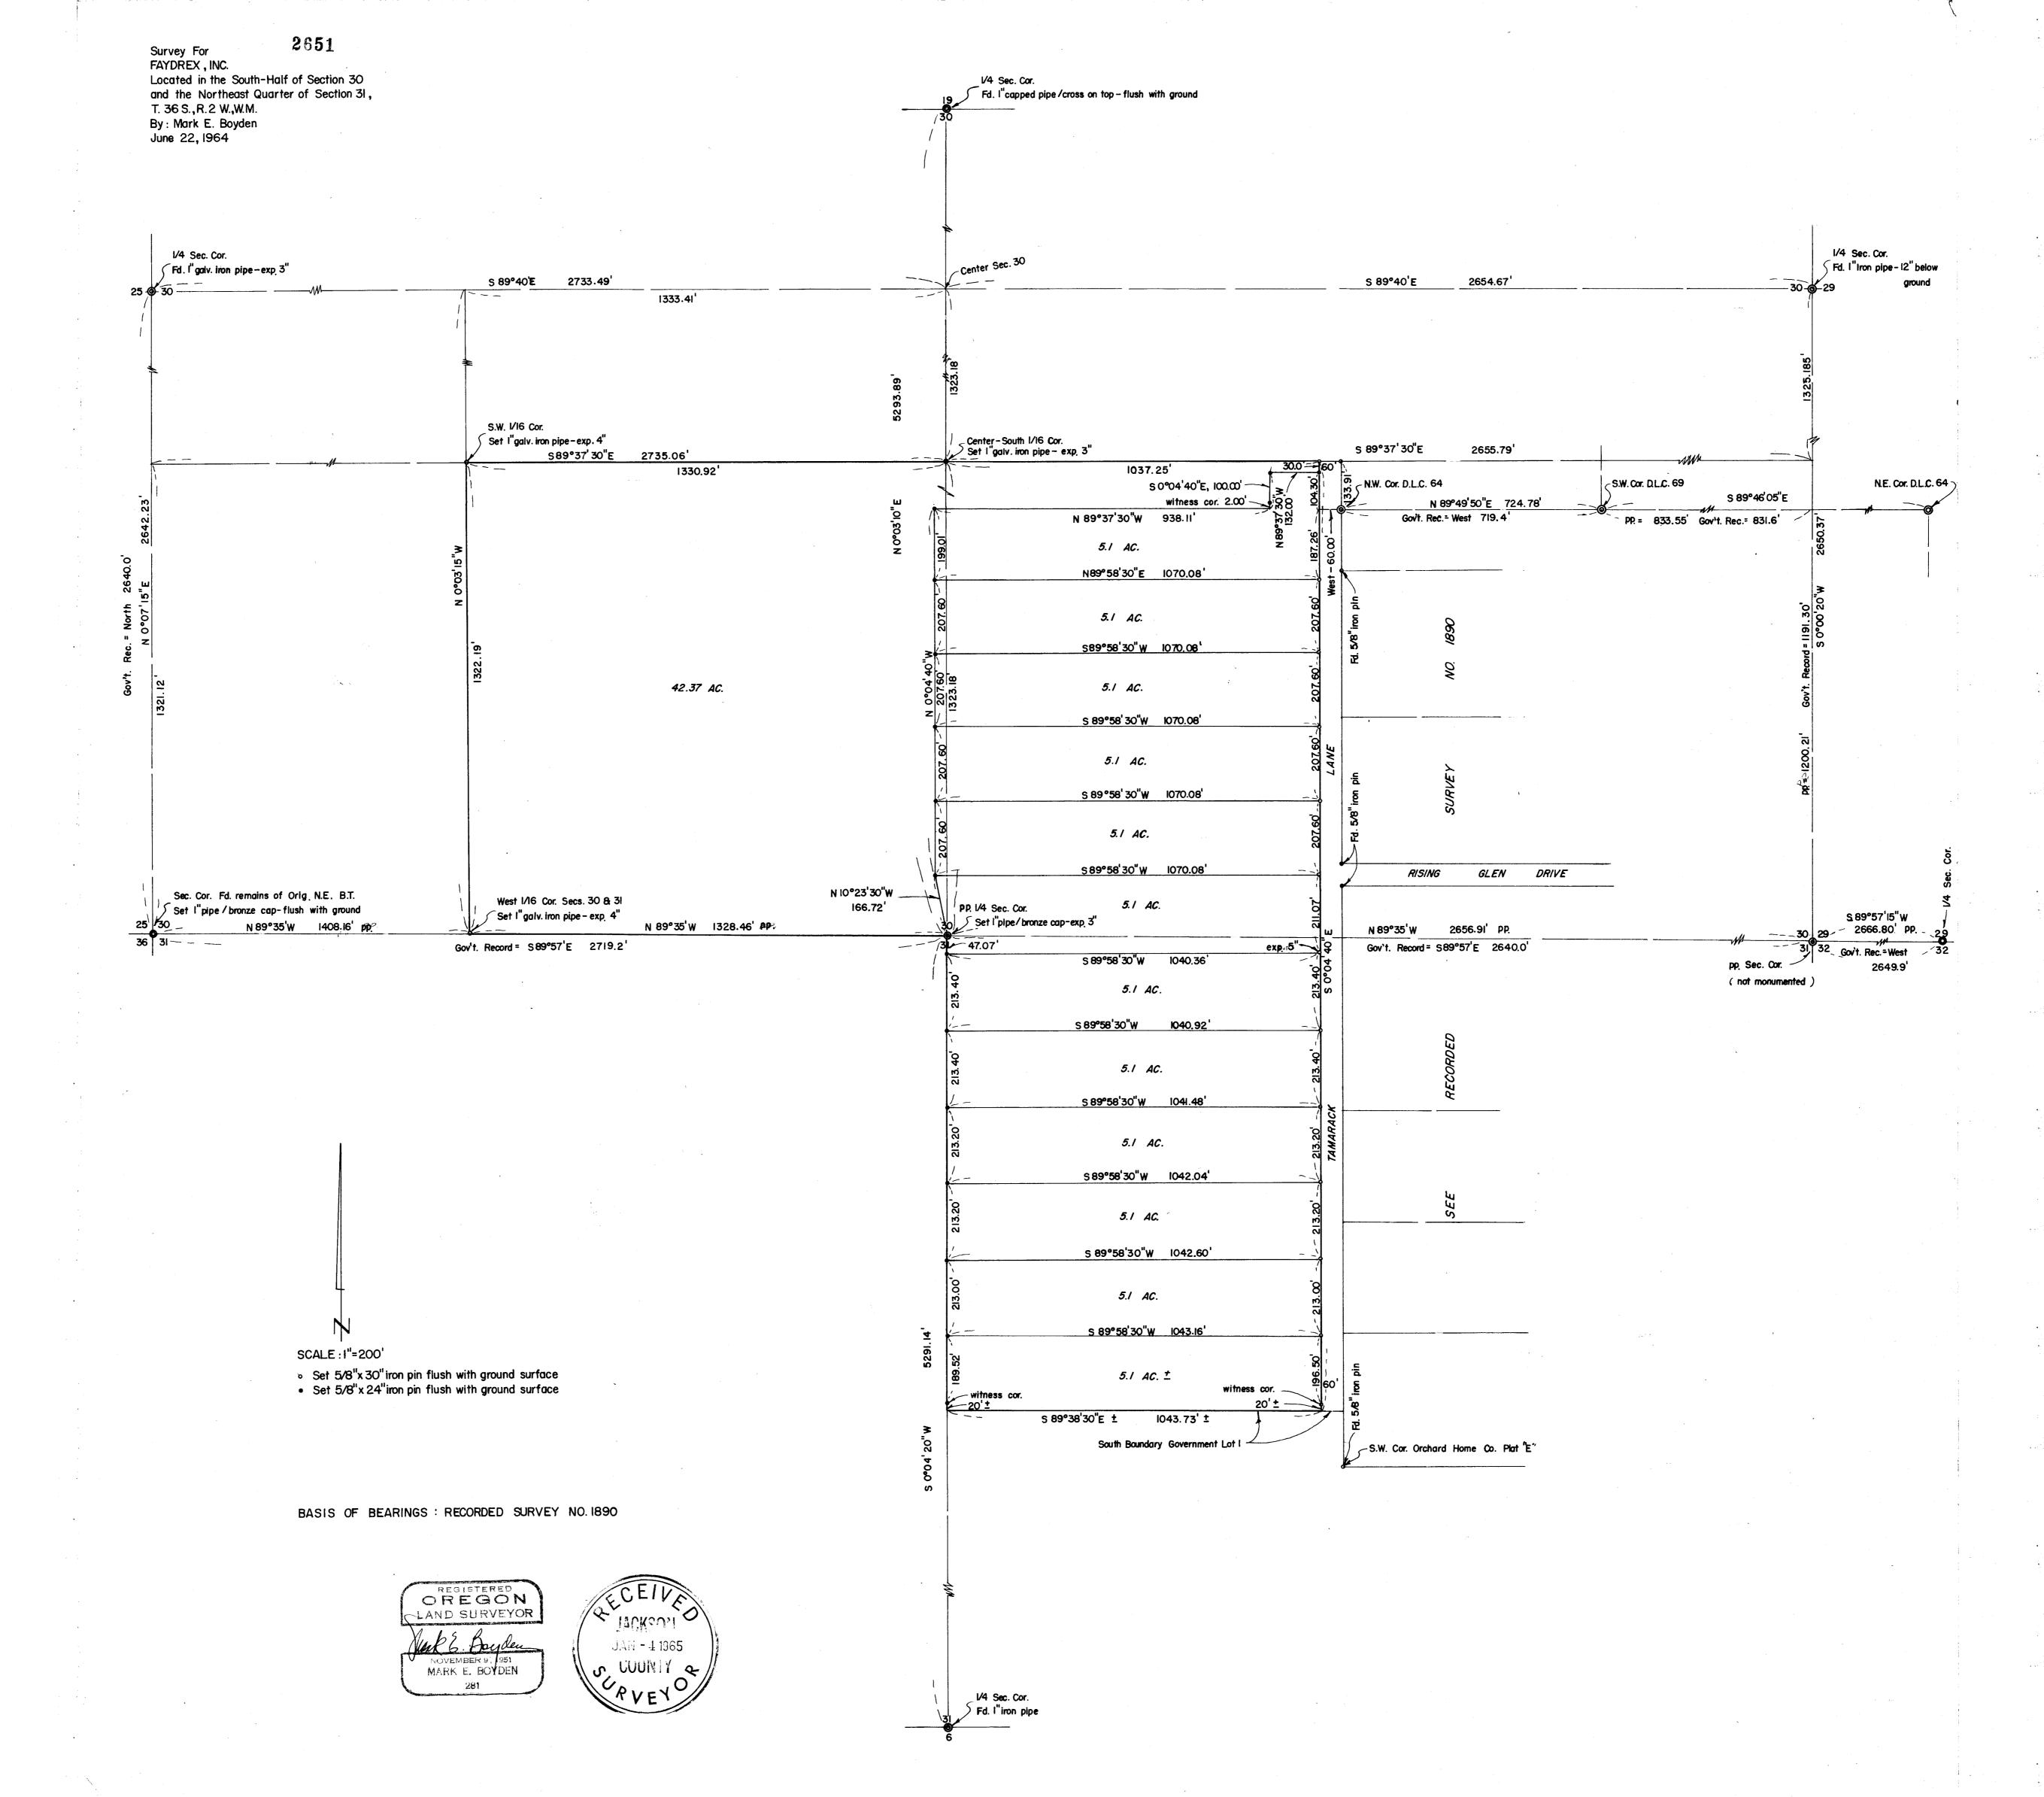
From controls previously established on Recorded Survey No. 1890, ran transit-chain closed-loop traverses around the subject property. Also made side ties to corners previously re-established by the County Surveyor, namely the South quarter corner of Section 31, the East, North and West quarter corners of Section 30, where the corner monuments were found in place.
