BOUNDARY SURVEY OF PROPERTY  
( LINES OF POSSESSION )

LOCATED IN  
DONATION LAND CLAIM  
44  
PORTION OF N 1/2 NW 1/4 & N 1/2 NW 1/4 NE 1/4  
SECTION 29 T. 38 S., R. 1 E., W. M.  
JACKSON COUNTY OREGON

FOR  
JACK D. KIELING

SURVEY NARRATIVE TO COMPLY WITH PARAGRAPH 209.250

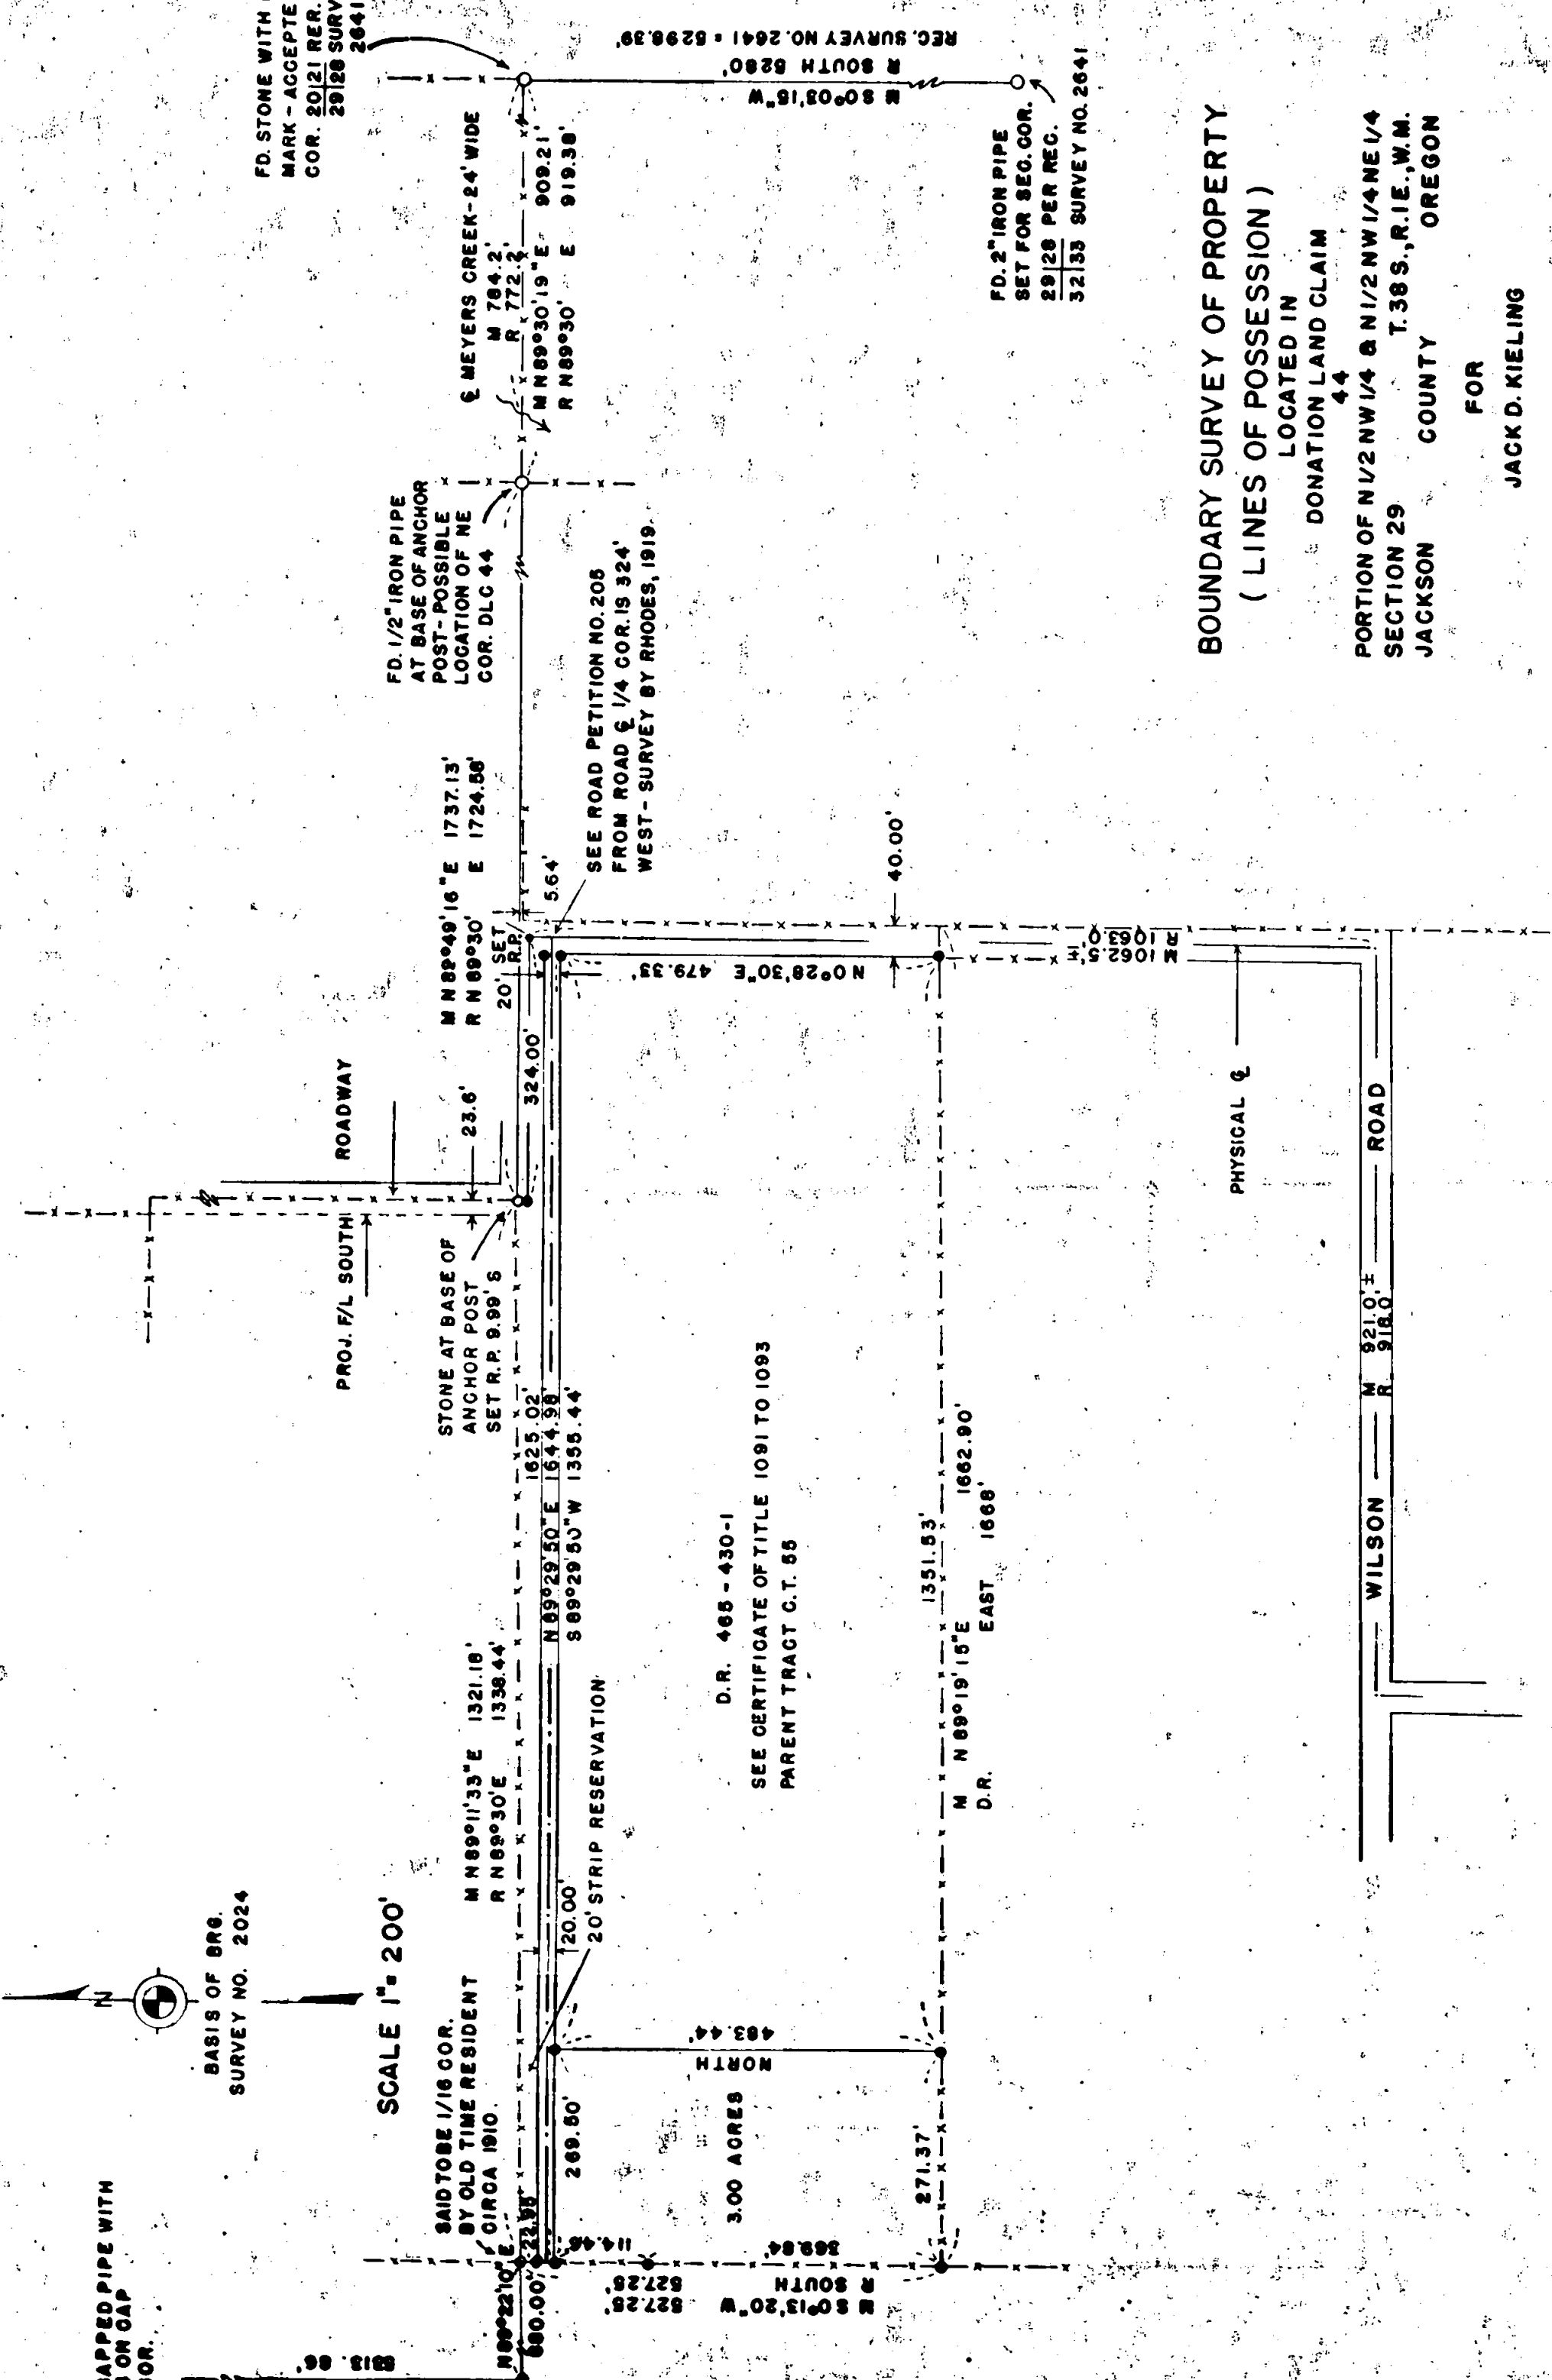
FD. 1" CAPPED PIPE WITH  
CROSS ON GAP  
SEC. COR.

SAID TO BE 1/16 COR.  
BY OLD TIME RESIDENT  
CIRCA 1910.

STONE AT BASE OF  
ANCHOR POST  
SET R.P. 9.99' S

FD. 1/2" IRON PIPE  
AT BASE OF ANCHOR  
POST-POSSIBLE  
LOCATION OF NE  
COR. DLC 44

FD. STONE WITH PUNCH  
MARK - ACCEPTED SEC.  
COR. 2021 REC. REC.  
COR. 20128 SURVEY NO.  
2641

FD. 2" IRON PIPE  
SET FOR SEC. COR.  
29/28 PER REC.  
32135 SURVEY NO. 2641

From pins set previously during the course of recorded survey 2541, I ran East closing on the points shown. Differences between measurement to those of record are indicated on the attached plat.

NE corner Section 29: Two residents testified that the true corner position falls "some 10 feet East" of the fence corner shown. One resident recalled that at one time an iron pipe existed as a corner monument which was used as a control point for flight photos used in the preparation of U.S.G.S. quadrangle maps.

NE corner of D.L.C. 44: Pipe said to have been set by Ager, but not necessarily represented to be the corner point. Location of this pipe is at the intersection of a wire fence said to have rebuilt in the original location of an old rail fence. Coordination through recorded survey No. 2641 was found to be in harmony with the location of this pipe.

N 1/4 corner Section 29: One resident whose knowledge extends back to circa 1920 states that "the fence projection South from the jog to the West up the fence some 1320 feet should hit an iron pipe he set some 10 feet South of the E-W fence line, said pipe having been set record bearing and distance from an old oak with surveyors marks on it". Another resident states that the corner location falls some feet East of the fence intersection. One resident whose knowledge extends back to 1908 remembered the bearing tree to the West. He also stated with conviction that the corner point was south of the E-W fence line, but uncertain as to direction East or West. The physical location of Wilson Road fits Rhode's survey of 1919 holding a point approximately 10 feet South of the fence intersection shown. A 5/8" iron pin was placed there as a reference point only.
