1/4 COR RS583 SURVEY NARRATIVE TO COMPLY WITH O.R.S. 209.250, REVISED BY CHAPTER 555, O. L. 1963

FOR - ELK LUMBER COMPANY
P. O. BOX 606, MEDFORD, OREGON

- 1. To reestablish the quarter section corner common to Sections 20 and 29, Township 32 South, Range 1 East, Willamette Meridian.
- 2. To determine and mark the true section line between the above mentioned Sections 20 and 29, T32S, R1E.

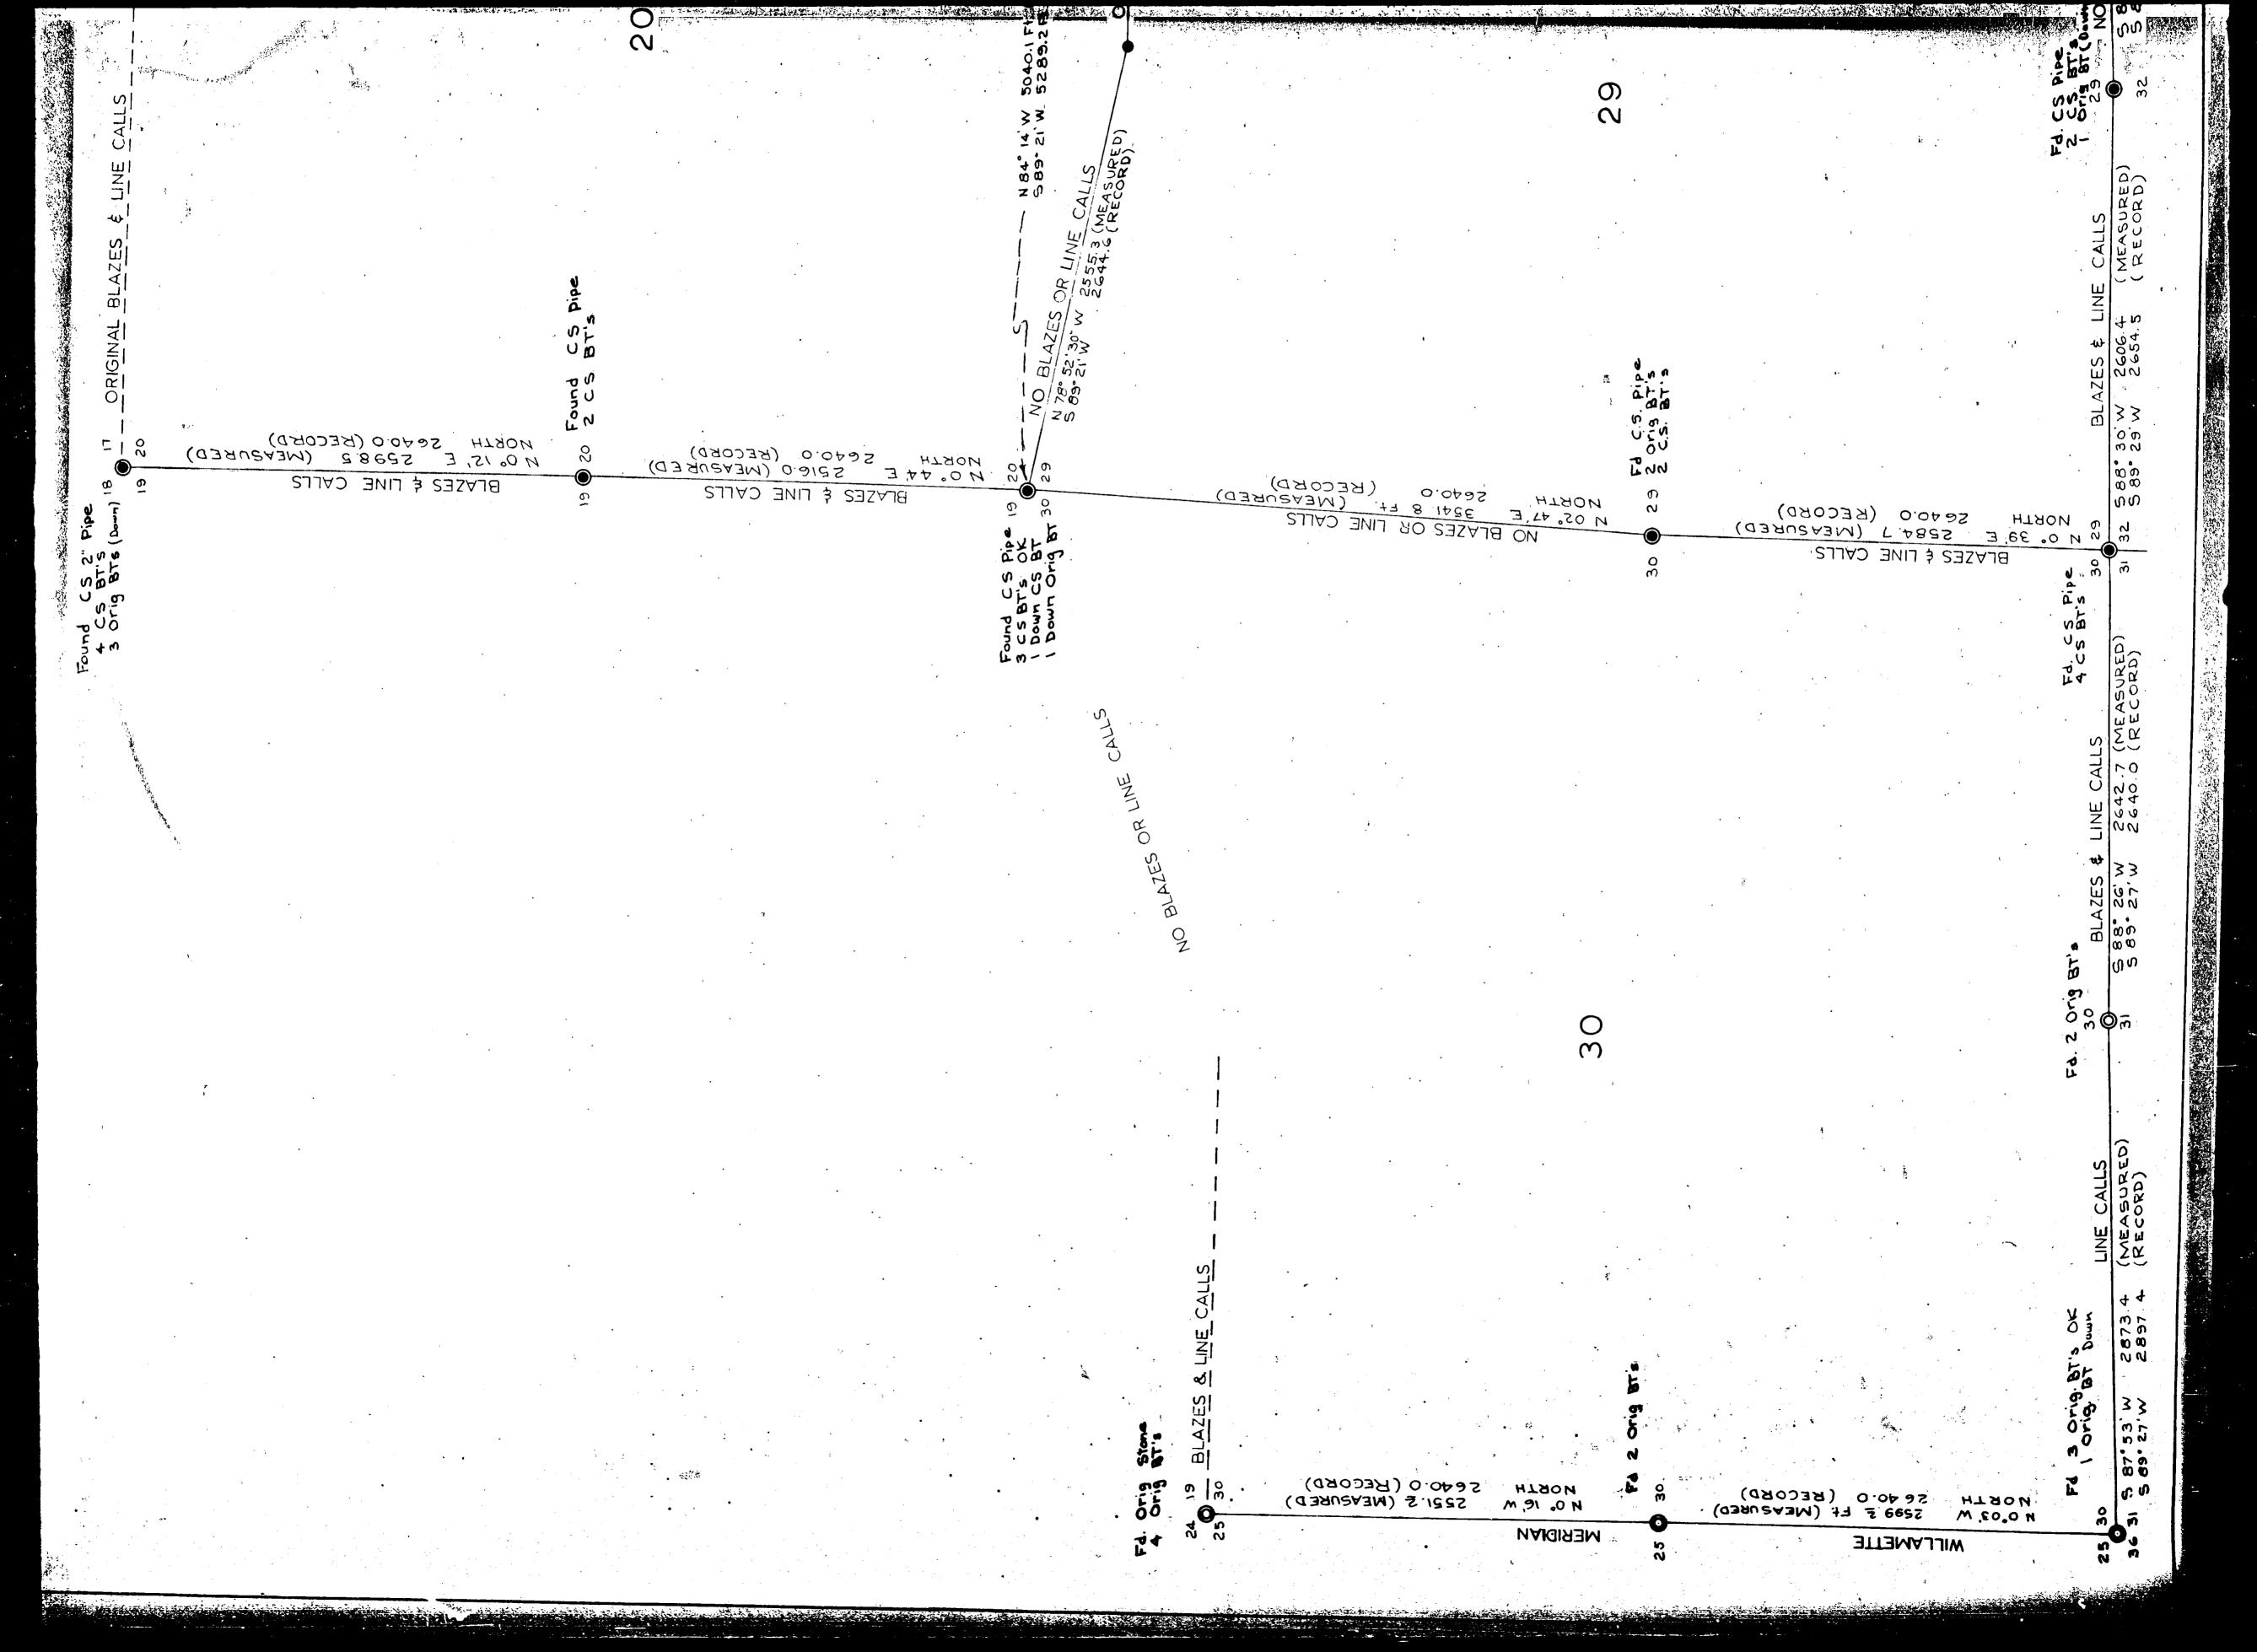
- 5. Used data from previous surveys by our crews and made additional surveys to complete a closed transit and tape traverse around Section 29, finding the length of the north half of the section line between Sections 30 and 29 to be 901.8 feet greater than the record distance. Other pertinent information from these surveys is shown on the map which is a part of this report.

- 5. Used data from previous surveys by our crews and made additional surveys to complete a closed transit and tape traverse around Section 29, finding the length of the north half of the section line between Sections 30 and 29 to be 901.8 feet greater than the record distance. Other pertinent information from these surveys is shown on the map which is a part of this report.
