SURVEY IN THE W 1/2 SECTION 24
T. 38 S., R. 1 W., W. M.
JACKSON COUNTY, OREGON
FOR
RON PITTS
SCALE 1" = 400'

SURVEY BY
CHARLES H. HURST
MEDFORD, OREGON
DATE
JUN 1 1966

Purpose : Line of occupation survey of the tract shown

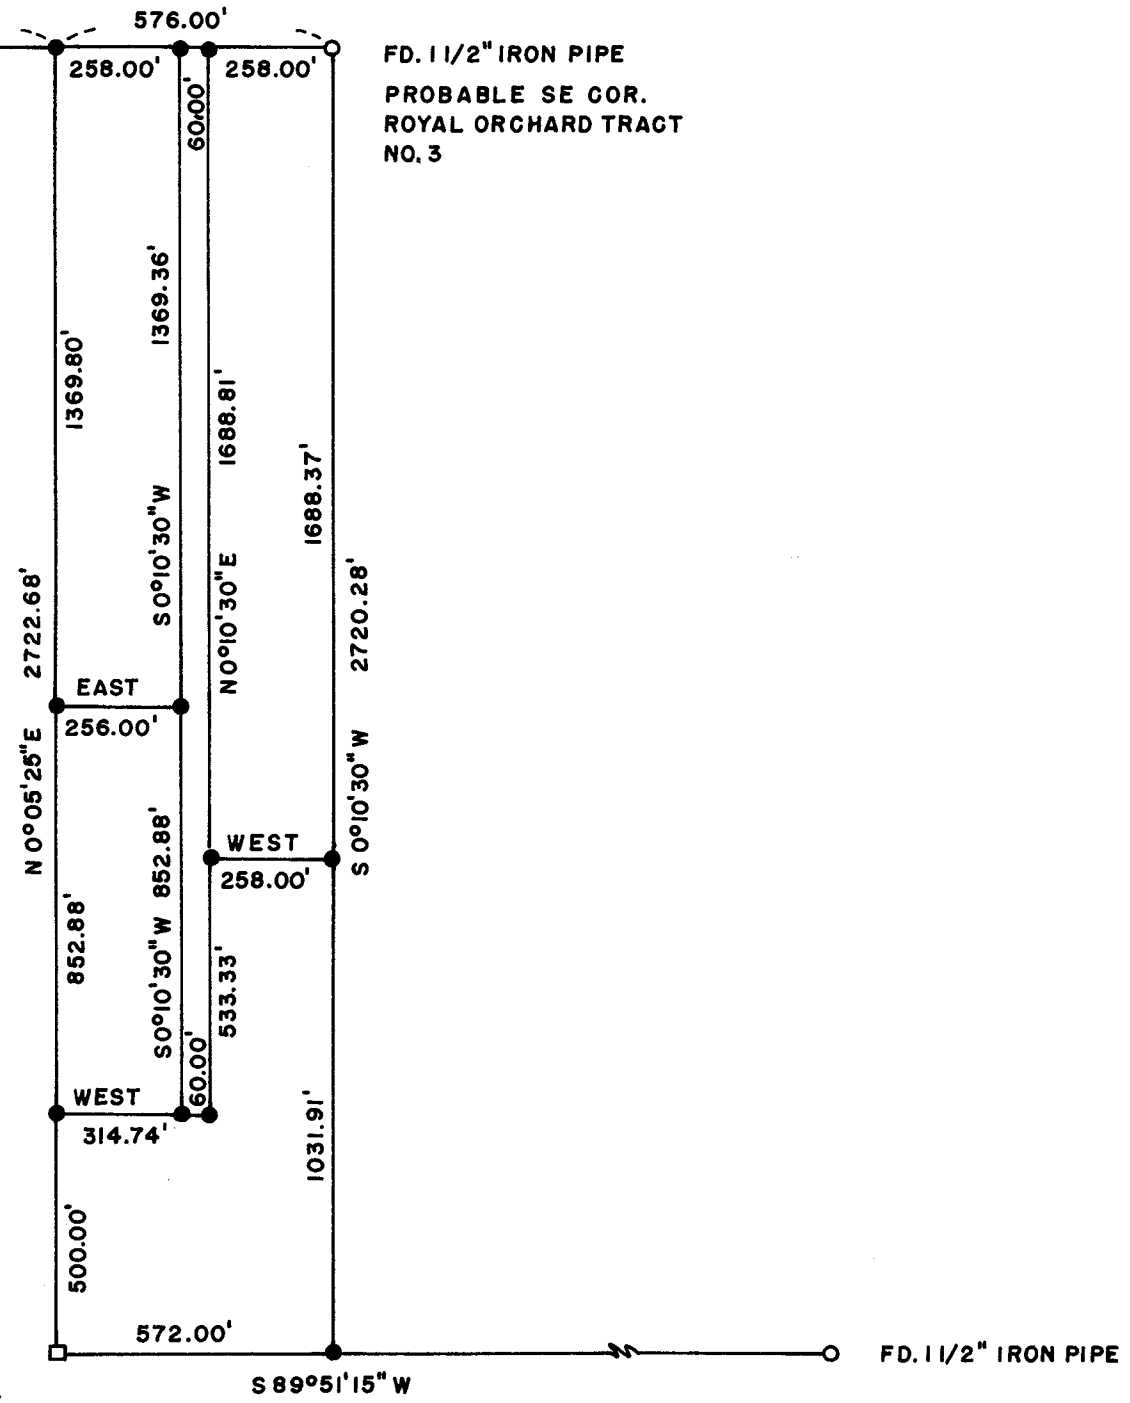
Bearing : Based on solar observation at the southwest corner of the tract shown taken May 23, 1966

This survey is essentially a line of occupation survey which tends to agree with old survey monuments found.

Deed record was held for both the north and south boundaries of the master tract.

Examination of old survey records indicate that Section 24 was relotted following the abandonment of DLC 76. The tract deed, however, appears to indicate that the east boundary of Government Lots 2 and 4 are coincident with the west boundary of abandoned DLC 76 or that the latter closely approximates relotted lines.

A 1½" galvanized iron pipe falling easterly from the southeast corner of the tract was held for line inasmuch as said line coincides with an old fence location. It was originally thought that said pipe represented the northeast corner of DLC 70. However, the triangulation distance returned was inconclusive in view of inconsistencies shown on the official township plat.

The 1½" iron pipe held for the northeast corner of the tract is suspected to be the southeast corner of Royal Orchard Tract No. 3 and identified on said plat as the southeast corner of DLC 80. Measurement from the southwest corner of DLC 80 to said pipe agrees with the official plat within 4 feet.

The unindorsed survey monuments found, inconsistencies in official records, and the general lack of adequate survey control preclude the accurate re-establishment of sidelines involved. This has been discussed with the client who is aware, under the circumstances, that the establishment of agreement lines, in lieu of an extensive survey, is in order. This procedure is strongly recommended.
