SURVEY FOR  
 HARRY E. RASMUSSEN, CENTRAL POINT, ORE.  
 LOCATION

D.L.C. #72 & SESE SEC. 25, T. 38S., R. 1W., W.M.

SURVEY NARRATIVE TO COMPLY WITH ORS 209.250

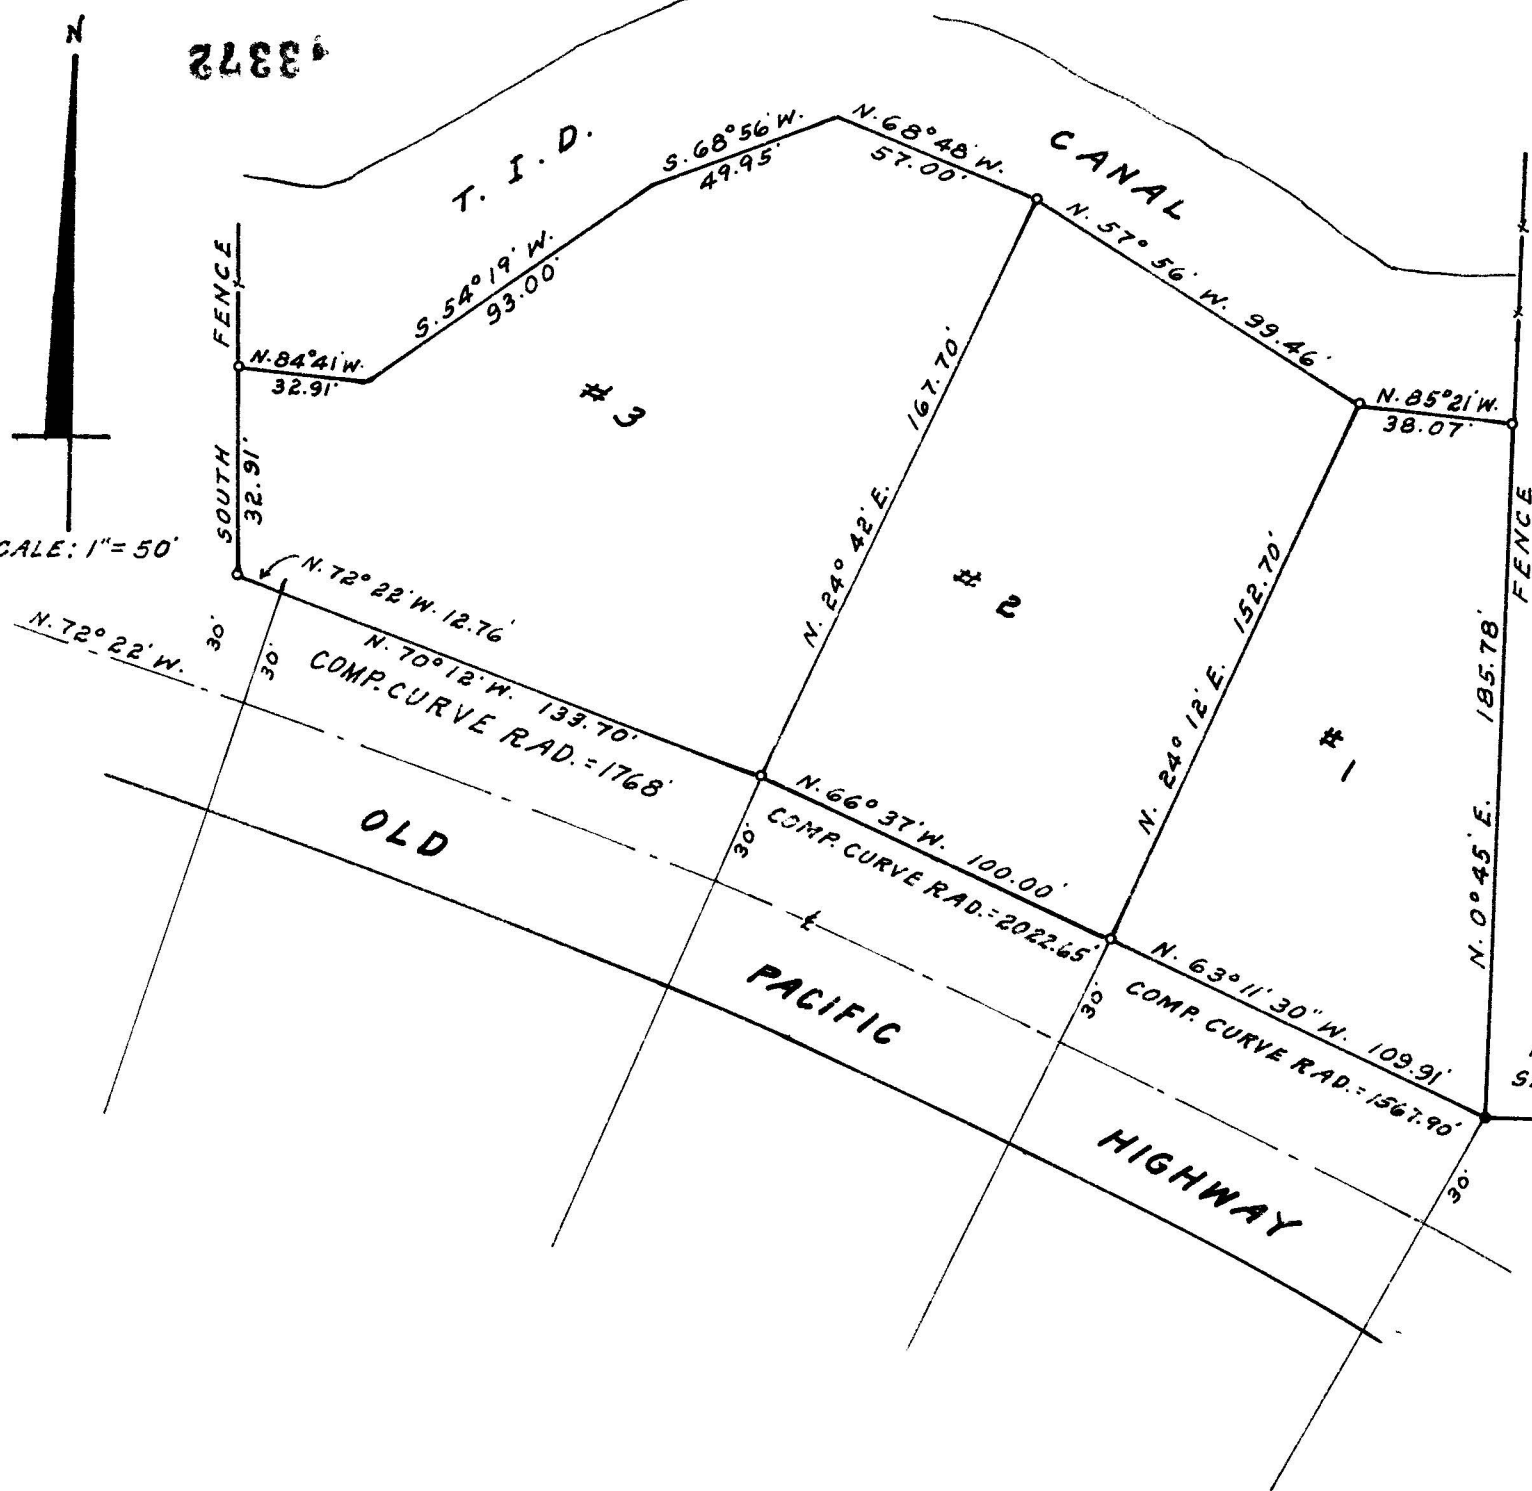
● = MONUMENTS FOUND AS DESCRIBED  
 ○ = 1/2" + 24" IRON RODS SET FLUSH  
 BEARING DATUM: SOLAR OBSERVATION

NOTE: P/L ON ROAD R/W TAKEN FROM EXISTING ROAD PAVEMENT &

PROCEDURE: The property description is tied to the SE corner of D.L.C. # 41. I ran a traverse from this corner to an iron pipe found on a N-S fence line on Northerly side of the old highway 99 this pipe being recognized as the corner between two properties. The traverse run for verification of descriptive position. The property subdivided according to the bearings and distances shown on accompanying map. Corner monuments set as indicated. Solar taken Monday, February 20th, 2:30 P.M. P.S.T.
