SURVEY FOR CLAYTON J. WOODWARD
SECTION 29, T.38 S., R. 3 W., W M.
Jackson County, Oregon
February, 1967

Verlyn Thomas, Professional Land Surveyor
Talent, Oregon

SURVEY NARRATIVE TO COMPLY WITH O.R.S. 209.250 REVISED BY CHAPTER 555, O.L. 1963

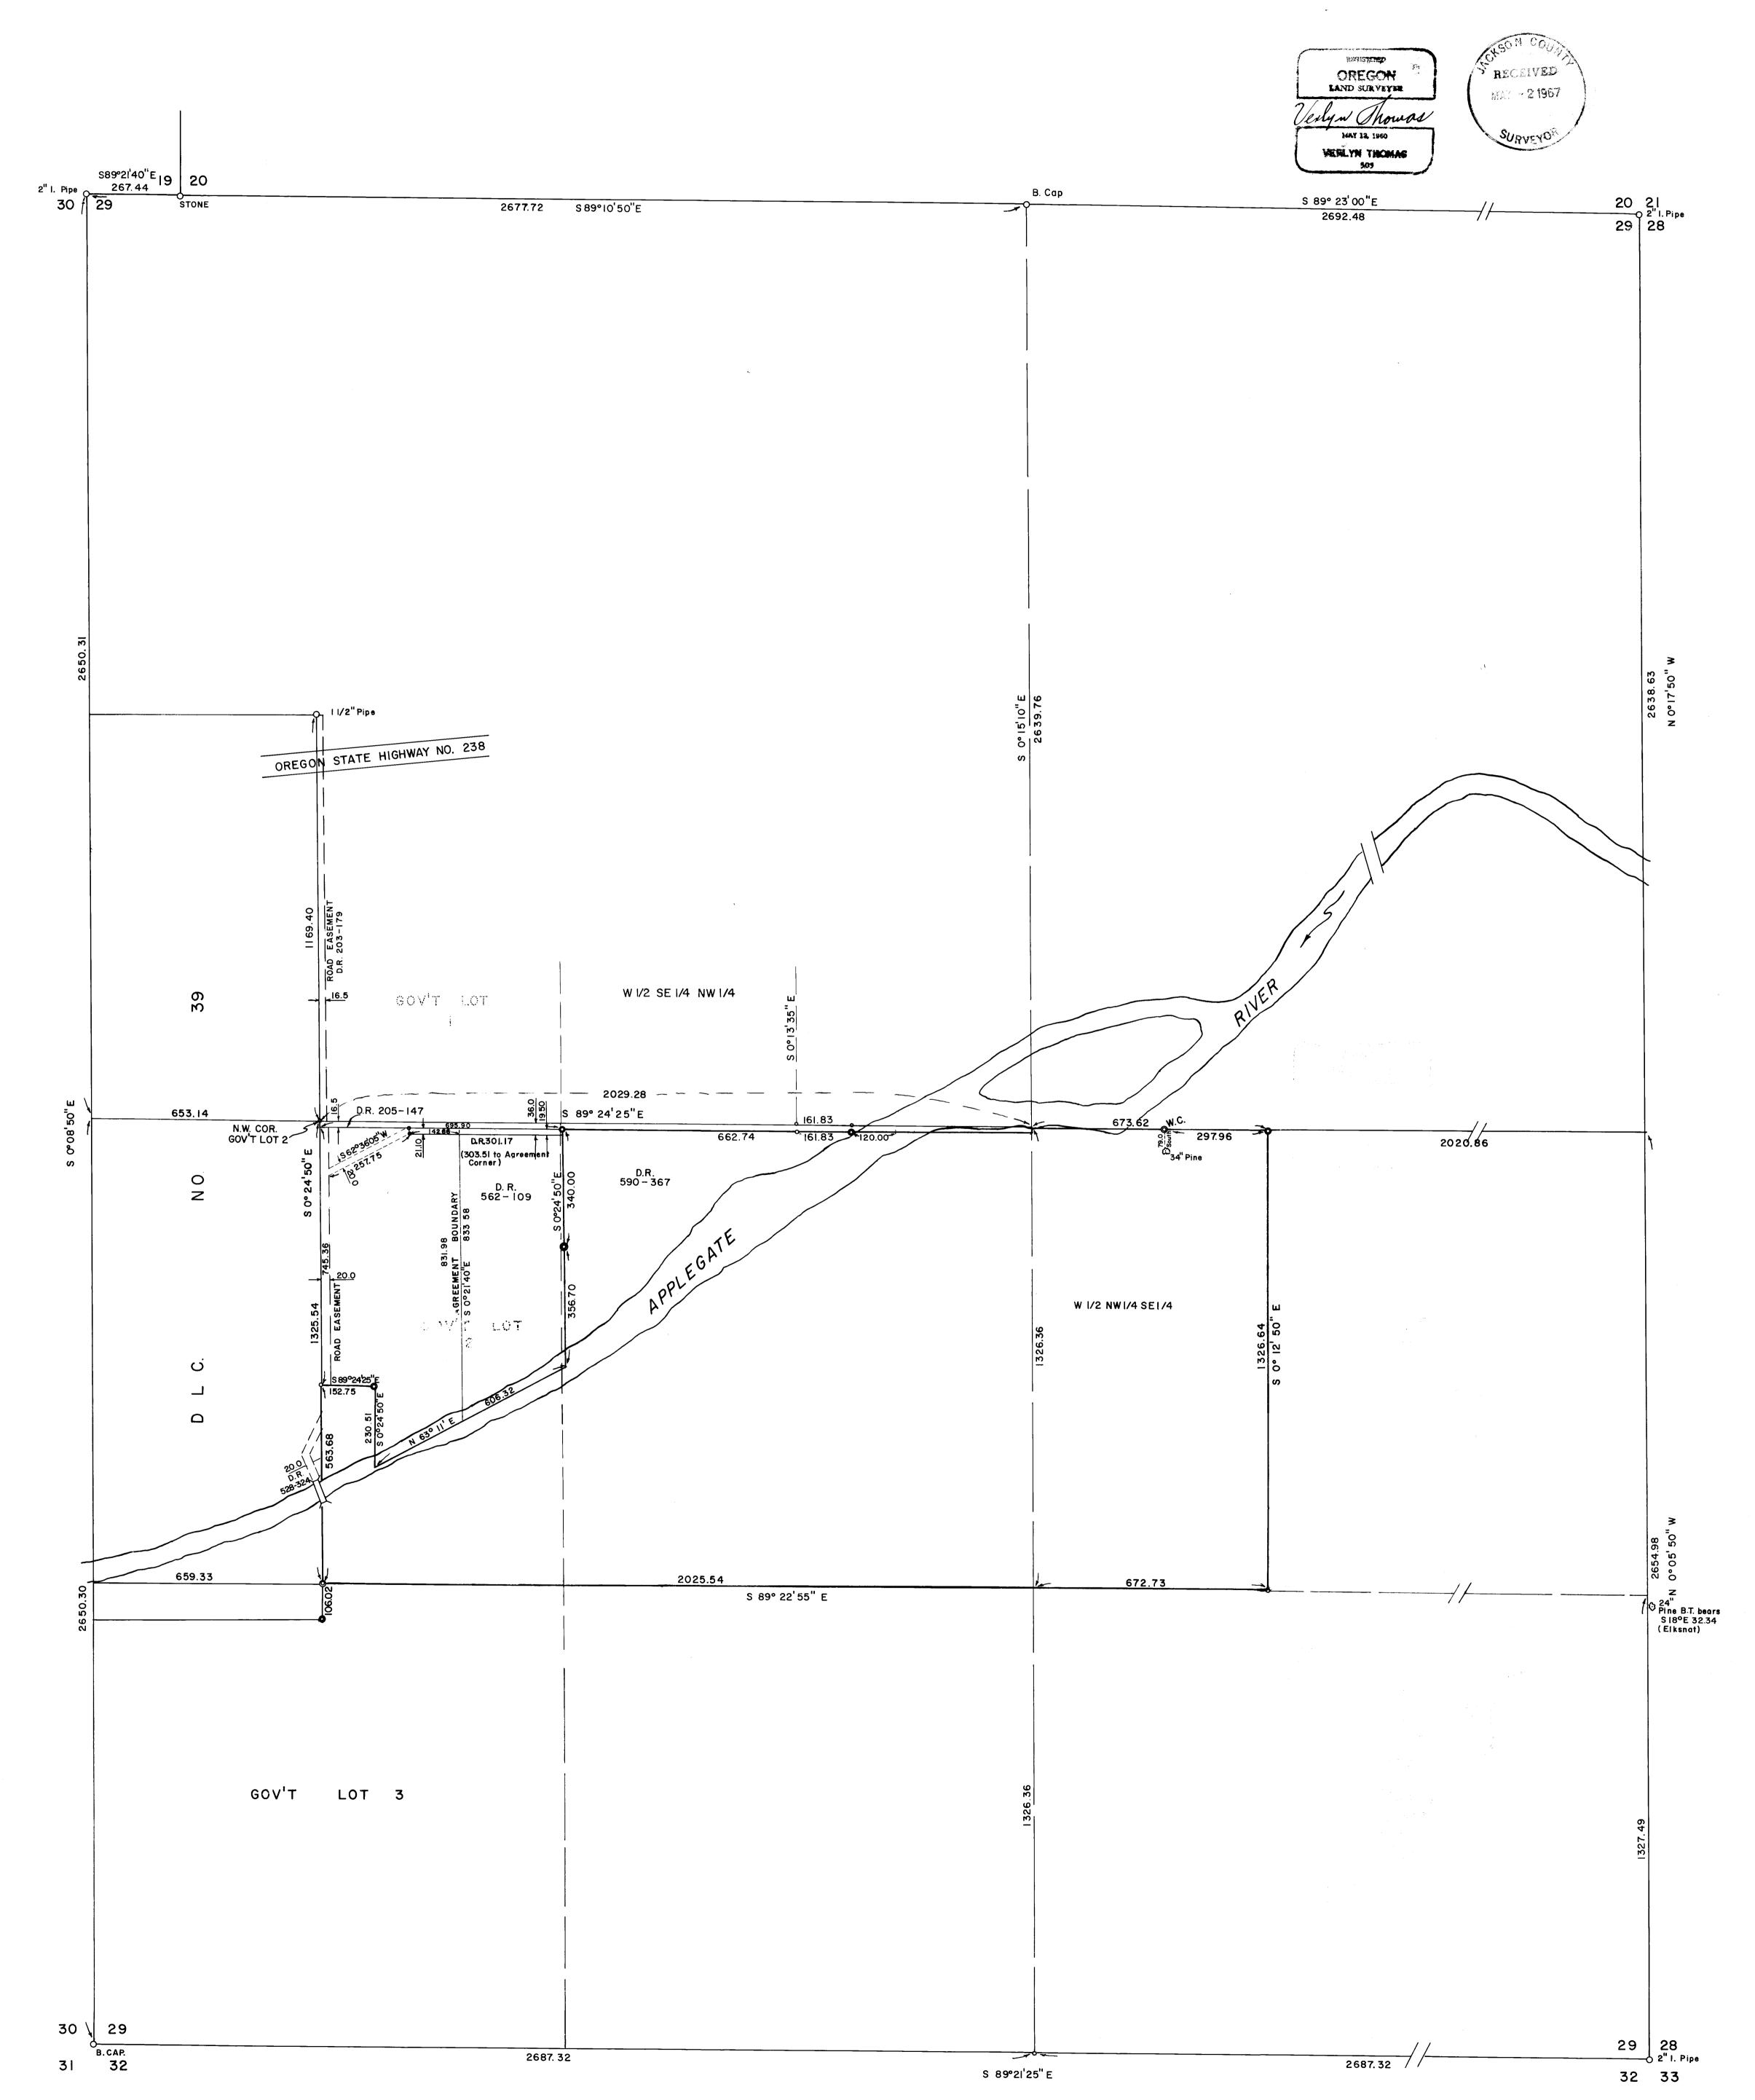
3424Survey No.

ORIGIN OF BEARINGS' Recorded Survey No 251

SCALE 1"= 200

> A traverse was then run around said Section 29, tying the Section corners and the North $\frac{1}{4}$ corner, as shown on the accompanying plat. A thorough search was made for the west, south, and east $\frac{1}{4}$ corners, with no success.

Research revealed that Surveyor Elksnat had determined a location for the South 1/16 corner between Sections 28 and 29, where an 18" Pine was found with scribing visible. Elksnats' plat indicated said tree to be a 9" Pine, bearing S 18° E, 49 links (32.34 feet) from said 1/16 corner. Said plat also indicated the East $\frac{1}{4}$ corner of Section 29. Measurements in the field revealed that a projection of the bearing and distance from the Southeast corner of Section 29 through the location of the Elksnat 1/16 corner resulted in a location for the East $\frac{1}{4}$ corner of Section 29 relatively close to the old fence corner long accepted as being close to the $\frac{1}{4}$ corner. Whereas a single proportionate location for the missing \(\frac{1}{4} \) corner would position the corner approximately 8 feet south of said fence corner. In view of this evidence, and the fact that the Elksnat corner was 1327.49 feet North of the Southeast section corner (rather than 1320 feet) would seem to indicate that Elksnat probably surveyed to the then existing $\frac{1}{4}$ corner. Therefor, a location for said missing $\frac{1}{4}$ corner was determined from the above described evidence, as indicated on the accompanying plat.
