**SURVEY FOR C.C. THOMPSON**

Sec. 32, T.36S., R.2W., W.M.

Jackson County, Oregon

June 12, 1967

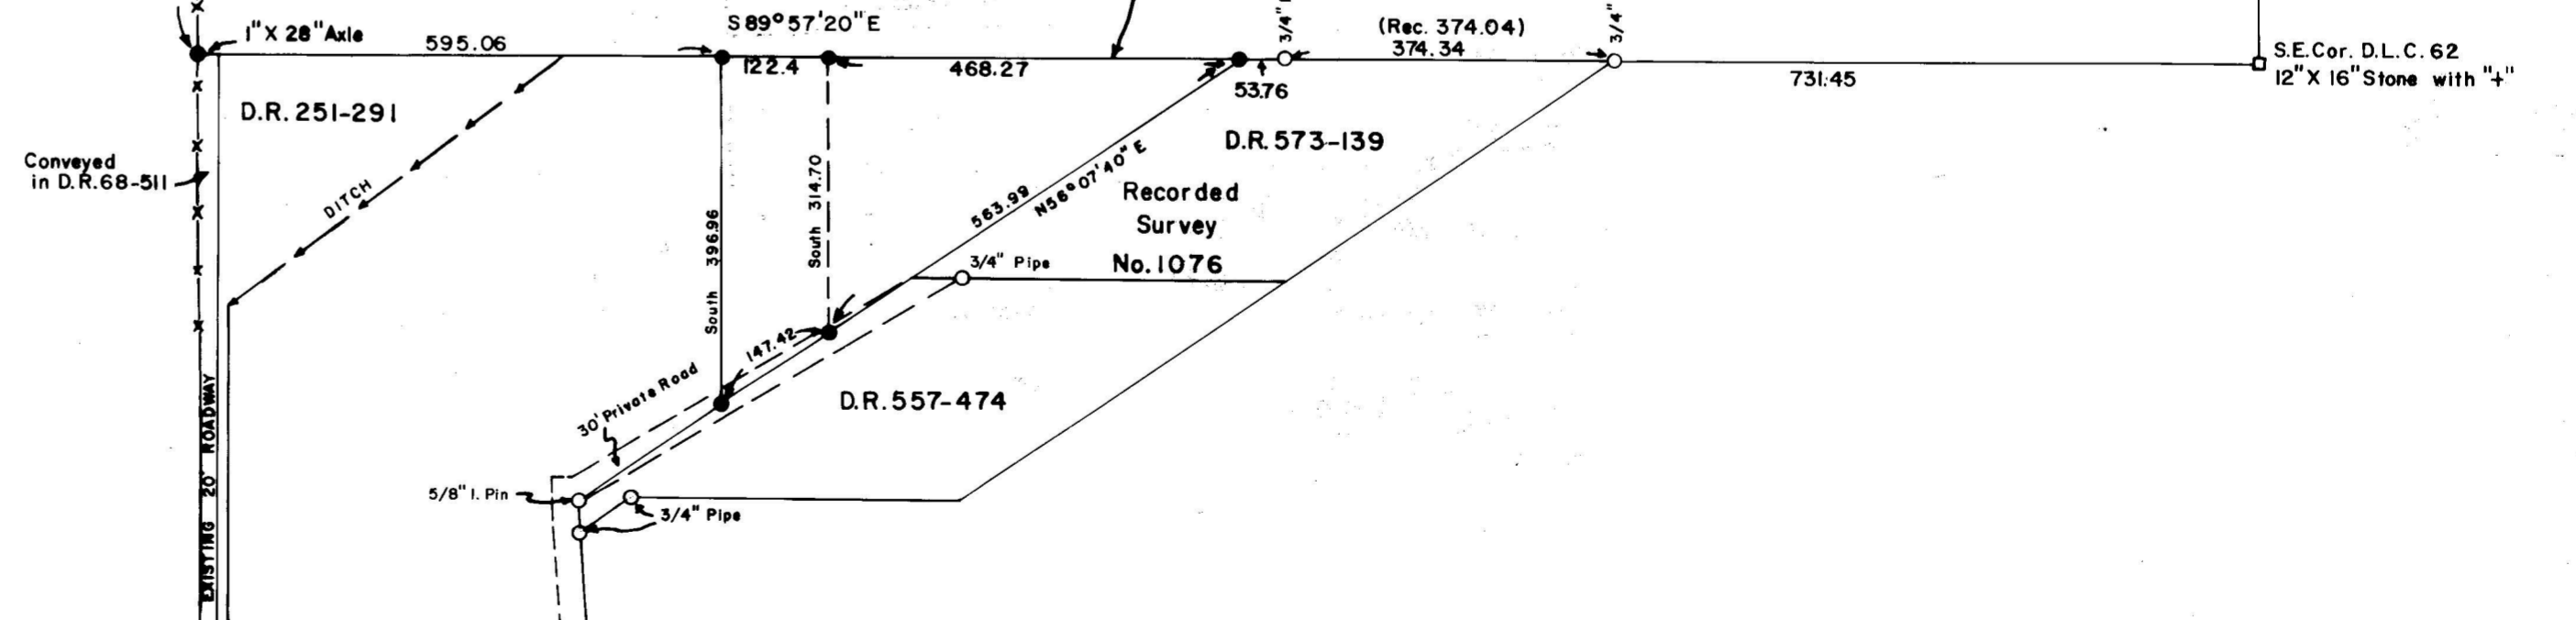
S.W. Cor.  
D.L.C. 63

SCENIC AVENUE N89°58'05"E 4380.63 (Computed)

D.L.C. 66

N.E. Cor.  
D.L.C. 66

6" X 6" Stone on  
East bdy.  
D.L.C. No. 66

S.E. Cor. D.L.C. 62  
12" X 16" Stone with "4"

In view of the above problem, a survey was initiated to reestablish the missing Southwest corner of D.L.C. 62. Survey ties were made from Survey 1076, to the various D.L.C. corners as shown on the accompanying Plat. A pro-rated location was then computed for the Southwest corner of D.L.C. 62. Every computation resulted in a location several feet West of the North-South fence accepted by landowners as being the West boundary of that certain road conveyed by Deed Record Volume 68, page 511, and as being the true property line. Further testimony by long-time residents of the area revealed this fence to be in place at least 50 years. In view of the above facts, it was deemed impractical for this surveyor to reestablish a Southwest corner of D.L.C. 62 based on pro-rated measurements.

Therefor, a 1"x28" axle was placed in said North-South fence, on a projection of the property line as established in Survey No. 1076, with the Southeast corner of D.L.C. 62. A "Boundary Line Agreement" was then prepared for this line to establish it as the true property line.

The property in question was monumented and descriptions prepared, relative to the stone monument at the Southeast corner of D.L.C. 62.
