Survey For:
A. V. THOMPSON
Located in D.L.C. No. 43,
South 1/2 Sec. 15,
T.38 S. R.1W., W.M.
By: Mark E. Boyden
June 5, 1968

SURVEY NARRATIVE TO COMPLY WITH O.R.S. 209.250

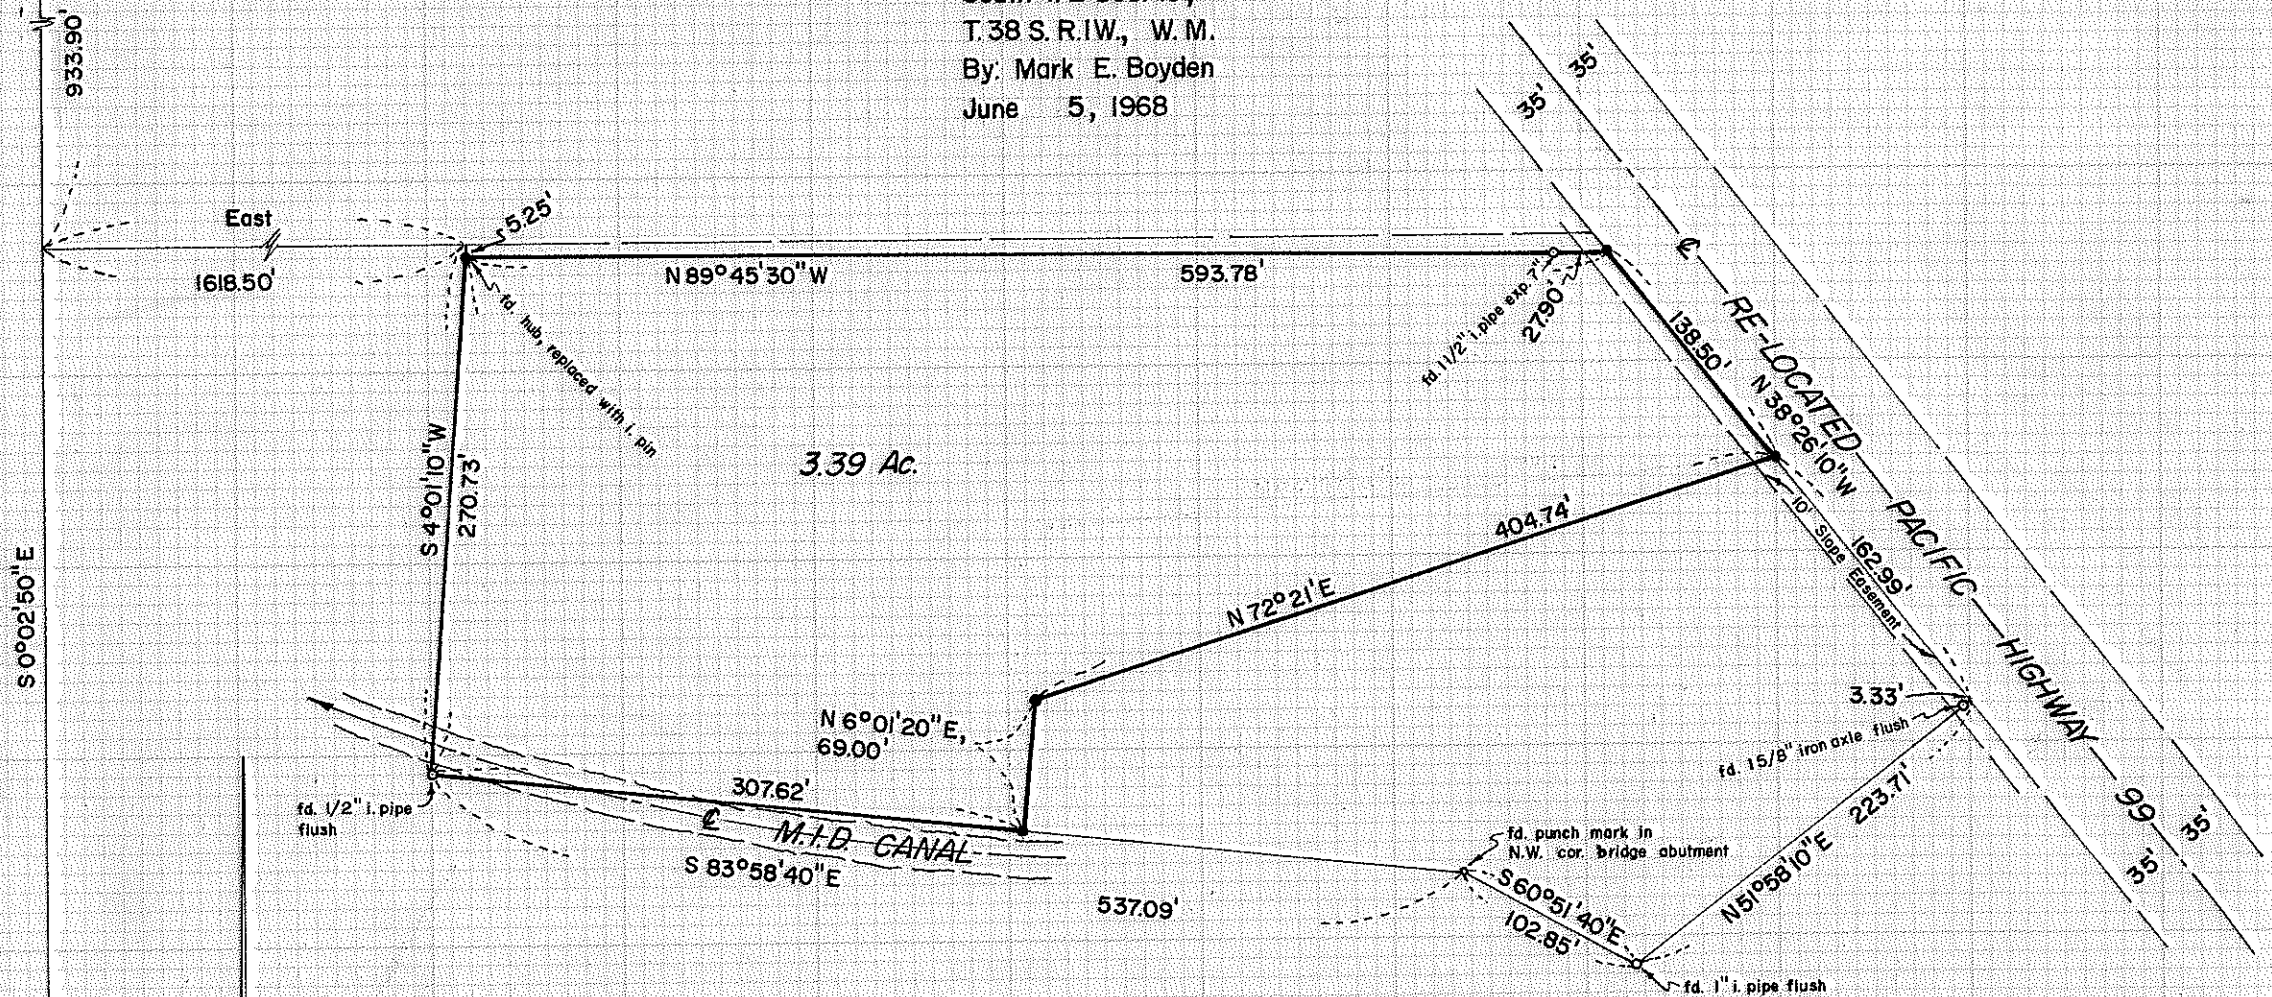
East
1618.50'

3.39 Ac.

RE-LOCATED
PACIFIC
HIGHWAY

M.F.D. CANAL

- Set 5/8" X 24" iron pin flush
- Fd. monument as indicated

Basis of Bearings:
Recorded Survey No. 2016

SCALE: 1" = 100'

PROCEDURE: Found the monuments for the Northwest corner of Donation Land Claim No. 43 and the Southeast corner of Donation Land Claim No. 55 as described in the Government Corner Re-establishment Records on file in the office of the County Surveyor.

Traversed Southerly and Easterly from said Northwest corner of D.L.C. #43, and then enclosed the present Thompson ownership by random traverse. Ties were made to the 5/8" iron pins set by the State Highway Department on the Southwesterly right-of-way line of the Re-located Pacific Highway 99 at Station P.C.S. 297+70.45 and Station P.O.T. 310+00 and equated to ties made on Recorded Survey No. 2016 for alignment and meridian control.

Minor differences in the coordinate position of said right-of-way pin located at Highway Station P.C.S. 297+70.45 were adjusted for a mean average of the two surveys. It was found that the existing old fence line near the North property boundary lies Southerly of the record position. A description of the strip lying Northerly from the 3.39-acre tract was prepared so that Thompson can convey this strip to the adjoining property owner.

Monumented the additional corners as shown on the map to accompany this report.
