SURVEY NARRATIVE TO COMPLY WITH ORS-209-250

SURVEY FOR: MR. L. T. GRIFFITHS
ROUTE 2, Box 536
GOLD HILL, OREGON

SURVEY LOCATION: SOUTHWEST $\frac{1}{4}$, SECTION 32, TOWNSHIP 35 SOUTH,
RANGE 2 WEST, WILLAMETTE MERIDIAN, JACKSON
COUNTY, OREGON

PURPOSE OF SURVEY: TO ESTABLISH THE BOUNDARIES OF THE NORTH
 $\frac{1}{2}$ OF THE SOUTHWEST QUARTER AND THE WEST $\frac{1}{2}$
OF THE SOUTHWEST OF THE SOUTHWEST QUARTER OF
SECTION 32, TOWNSHIP 35 SOUTH, RANGE 2 WEST,
WILLAMETTE MERIDIAN.

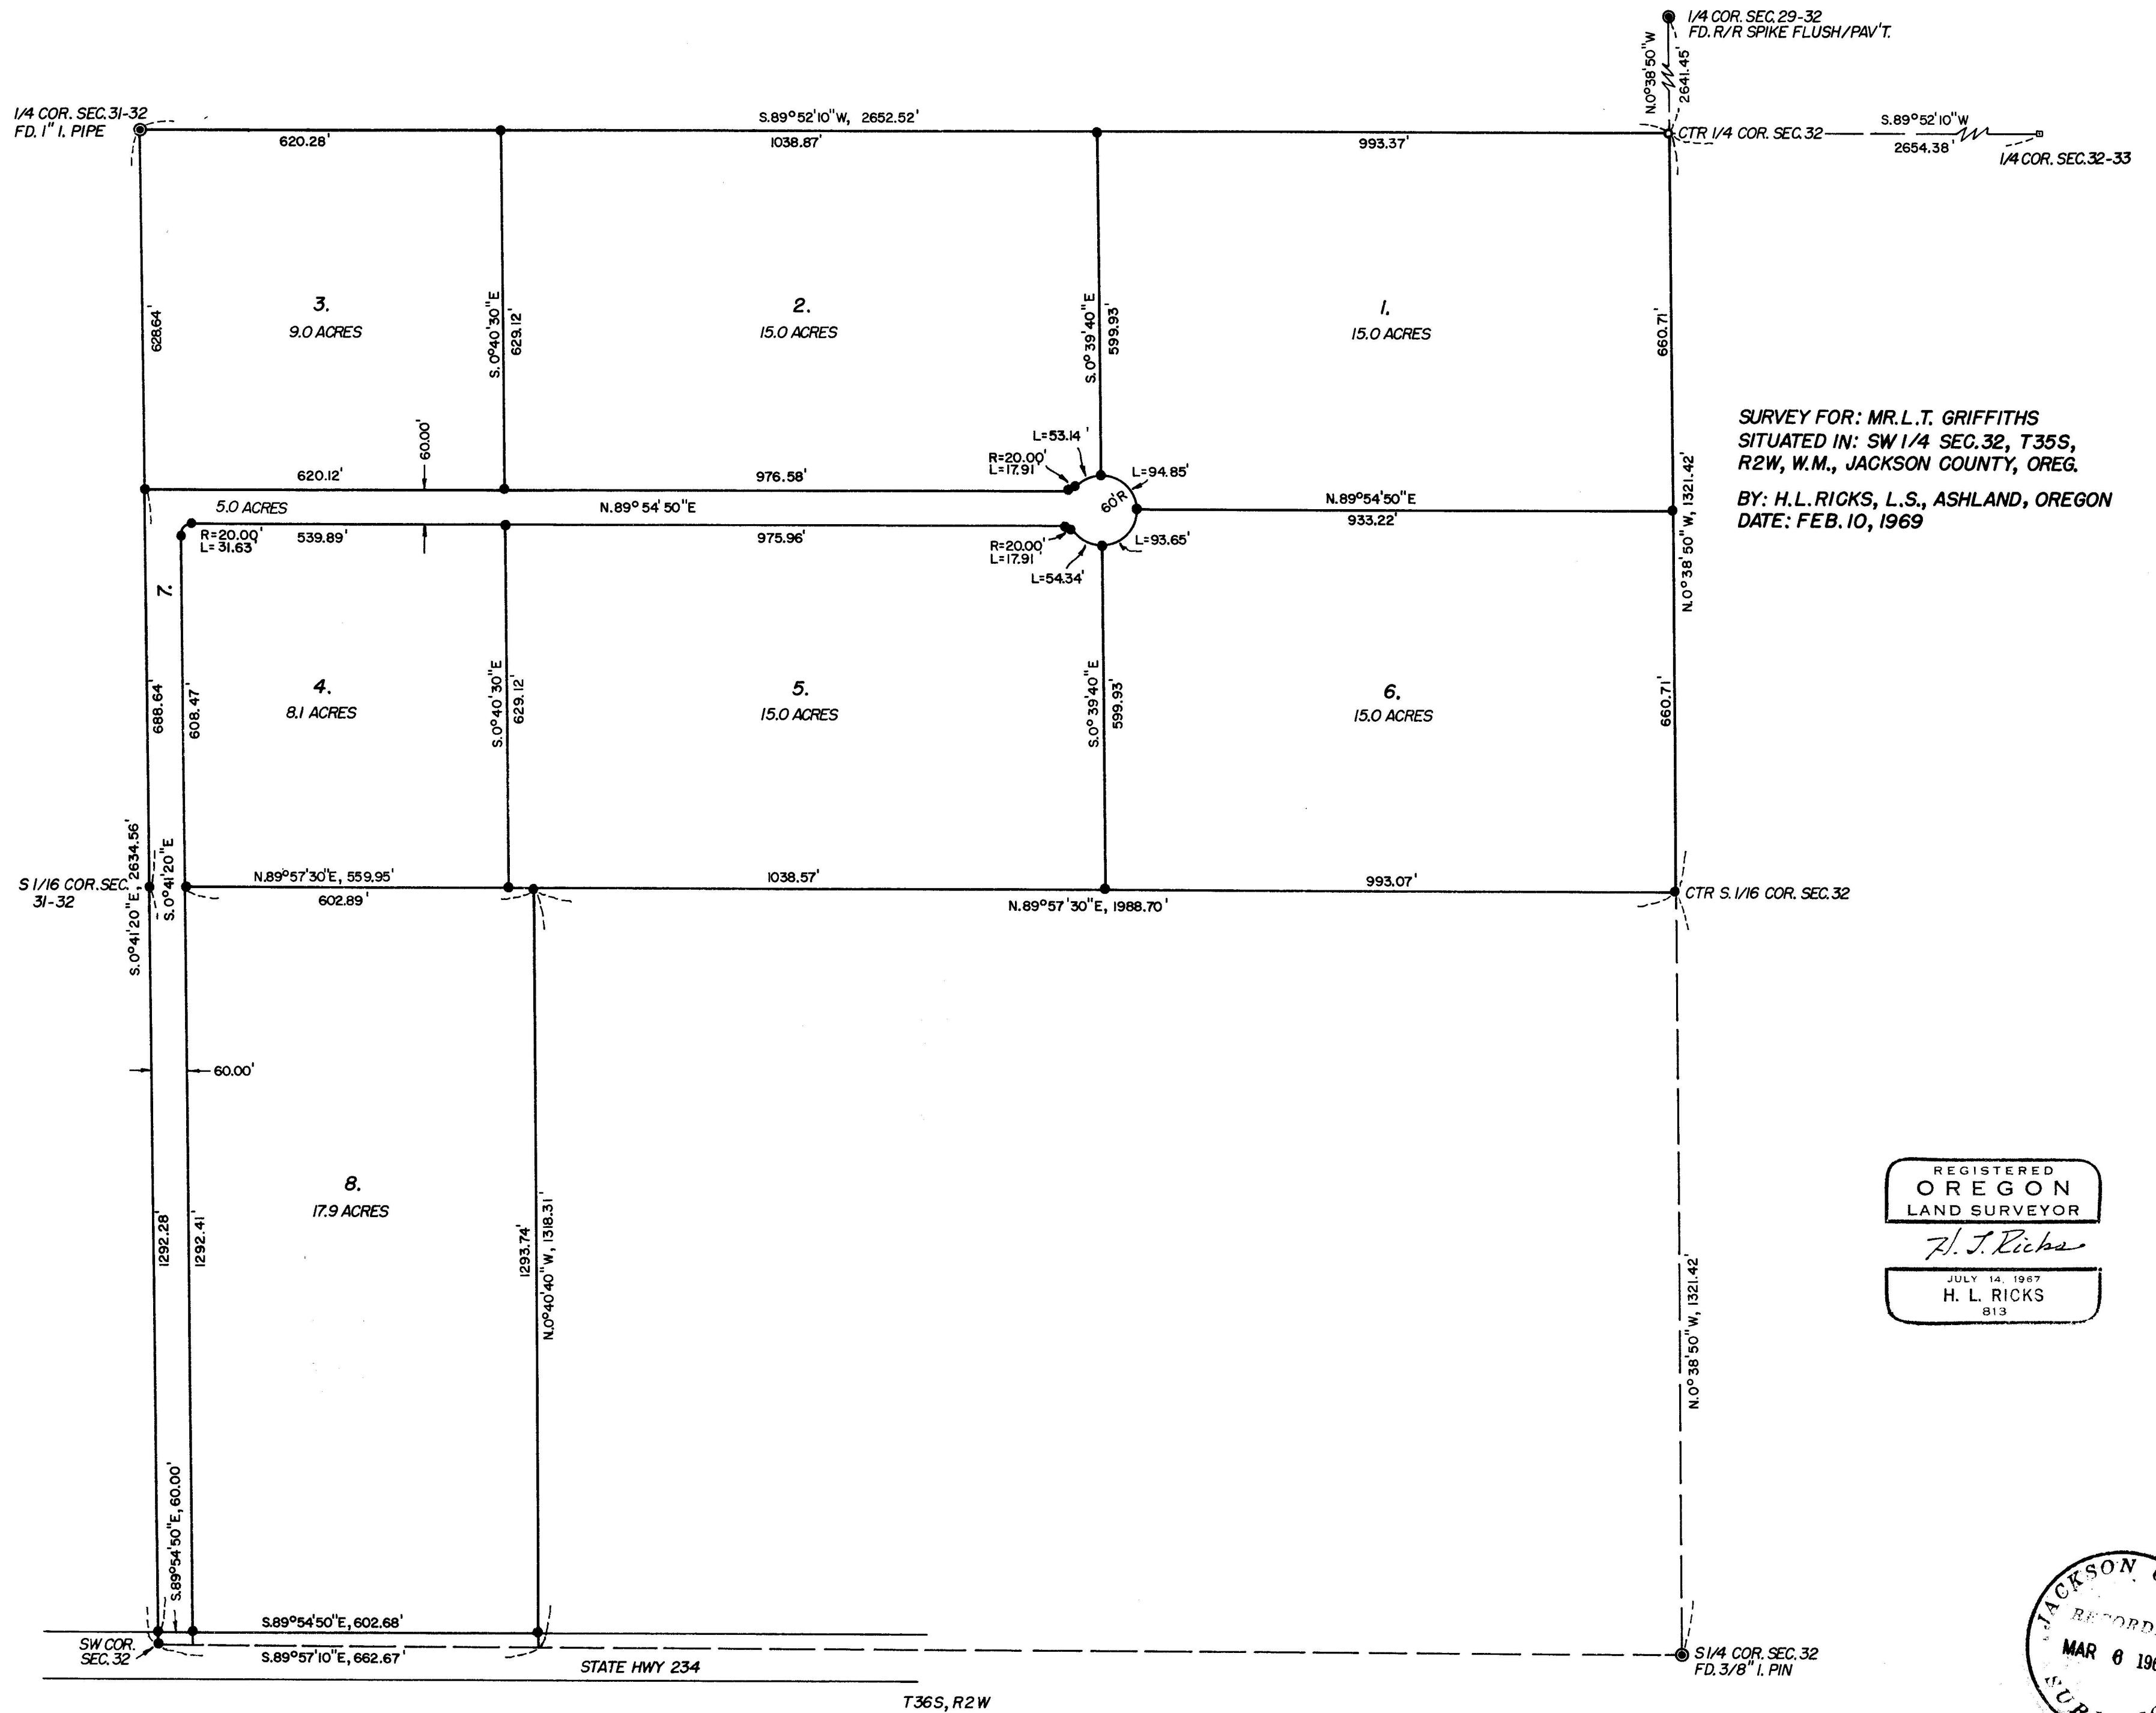
THEREBY HAVING THE NECESSARY CONTROL OF THE OUTSIDE BOUNDARIES
OF THE SOUTHWEST QUARTER OF SECTION 32 THE PROPERTY PINS
WERE SET AS SHOWN ON THE ACCOMPANYING PLAT AS INSTRUCTED BY
THE CLIENT.

RUNNING THENCE WEST ALONG SAMS VALLEY ROAD THROUGH THE NORTH $\frac{1}{4}$ CORNER (BEING A RAILROAD SPIKE WITH NO EVIDENCE OF THE B.T.'S IN THE NORTHWEST AND SOUTHWEST QUADRANTS, BUT DID FIND A 2" GALVANIZED IRON PIPE NORTH 30 FEET, NO RECORD ON THIS; THE RAILROAD SPIKE CHECKED ON LINE AND HALFWAY BETWEEN THE NORTHWEST AND NORTHEAST SECTION CORNERS; THEN CONTINUED ON TO THE NORTHWEST SECTION CORNER (BEING A RAILROAD SPIKE WITH B.T.'S IN NORTHWEST AND NORTHEAST IN GOOD CONDITION); THEN RUNNING SOUTH THROUGH THE FIELD AND THROUGH THE QUARTER CORNER 31 & 32 (BEING A 1" IRON PIPE WITH B.T.'S IN GOOD CONDITION) THEN ON SOUTH TO THE $\frac{3}{4}$ " PIN CLOSING THE TRAVERSE.

WE THEN SET THE CENTER $\frac{1}{4}$ CORNER A 1" X 30" GALVANIZED IRON PIPE AND REFERENCING SAME AS FOLLOWS:

IN ORDER TO ESTABLISH THE SOUTHWEST SECTION CORNER OF SECTION 32, WE FOUND NO EVIDENCE OF THE 1914 CORNER OR THE GAS PIPE REFERENCE; SO WE WROTE TO THE O.S.H.D. ASKING FOR REFERENCES AND FROM THIS INFORMATION WE SET THE CORNER BEING A $\frac{5}{8}$ " X 30" IRON PIN IN THE ROAD APPROACH FROM WHICH THE AFOREMENTIONED $\frac{3}{4}$ " IRON PIN BEARS SOUTHEASTERLY 6.80 FEET; ALSO THE POSITION OF WHERE THE CORNER IS SET CHECKS ON A PROJECTED LINE AND DISTANCE FROM THE WEST QUARTER AND NORTHWEST SECTION CORNER. THIS METHOD WAS DECIDED UPON AS THE SOUTH $\frac{1}{4}$ CORNER SECTION 31 IS NOT IN DUE TO HIGHWAY CONSTRUCTION. THE SOUTH SIXTEENTH CORNER SECTION 31 & 32 WAS SET ON THE SECTION LINE BEING A $\frac{5}{8}$ " X 30" IRON PIN FROM WHICH A 1" IRON PIPE WAS FOUND 0.60 FEET NORTH AND 0.05 FEET EAST.

SURVEY PROCEDURE: WE RAN A TRAVERSE AROUND THE ENTIRE OUTSIDE
BOUNDARY OF SECTION 32 BEGINNING AT A $\frac{3}{4}$ " IRON PIN NEAR THE
SOUTHWEST CORNER; RUNNING THENCE EAST THROUGH THE SOUTH $\frac{1}{4}$
CORNER (BEING A $\frac{3}{8}$ " IRON PIN WITH THE SOUTHWEST AND SOUTH-
EAST B.T.'S IN GOOD CONDITION), THENCE ON TO THE SOUTHEAST
SECTION CORNER, (BEING A $\frac{5}{8}$ " IRON PIN AT THE INTERSECTION
OF TRESHAM AND DUGGAN ROADS WITH THE IRON PIPE TO THE SOUTH
AND THE B.T. IN THE SOUTHEAST QUADRANT IN GOOD CONDITION),
THENCE NORTH ALONG DUGGAN ROAD MAKING A SIDE TIE TO R.S.
#2915 AND ON TO THE NORTHEAST SECTION CORNER OF 32 (BEING
A RAILROAD SPIKE WITH THE GAS PIPES IN NORTHEAST AND NORTH-
WEST AND THE B.T. IN SOUTHEAST ALL IN GOOD CONDITION).
