SURVEY FOR MALCOM McCARTY  
SEC. 21, T. 38 S., R. 4 W., W. M.  
JACKSON COUNTY, OREGON  
MAY 6, 1969

SURVEY NARRATIVE TO COMPLY WITH O.R.S. 209.250  
REVISED BY CHAPTER 555, O.L. 1963.

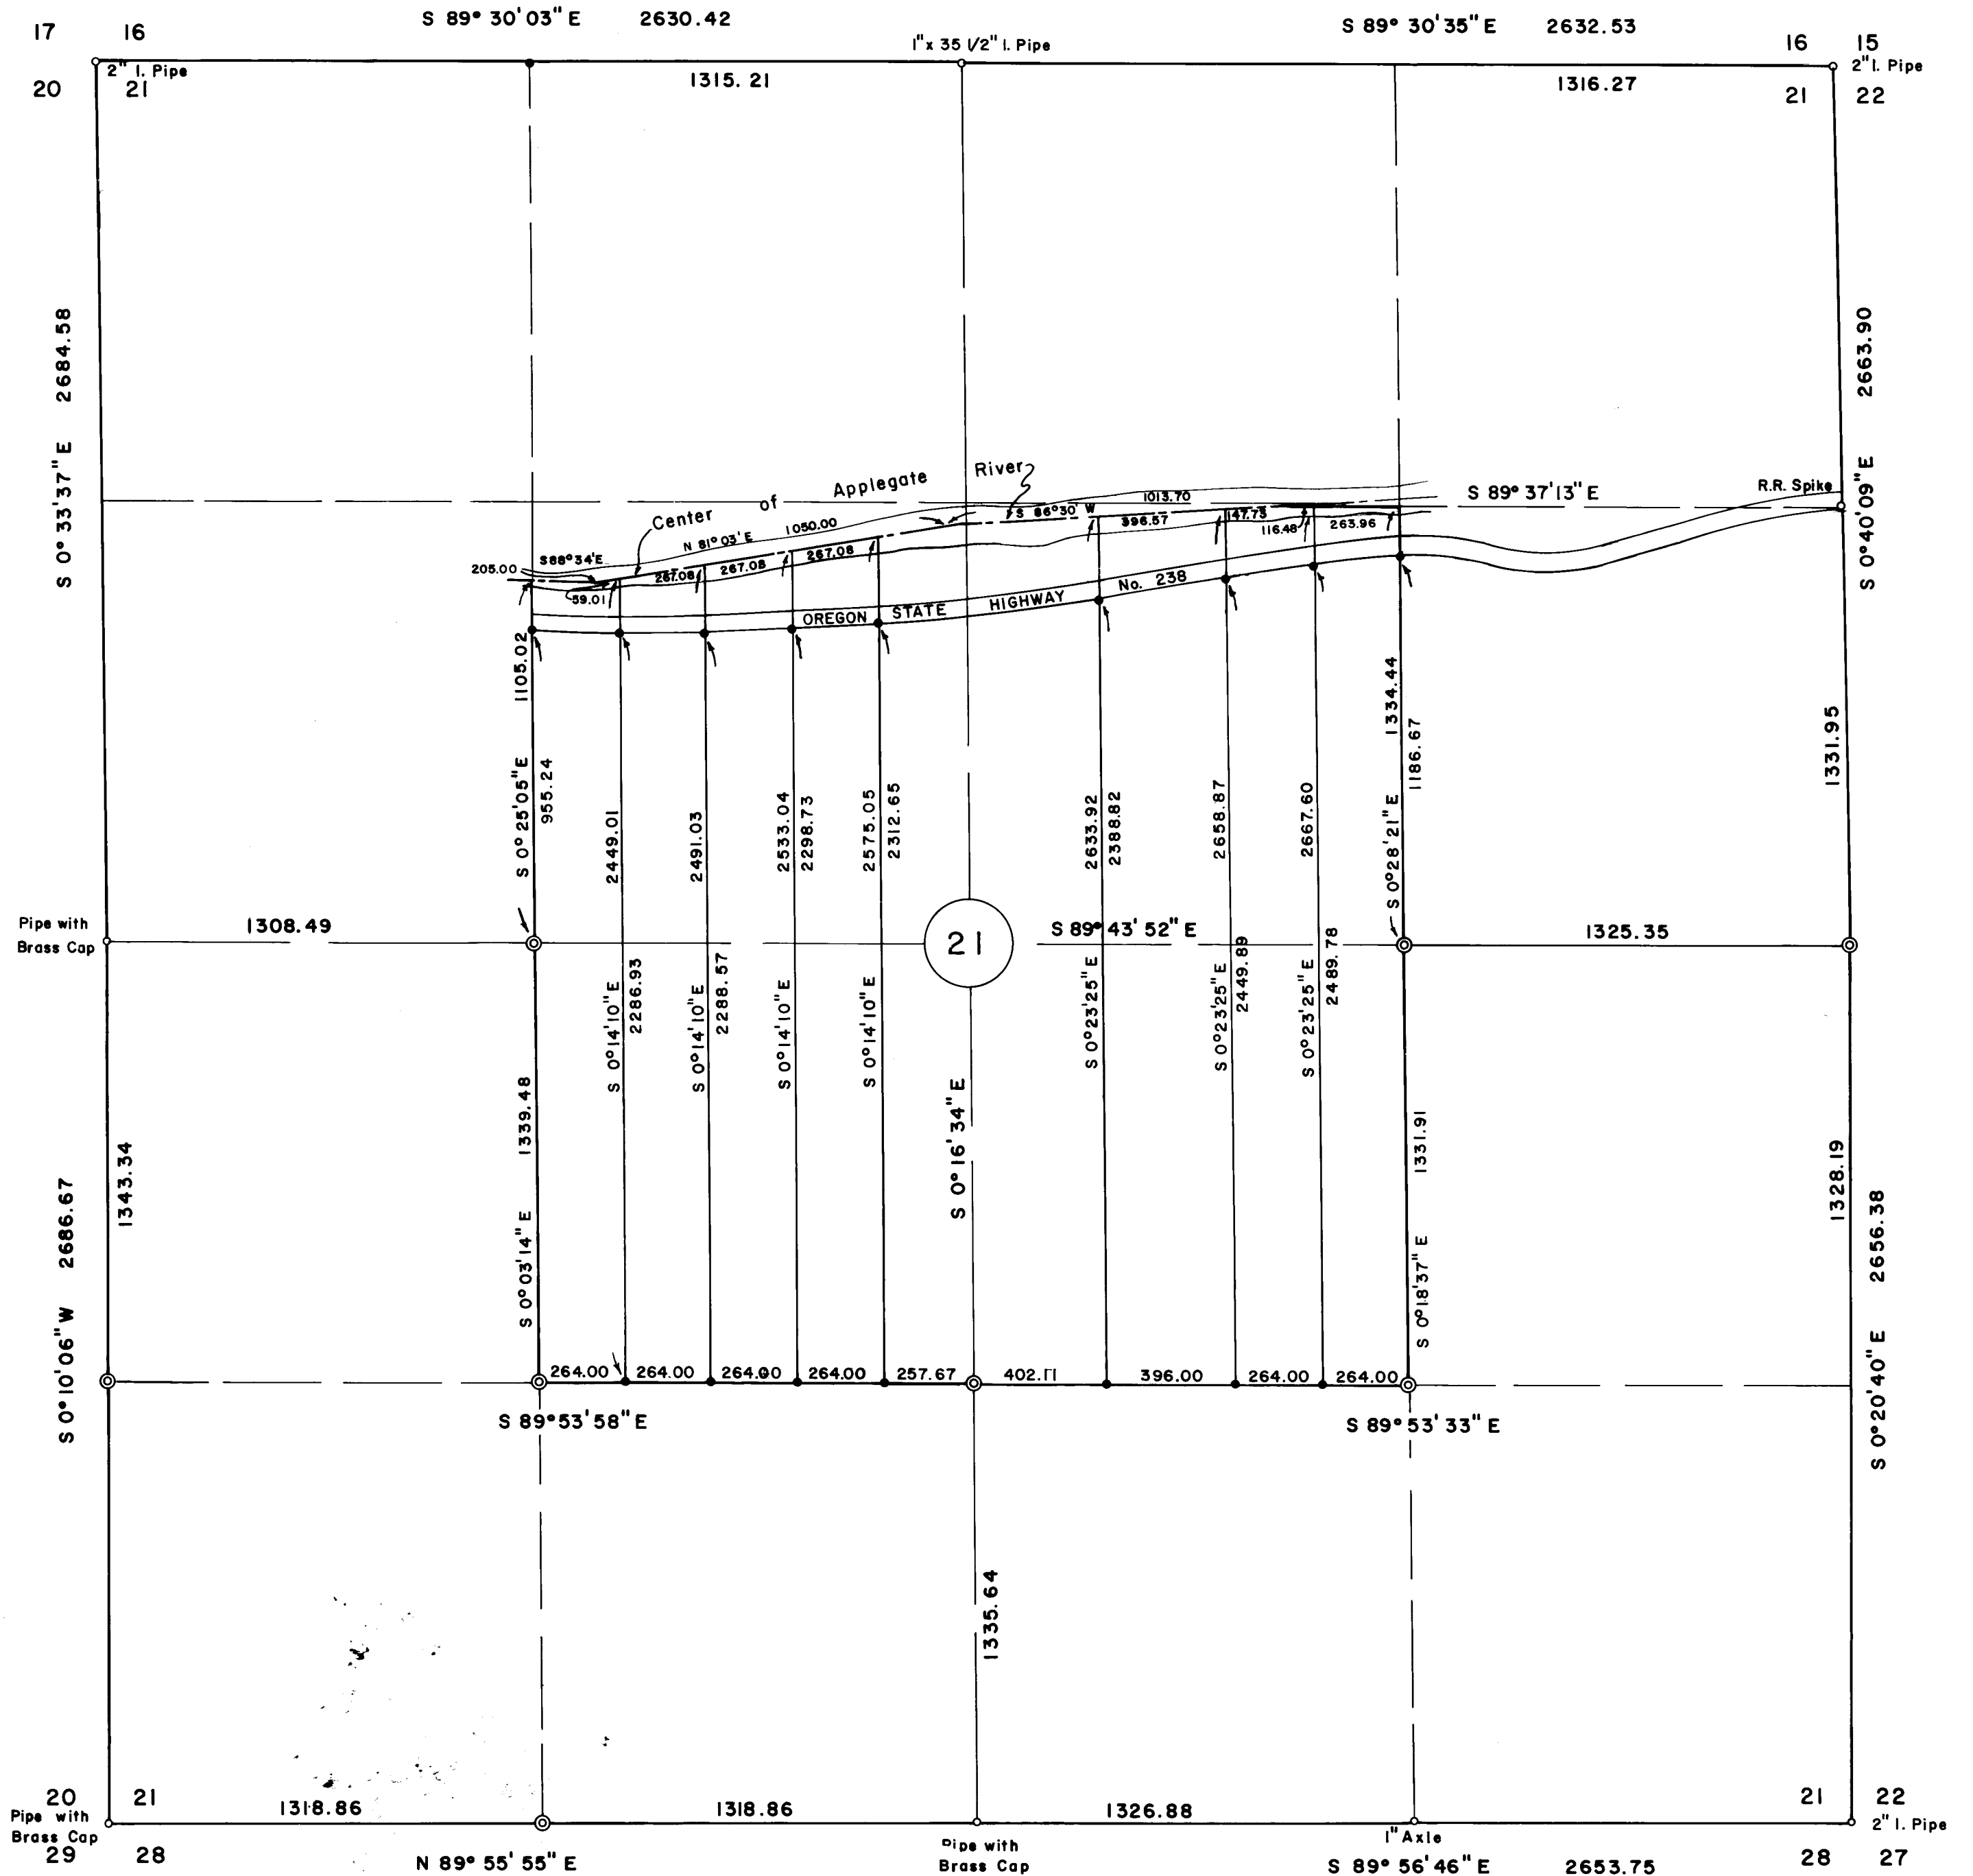
SCALE 1" = 400'

LEGEND

- Monument Found
- 5/8 x 24" Iron Pin set flush
- ⊙ 1/2 x 30" I. Pipe with metal Disc set

BASIS OF BEARINGS: R.S. No. 3607

$\frac{5}{8}$ " iron pins were set at intervening tract corners, and at Witness corners set along the South side of Highway No. 238, as shown on the accompanying Plat.

PROCEDURE: Found evidence of all exterior section and one quarter corners for Section 21. Traversed between corners and computed location of intermediate 1/16 corners, as shown on accompanying Plat. Certain discrepancies for the location of exterior 1/16 corners were revealed by the random traverse. Research of records produced a 1938 survey of the North line of Section 21, performed by Les Smith for one Fred Powers. In this survey, surveyor Smith found original B.T.'s for the Northwest corner of said Section 21, and set a 2"X36" iron pipe, though he noted bearings and distances to the trees did not conform to original notes. We recovered said 2" iron pipe, but found no evidence of the B.T.'s.
