SURVEY NARRATIVE TO COMPLY WITH PARAGRAPH 209.250  
OREGON REVISED STATUTES

SURVEY FOR: Robert E. Trettin  
Route 4, Box 414C Pioneer Road  
Medford, Oregon

LOCATION: Tract situate in the Northeast One Quarter (1/4)  
of Section 13, Township 38 South, Range 2 West,  
Willamette Meridian, Jackson County, Oregon.

PURPOSE: To monument the corners and prepare a description  
of the parcel of land shown on the attached map,  
also to define by legal descriptions the centerline  
of the existing access road and the water line  
easement as shown.

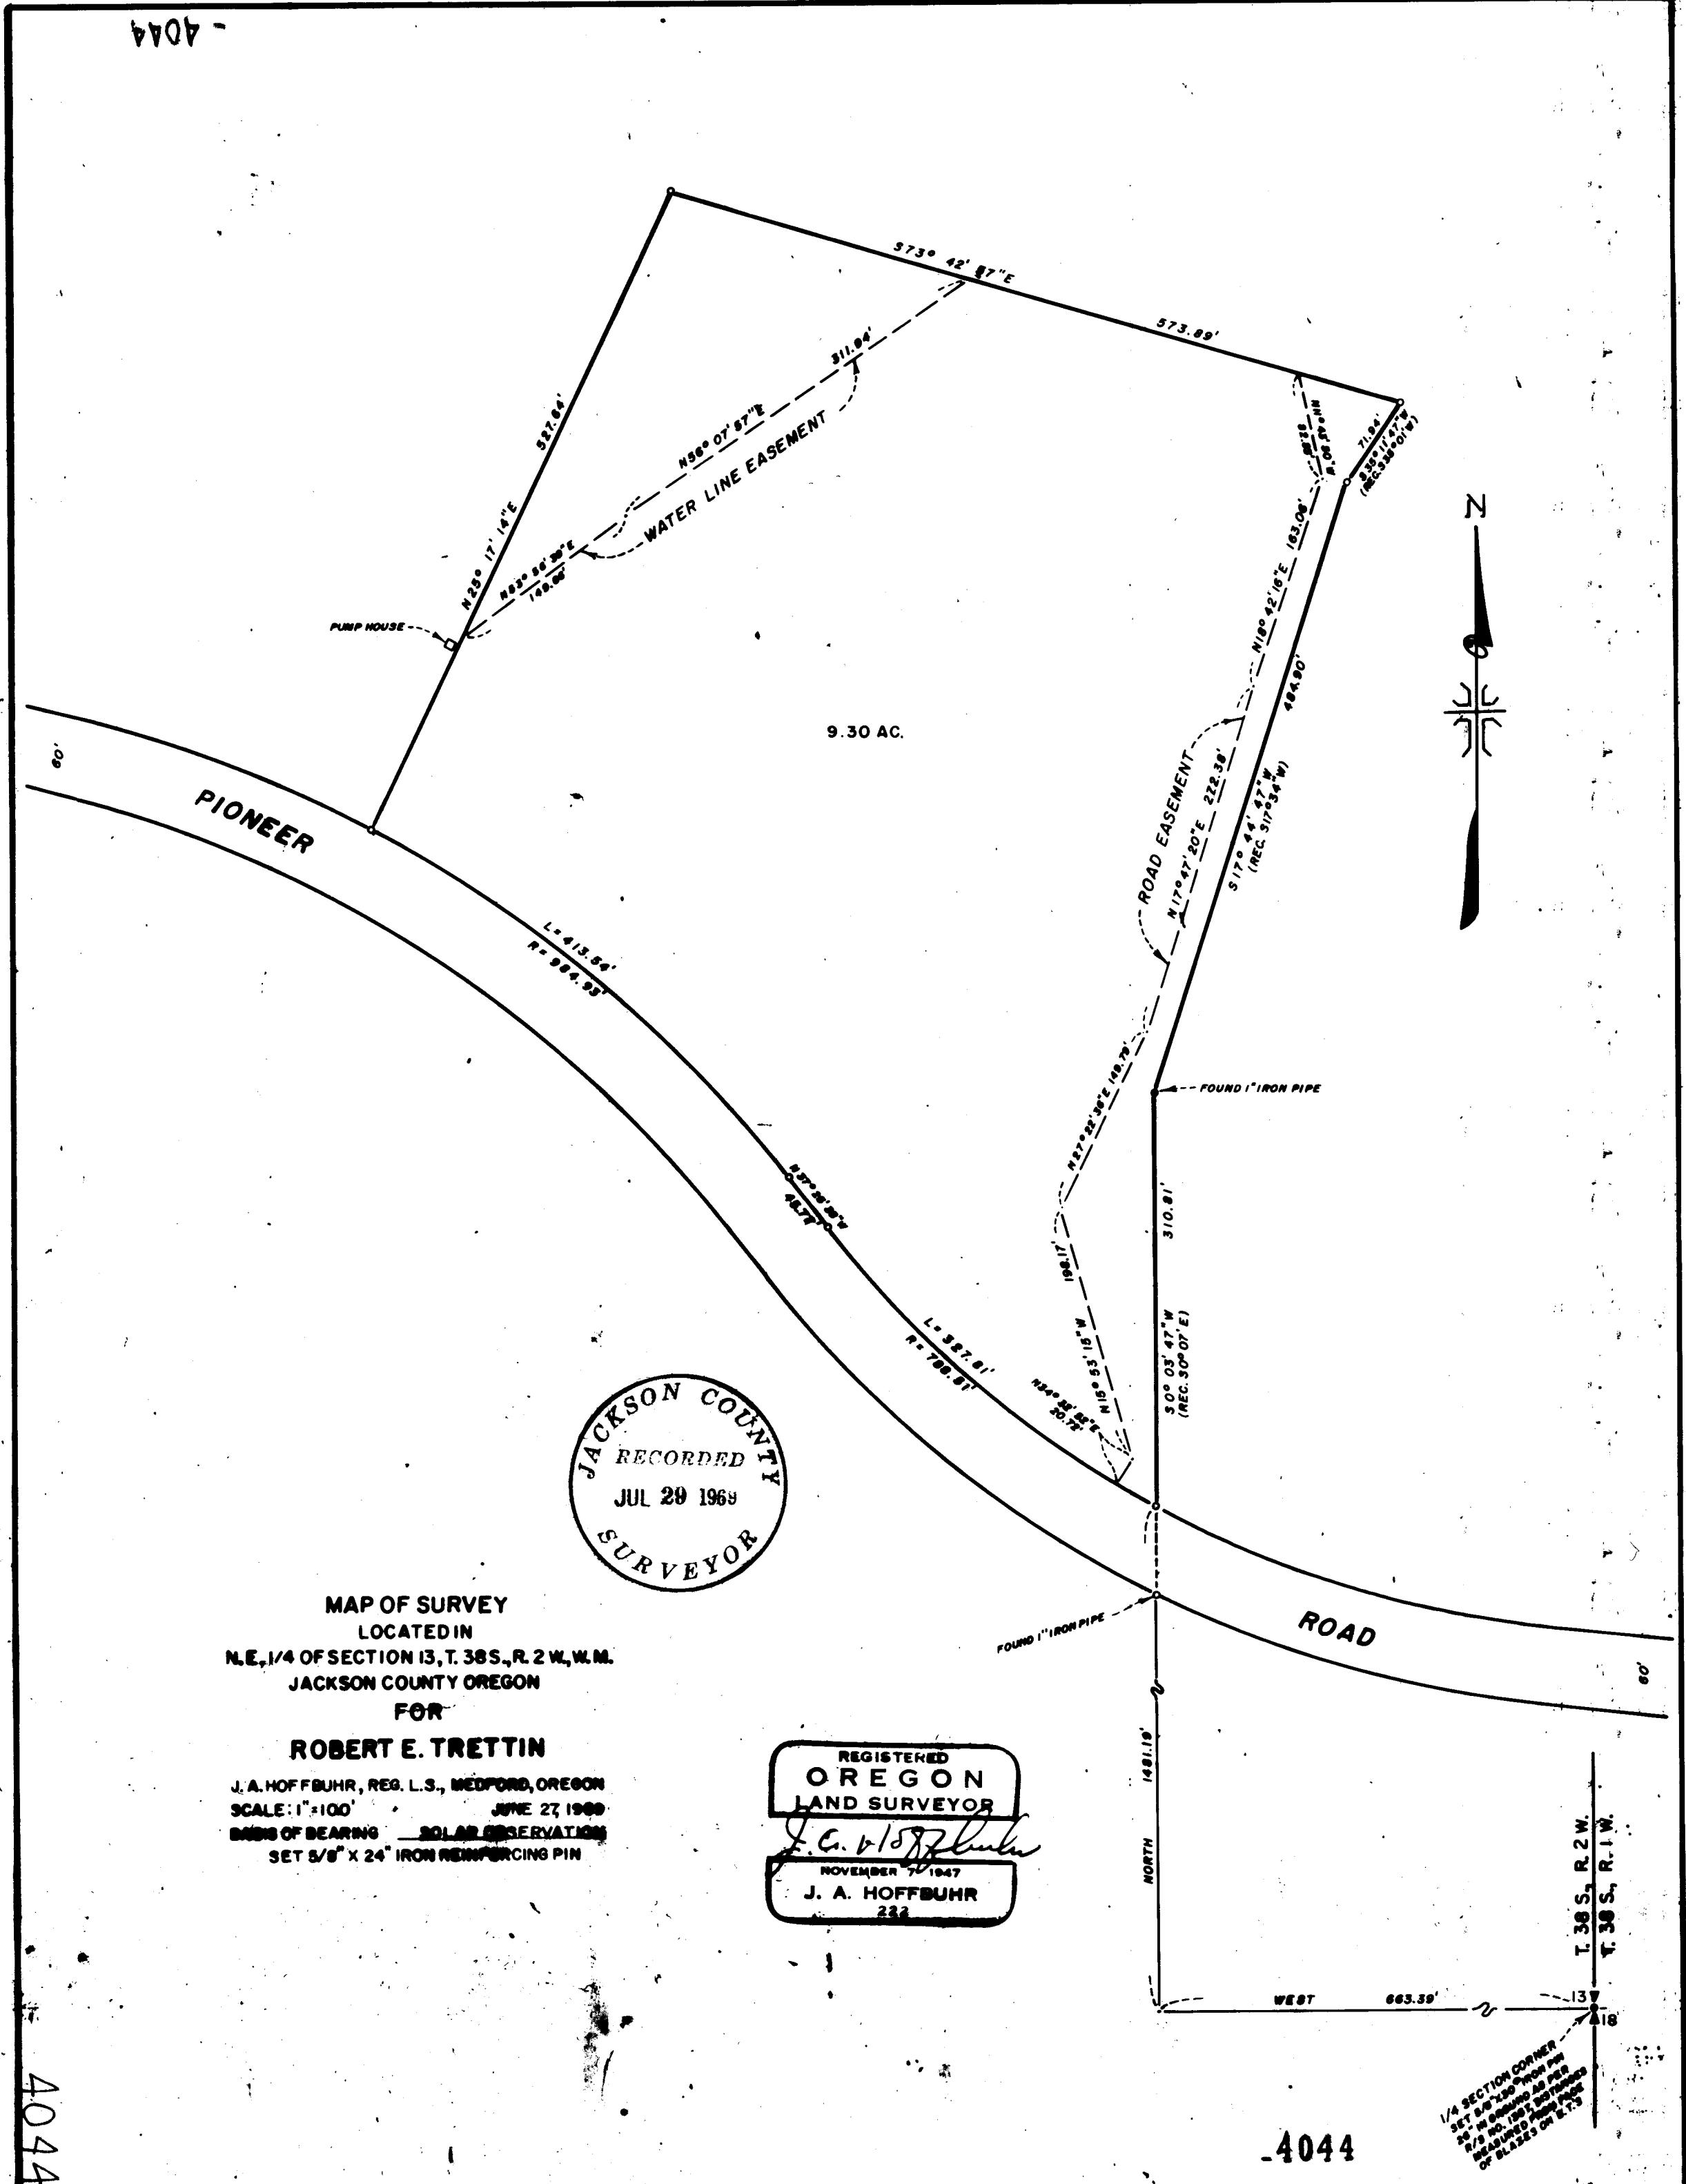
-4044-

The North and West lines of the tract were positioned by the client as shown.

The centerline of the Water line Easement and the centerline of the Road Easement was traversed and described as shown.

The coordinated traverse was extended through the approximate locations of the two Westerly corners of the Claim line in question and around the perimeter of the tract to be surveyed. Ties were made to all the physical evidence that could be located in an attempt to retrace the original unrecorded and missing survey as nearly as possible.
