MAP OF SURVEY

LOCATED IN 1/2 NW 1/4 SW 1/4 SEC. 5, T. 39 S. E. 1 E. W. 1/4 M. JACKSON COUNTY OREGON FOR

GERTRUDE BEECHER

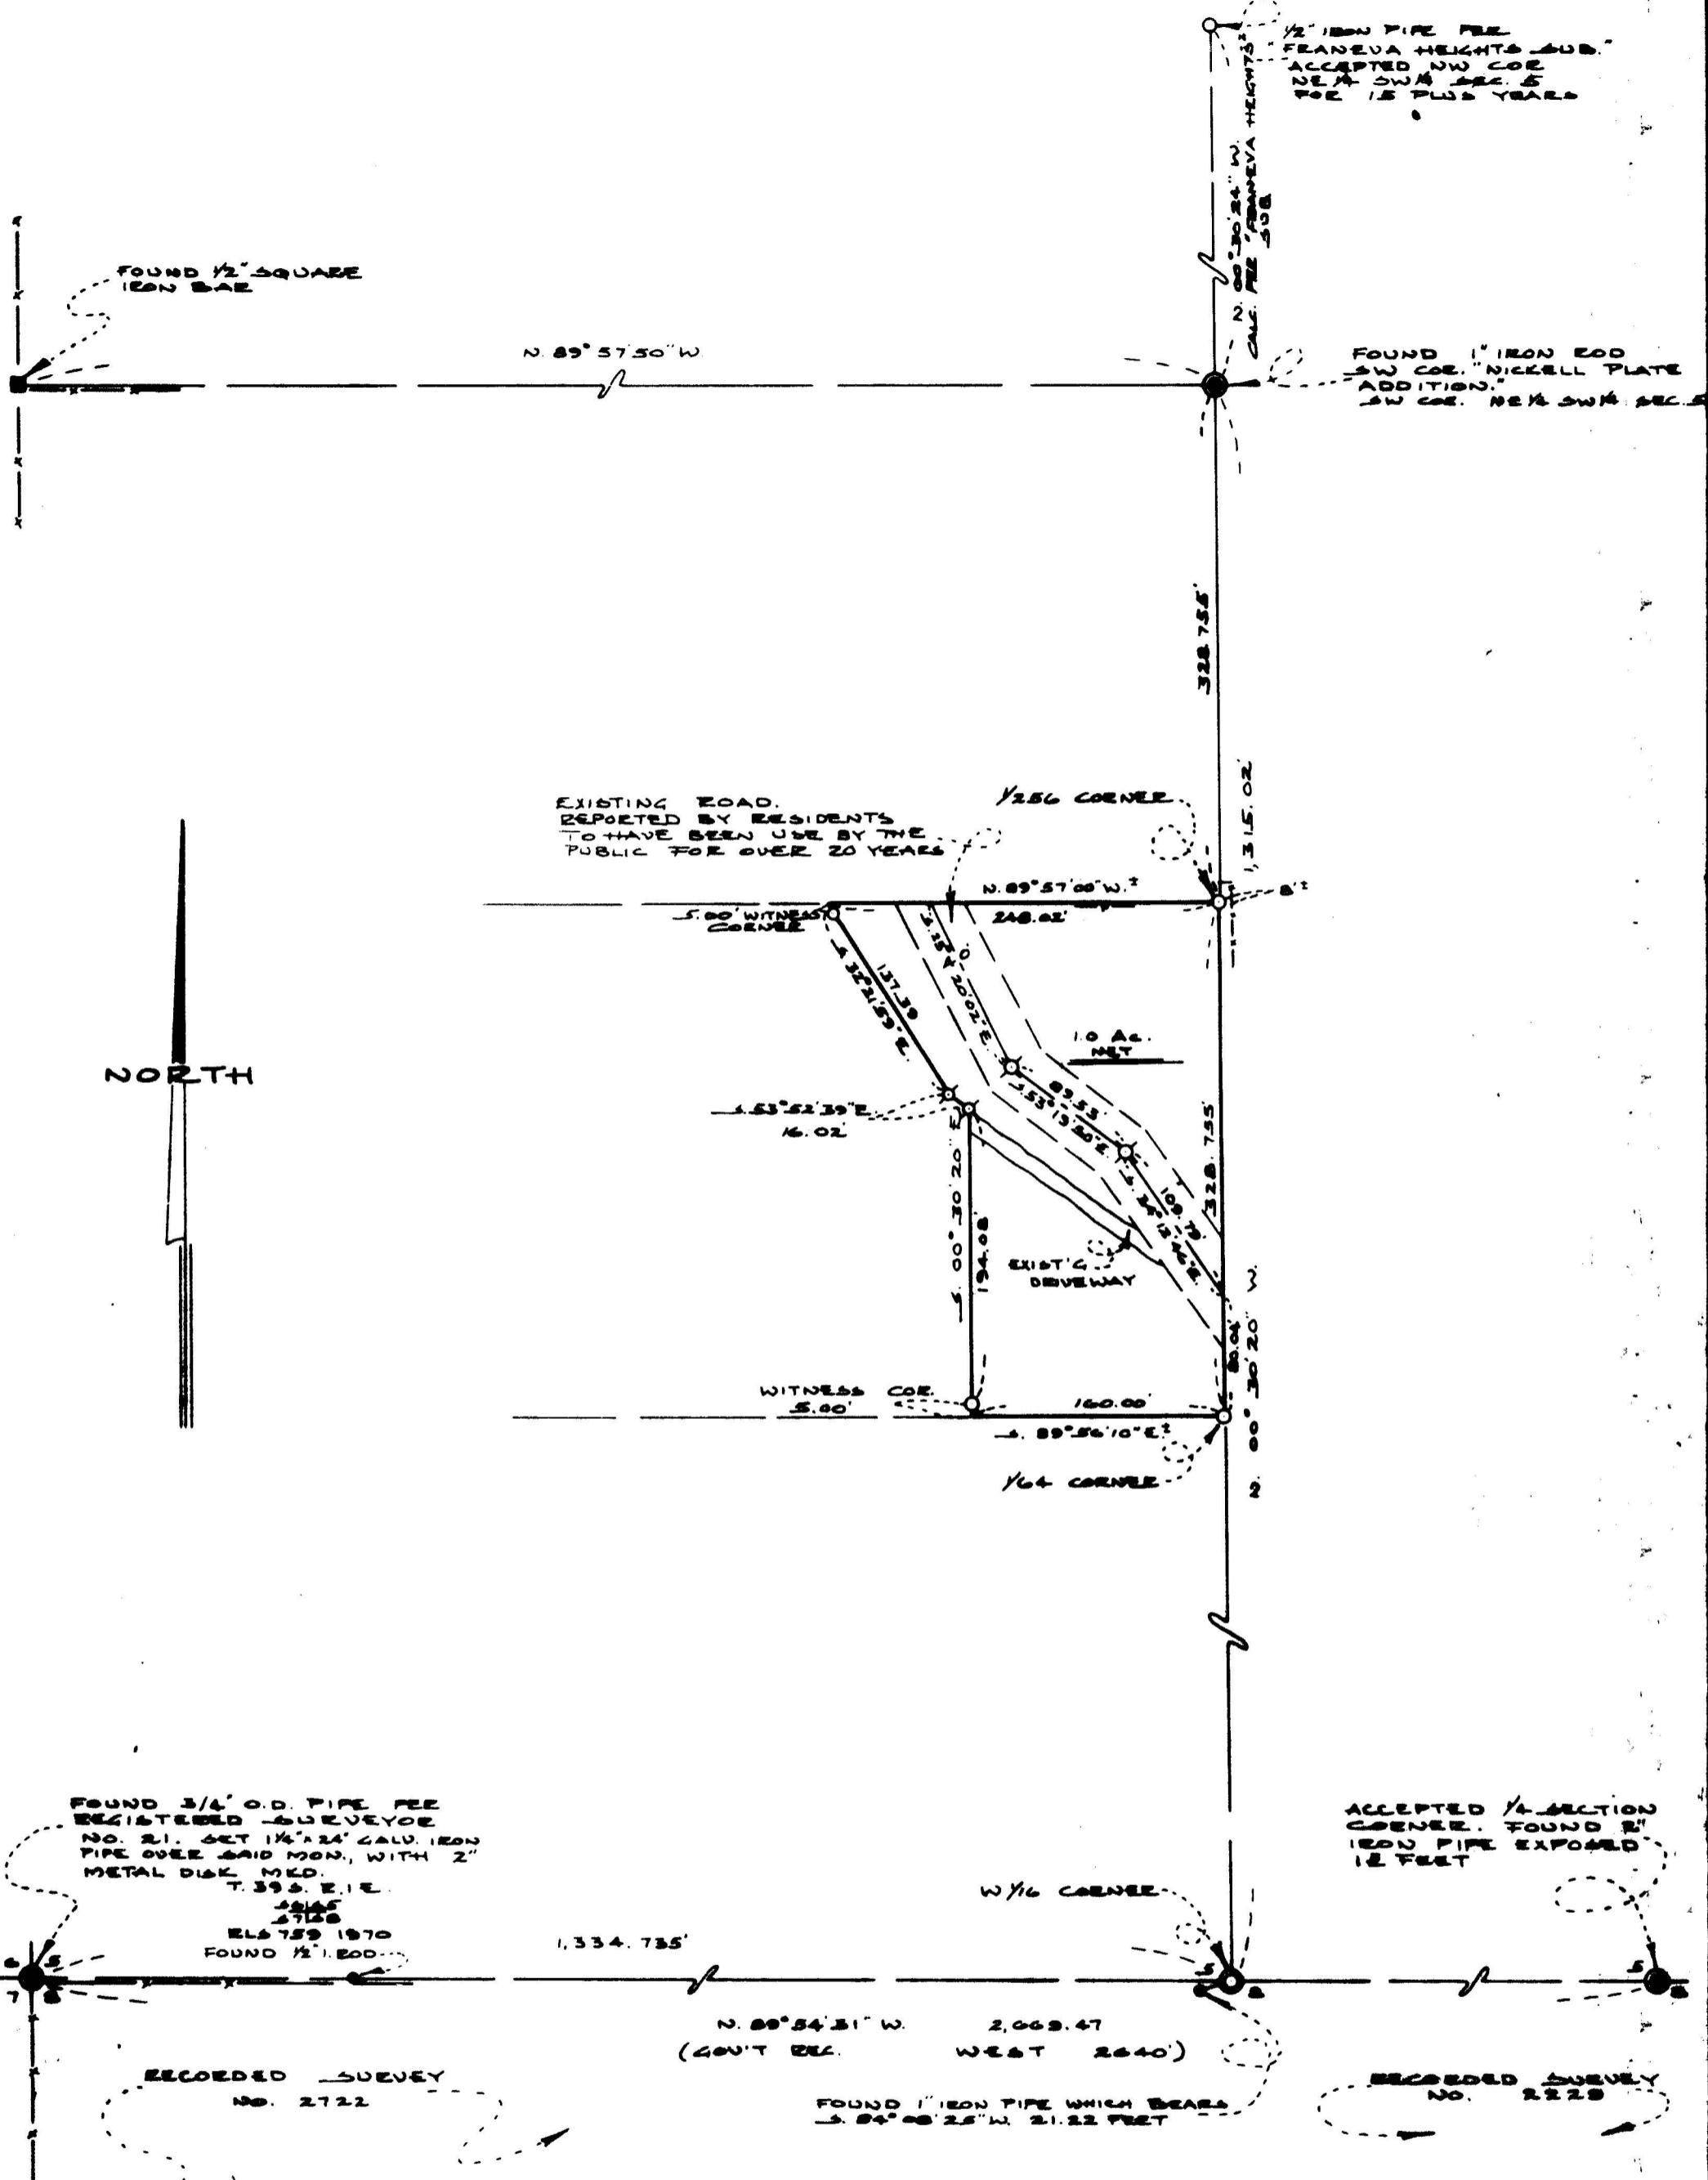
FOUND 3/4" O.D. PIPE PER REGISTERED SURVEYOR NO. 21. SET 1 1/2" x 24" GALV. IRON PIPE OVER SAID MON., WITH 2" METAL DISK MKD. T. 393 E. 1 E. 48145 47155 EL 5759 1970 FOUND 1/2" IRON

ACCEPTED 1/4 SECTION CORNER. FOUND 2" IRON PIPE EXPOSED 12 FEET

FOUND 1" IRON PIPE WHICH BEARS S. 84° 00' 25" W. 21.22 FEET

EVERETT L. SWAIN, S.L.S. ASHLAND, OREGON  
 SCALE: 1" = 100'  
 BASIS OF BEARING: "FRANCOVA HEIGHTS SUB."  
 O - SET 1/2 INCH GALVANIZED IRON PIPE TAGGED EL 5759  
 1 - SET 3/4 INCH GALVANIZED IRON PIPE TAGGED EL 5759  
 2 - SET 1 INCH GALVANIZED IRON PIPE W/ 2" BRASS DISK  
 3 - SET 3/8 INCH IRON ROD TAGGED EL 5759

The Section corner common to Sections 5, 6, 7 and 8, said Township and Range, was again scrutinized. A search was made for the original bearing trees. Past fires have eliminated the possibility of recovering these trees. The monument as shown by Surveyor L. E. Ager, fits the existing improvements quite well. The surplus distance per half mile is very consistent with that found by Surveyor Charles Hurst, when said surveyor ran the North-South centerline of Section 5, said Township and Range. Also, the bearing was computed between said section corner and the found  $\frac{1}{2}$  inch square iron bar on the West boundary of Section 5, said Township and Range. The angle returned per this survey checks Government record within  $0^{\circ}03'20''$ . Therefore, due to the lack of proof positive relating to the original position of said section corner and that the existing monument fits the established improvements quite well, I have accepted this corner in its present location.

- PURPOSE:** To survey, monument and prepare a legal description for a parcel of land 1 acre in size, per clients instructions.
- PROCEDURE:** Commenced this survey at the accepted quarter section corner common to Sections 5 and 8, said Township and Range. Traversed Northwesterly to a 1 inch iron rod reported to be the Southwest one-sixteenth section corner (Southwest corner of Nickell Plate Subdivision) per "Franeva Heights Subdivision" and recorded survey No. 2983. Traversed Southerly tying all monuments that could be found along the North-South centerline of the Southwest quarter of Section 5. In the vicinity of the West one-sixteenth section corner, found a 1 inch iron pipe. Recorded survey No. 2722 reported finding a 3/4 inch iron pipe. A thorough search was made for said 3/4 inch iron pipe with nothing being revealed. Continued said traverse Easterly to the aforementioned quarter section corner. The traverse "Error of Closure" was 1/20,000 plus. The traverse was then balanced by the "Compass Rule Method". The control traverse was continued from the vicinity of the West one-sixteenth section corner Westerly to a 3/4 inch pipe reported to be the section corner common to Sections 5, 6, 7 and 8, said Township and Range, per recorded survey No. 2722. The control traverse was extended from the vicinity of the Southwest one-sixteenth section corner to the vicinity of the South one-sixteenth section corner common to Sections 5 and 6, said Township and Range. A review of the survey records at City Hall, Ashland, Oregon revealed that on March 18, 1889 Mc Call ran from some unknown North-South line South  $89^{\circ}56'$  West 2,661.35 feet to the West line of Section 5. This East-West line is shown to be 9.65 chains Southerly of the North boundary of Nickell Plate Subdivision. Therefore, I believe he was on the East-West centerline of the Southwest quarter of said Section 5. A search in the vicinity of the South one-sixteenth section corner revealed a  $\frac{1}{2}$  inch square iron bar, situated in the North-South fence line. There still remains some evidence that a fence was located Easterly from this found monument. This survey returns a distance of 1,326.25 feet between said  $\frac{1}{2}$  inch square bar and the 1 inch iron rod at the Southwest corner of Nickell Plate Subdivision. Mc Call indicated the distance would be 1,330.65 feet or one-half the distance between the North-South line and the West boundary of said Section 5. At this time I might add that this survey returns a distance of 2,660.97 feet from the found  $\frac{1}{2}$  inch square iron bar to the North-South centerline of Section 5, said Township and Range.
