SURVEY IN SE 1/4 SEC 12 T38S RIW WM
FOR
CLOY SMALL

EDWARD A. MCGINTY
MEDFORD OREGON
APRIL 1972

SURVEY NARRATIVE TO COMPLY WITH O.R.S. 209-250

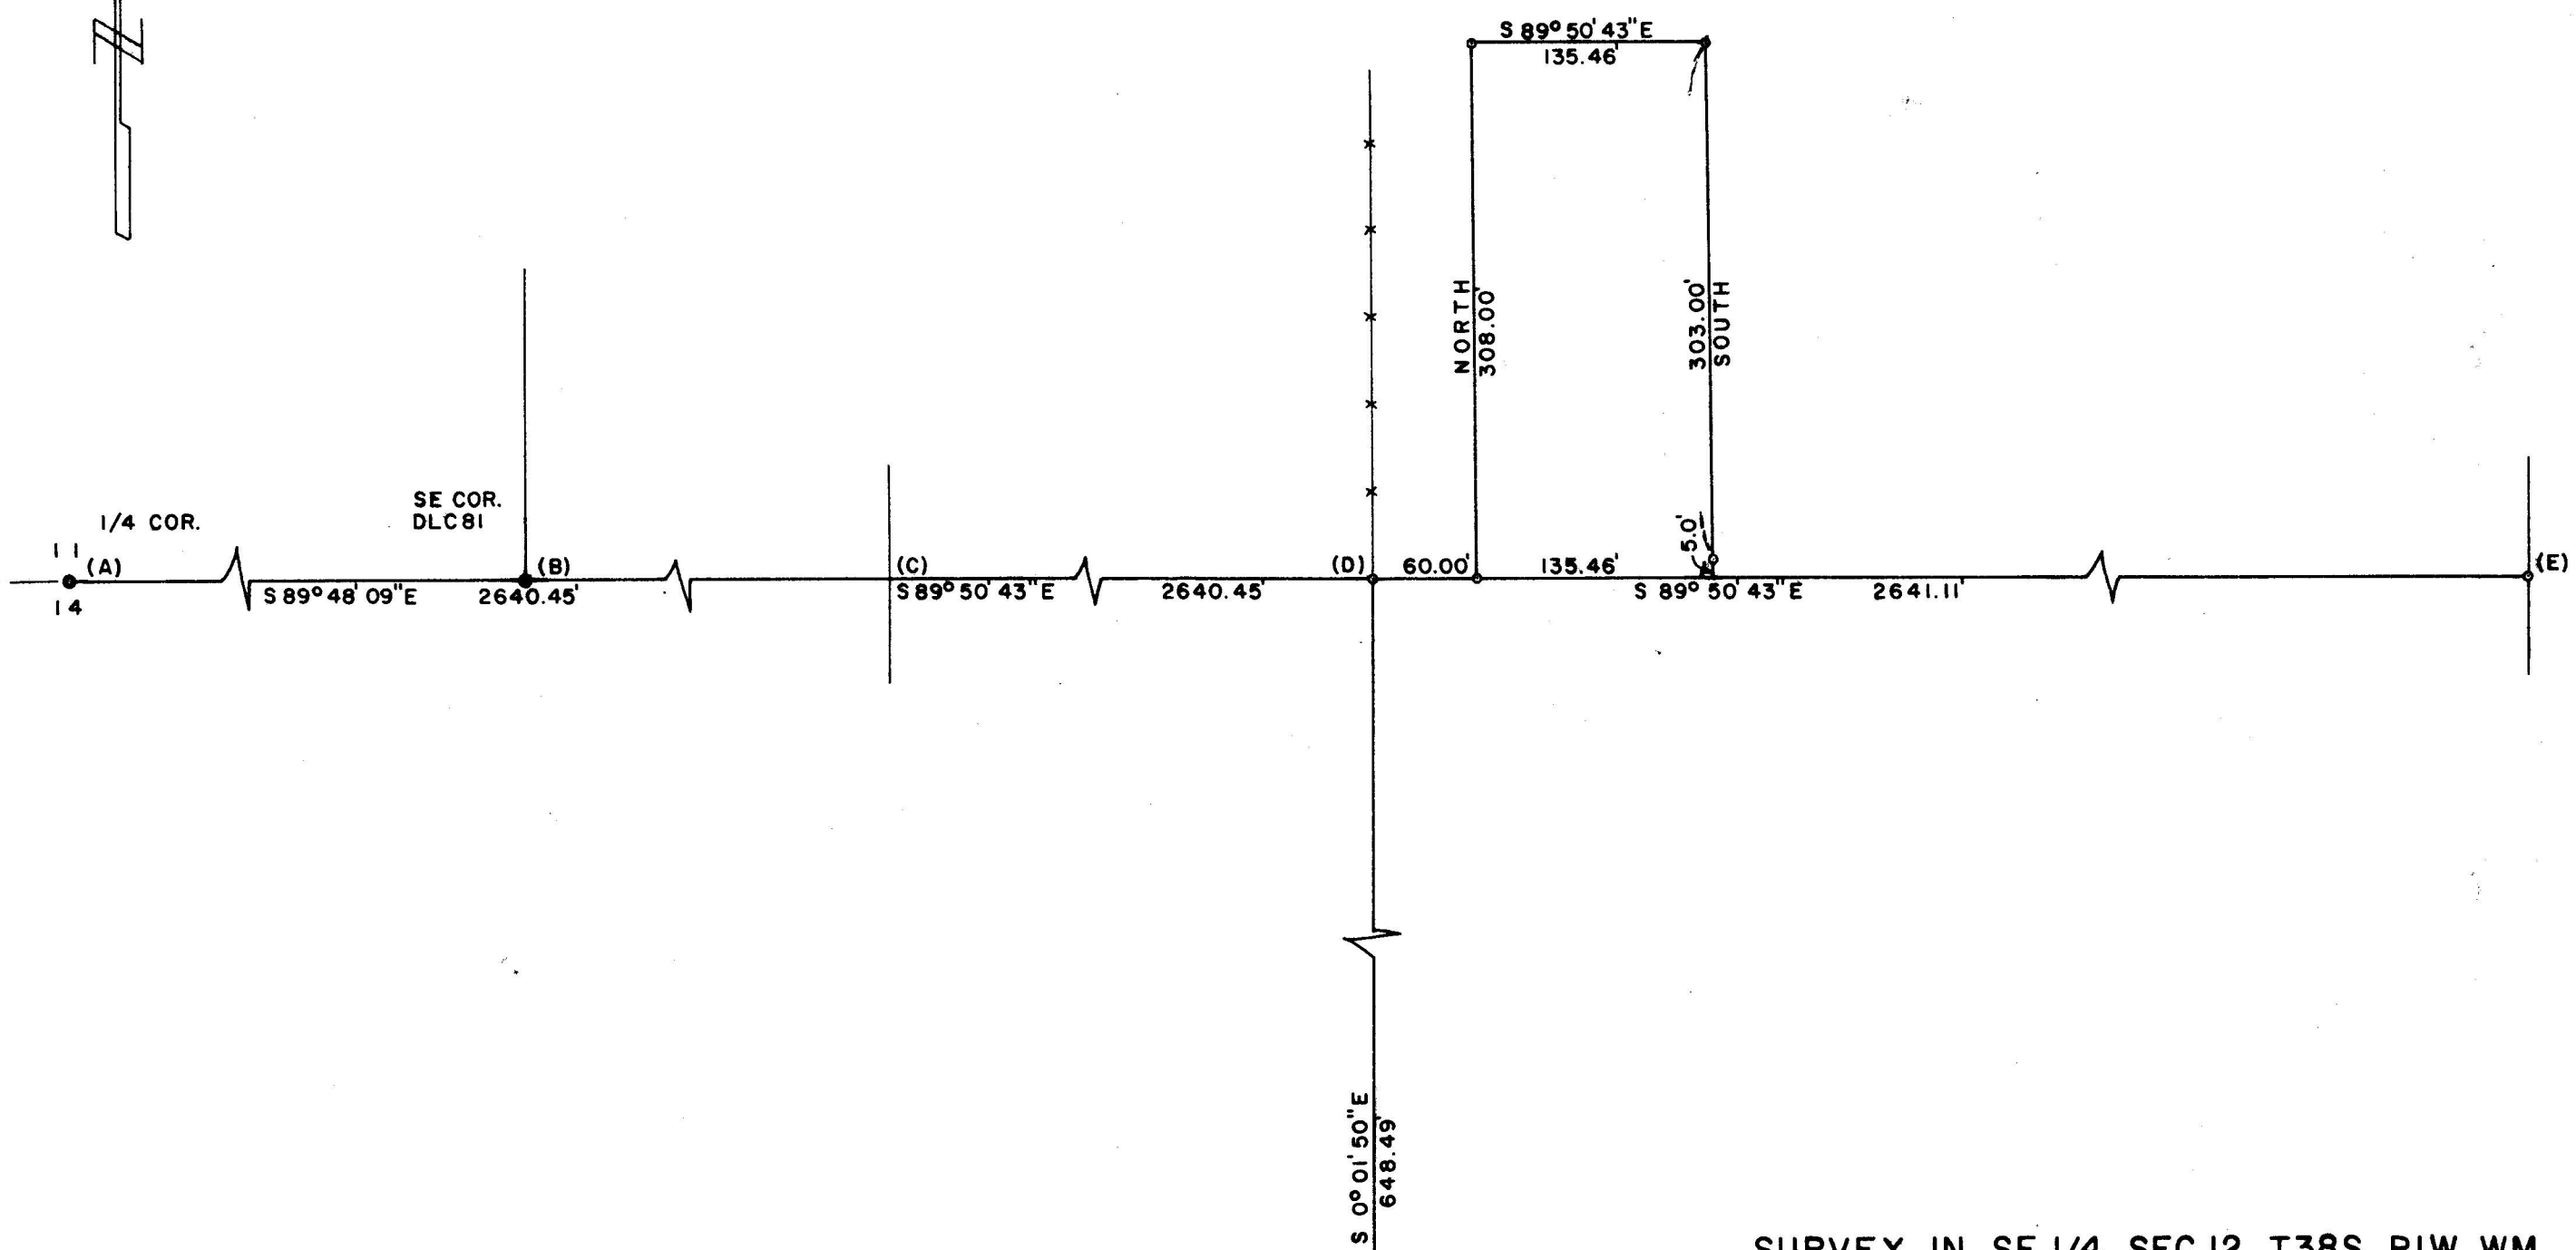
72-18

FD 1. AXLE

SCALE 1" = 100'
SET 5/8" I. PIN

Surveyed tract of land as shown, subject to any portion within public r/w or which may be southerly of the south line of Sec. 12. The southerly line, as shown, was determined by the following procedure; from the county survey re-estab. 1/4 corner betw. Secs. 11/14, ran S.89°48'09"E through the southeast corner of DLC 81, a distance of 2640.45 feet (record S.89°47'E., 2640.00 ft.) to a point midway from the 1/4 cor. and Point D which is average fence line running northerly and old iron axle which bears southerly at Point C; thence S.89°50'43"E., 2640.45 ft. (record S.89°48'00"E., 2640. ft.) to Point D, being the best location for the east west distance, with evidence so far recovered (close agreement with the officially recorded old fence line which has been in the same place for approx. 60 yrs. etc.; thence continuing S.89°53'43"E., 2641.11 ft. to point E where I found a 3/4 inch iron pipe which was indentified to me by an old time resident of 30 yrs., which had been identified to him by and old time resident when he moved into the area as the only good section corner within miles. This 3/4 iron pipe was replaced with a 5/8 in. iron pin, 30 ins. long, in an old rock mound which previously had been a fence corner, evidence of old fence running northerly.

In 1958 a P P & L survey accepted pipe as Section corner But failed to tie in witness trees. They cleared the area around said corner for construction of power line, also rebuilt East-west fence, approx. 8 ft. southerly. Found no evidence of trees because of the 1958 construction, this location is possibly the best location for the section corner, with evidence so far as found.

Calculation to coordinates placed by BCVSA. Survey to Section corner to the south and it does not conform too close to record.
