Survey by: L.J. Friar P.L.S. 961. Medford, Oregon

SURVEY NARRATIVE TO COMPLY WITH PARAGRAPH 209.250 O. R. S.

November 30, 1973

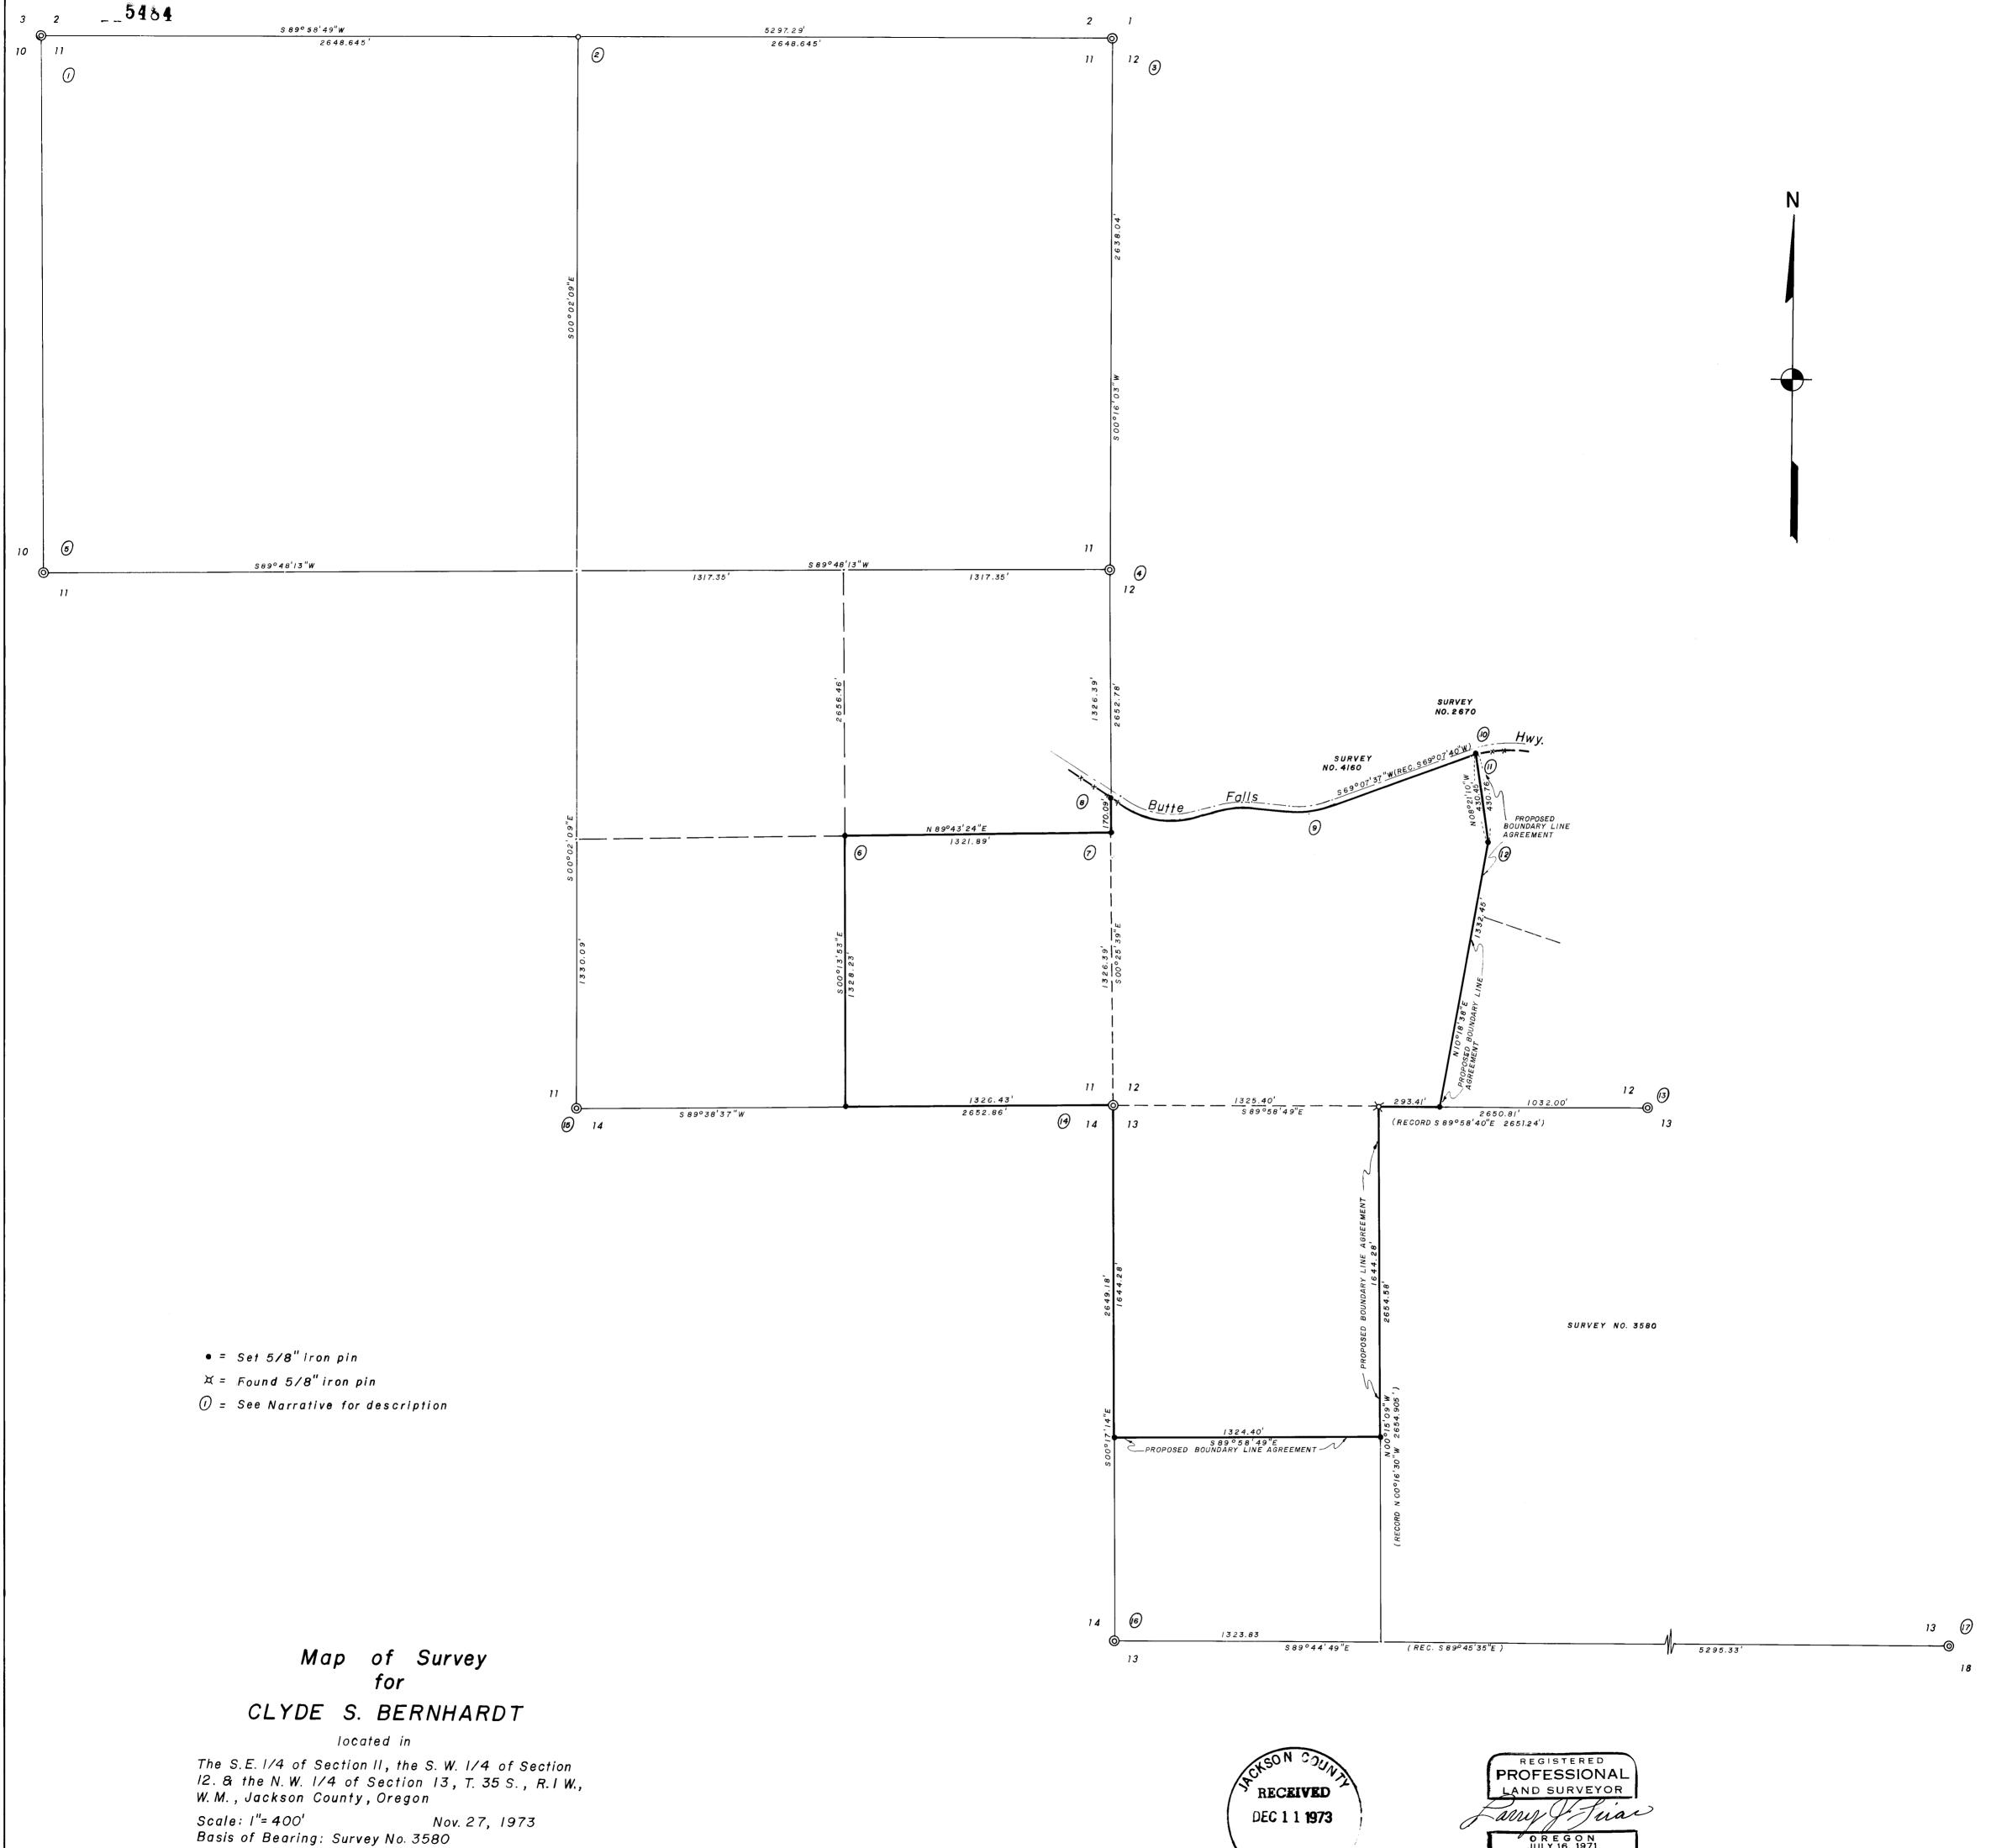
- 16. ½ Corner Sections 13 and 14 found 3/4 inch iron pin with Brass cap stamped L. S. 483, 1966.
- 17. ½ Corner Section 13, T. 35 S., R. 1 W. and Section 18 T. 35 S., R. 2 W., Fd. 5/8 inch iron pin set on Survey No. 3580.

- 4. $\frac{1}{4}$ Corner common to Sections 11 & 12, found $2\frac{1}{2}$! dia capped pipe per County Surveyors Re-establishment notes, the Bearings trees have been destroyed.
- 5. Corner common to Sections 10 and 11, found 1" dia, iron pipe per County Surveyors Re-establishment notes.
- 6. S. E. 1/16 Corner Section 11. The Corner falls in the South face of 18" dia. Madrone.

- 7. N. 1/16 Corner Sections 11 and 12, Set 5/8 inch iron pin in North-South fence line, found 2½ inch dia. capped iron pipe S. 27°51'52" W. 3.53 feet.
- 8. Set 5/8 inch iron pin Witness Corner in North-South fence line 1.5' South of Right of Way fence.
- 9. Re-established Highway Centerline P. I. from County Road Department R. P. Notes.
- 10. Found concrete nail on Highway Centerline at Pr. Cl. Star. 126+82.27.
- 11. Set 5/8 inch iron pin witness corner on East side fence corner post.
- 12. Set 5/8 inch iron pin in remains of East-West fence line on the Northerly projection of North-South fence line.
- 13. % Corner Corner Sections 12 and 13. Found 5/8 inch iron pin on S. Side Fence Corner post, from which bears;

- 14. Section Corner common to Sections 11, 12, 13 & 14 found 2½ dia. galv. Iron pipe per County Surveyors Re-establishment notes.
- 15. % Corner Sections 11 and 14 found stone marked % per County Surveyors Re-establishment notes, no bearing trees remain.

The Corner monuments used in this Survey, found and set are listed below.

- N. W. Corner of Section 11 found County Surveyors Brass Cap Per Re-establishment notes.
- 2. North & Corner Section 11, made extensive search of area around computed & Corner position, no evidence of corner exists. No monument was set at this corner.
- N. E. Corner Section 11, set 5/8" x 30" Iron pin 3. in Rock Mound, from which bears;
