# DEPENDENT RESURVEY

LOCATED IN  
SW 1/4 OF SE 1/4 OF SEC. 14, TWP. 39S., R. 1E.W.M.  
JACKSON COUNTY OREGON  
FOR

SURVEY NO. 5661

SURVEY NARRATIVE TO COMPLY WITH PARAGRAPH 209.250  
OREGON REVISED STATUTES

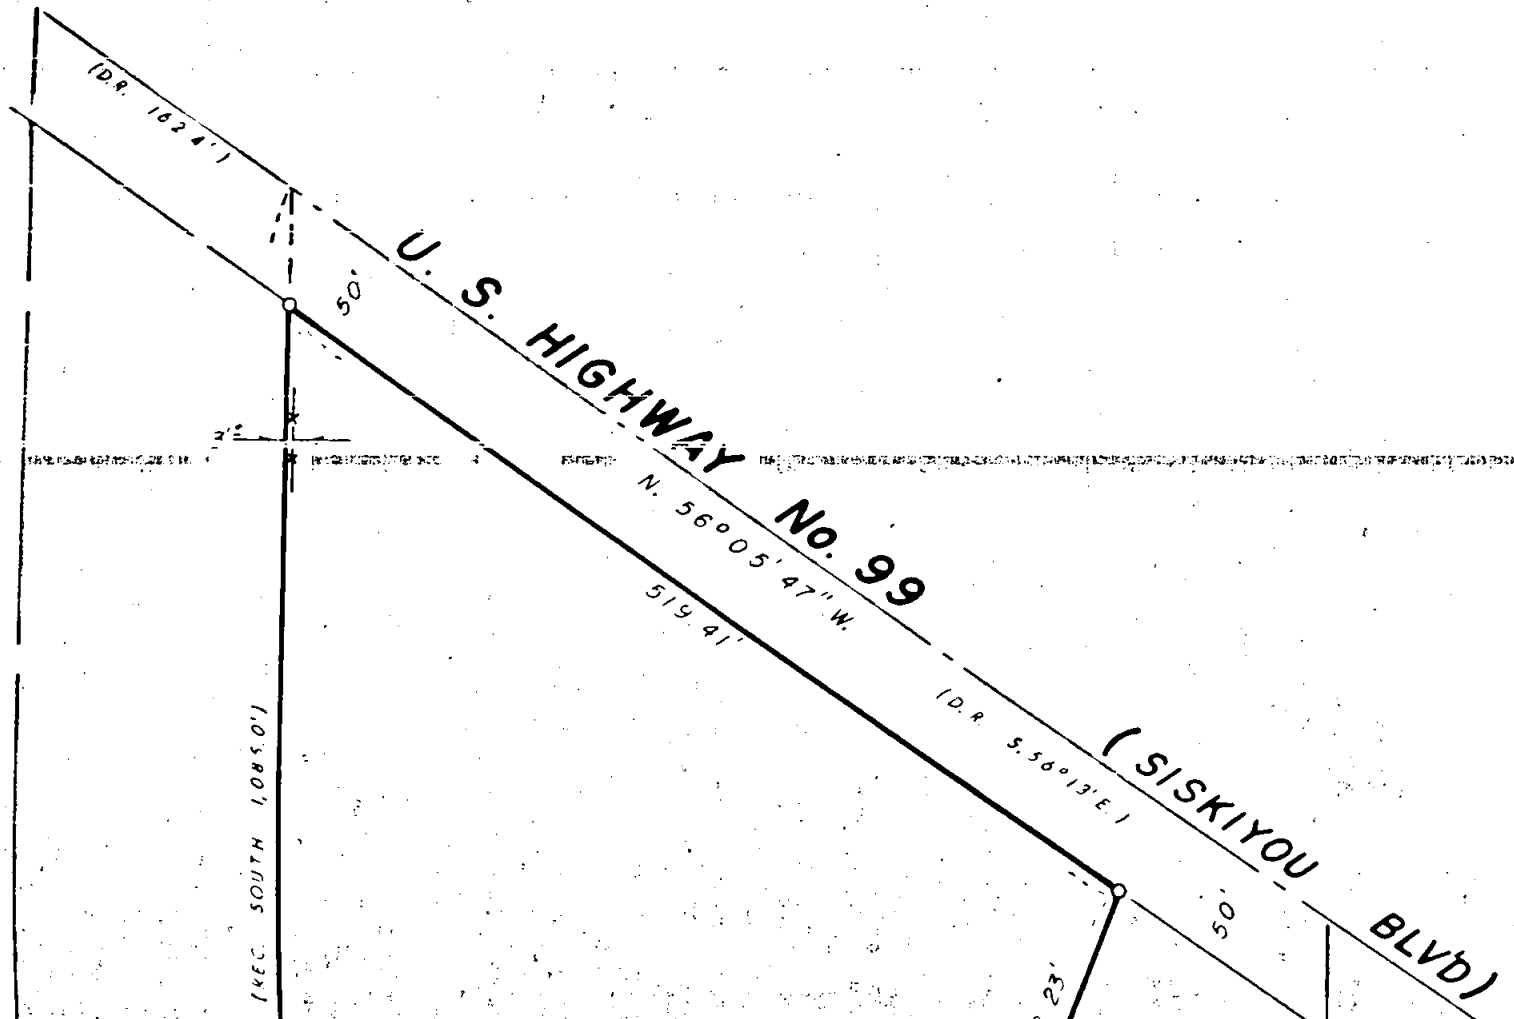
1/4 CORNER  
LOCATION DETERMINED  
FROM PREVIOUS TIE TO  
THE "ASHLAND CONTROL NET"

SECTION CORNER  
LOCATION DETERMINED  
FROM PREVIOUS TIE TO  
THE "ASHLAND CONTROL NET"

SECTION CORNER  
FD. PIPE W/BR. CAP  
per C.S. RE-EST'S

SCALE: 1" = 100'  
BASIS OF BEARING:  
N.O.A.A. TRUE BEARING N-S & SEC. 14  
● FOUND MONUMENTS AS SHOWN  
○ SET 5/8 x 24 INCH IRON PIN TAGGED RLS 759

THIS POINT FALLS  
IN A FENCE CORNER  
FENCES RUN  
NORTH-SOUTH  
EAST-WEST

1/4 CORNER  
FD. 1" G.I. PIPE  
W/BR. CAP

FD. 1/2" G.I. PIPE WHICH BRS.  
N. 88°51' W., 0.40'

E 1/16 CORNER  
(NO POINT SET)

N. 89°34'48" W. 2,665.95'  
(GOV'T REC. S. 89°54' E., 2,645.94')  
(MC CALL N. 89°30' W., 2,651.82'  
(BOOK 8, PAGE 208 21, APRIL 12, 1897)

RD. 842.40 (GOV'T REC. 844.8)  
SW COR. D.L.C. No. 52  
FD. G.I. PIPE W/BR. CAP  
C.S. RE-EST'S

SECTION CORNER  
SET 2" x 20" G.I. PIPE  
W/3" BR. CAP AND  
SWAIN SURVEYING  
1975 R.I.E.  
514 513  
SEC 523 524 COR  
RLS 759 1974

PROCEDURE: The section line common to Sections 14 and 23, East of the North quarter corner of Section 23, was needed for this survey. With the lack of section corners to the East of the section corner in question, to provide for a double proportion, the ties of the original Government Donation Land Claim notes were employed. After computing the location for said section corner, the section line alignment was checked in relation to the existing fence and checks within reason. Also, information was found in McCall's field Book 8, page 20 and 21, dated April 12, 1897, which indicates he ran this line. His corners were looked for with negative results. However, the calculated results check McCall's values within reason. The remainder of the data necessary to establish said survey was taken from the Ashland Control Net.
